Accident to the SCHLEICHER - ASH25
registered **F-CLMR**
on 14 March 2022
at Volonne

Time	Around 13:25 ¹
Operator	Centre Savoyard de Vol à Voile Alpin
Type of flight	Instruction
Persons on board	Instructor and pilot under instruction
Consequences and damage	Glider substantially damaged

Collision with terrain during mountain flight, in instruction

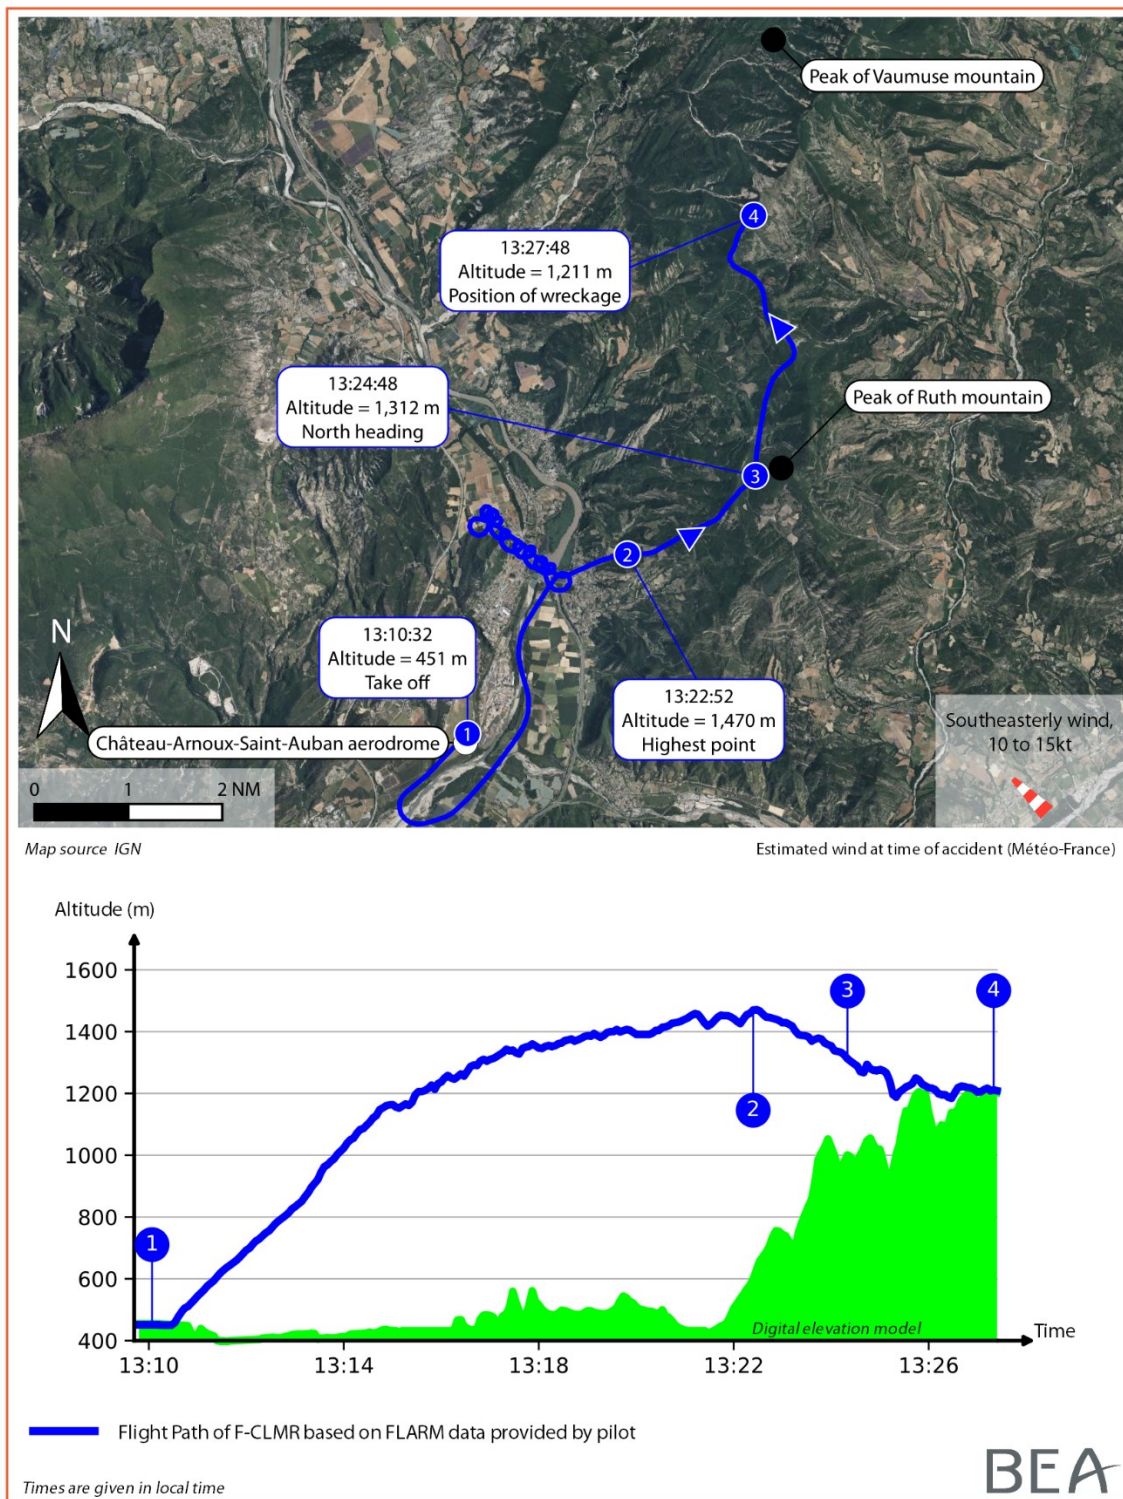
The pilot under instruction, accompanied by the instructor, carried out a towed take-off at 13:11. After using updrafts around the Durance river dam and reaching an altitude of 1,470 m, he headed north, passing onto the lee side of the terrain where the glider encountered a strong downdraft. The instructor took over the controls and followed the ridge line of Ruth mountain at an altitude of about 1,200 m. The altitude of the terrain overflown increased, and the glider came closer to the ground. The instructor turned to the right, the glider lost altitude, hit the branches of a tree and collided with the ground 30 m further on.

Figure 1: flight path of glider
