Accident to the SCHEMPP HIRTH - JANUS C
registered **F-CLUI**
on Monday 23 October 2023
at Bagnères-de-Luchon

Time	Around 14:30 ¹
Operator	Aéroclub Aire sur Adour
Type of flight	Instruction
Persons on board	Instructor, student pilot
Consequences and damage	Glider substantially damaged

Long landing, runway overrun, ground loop, in instruction

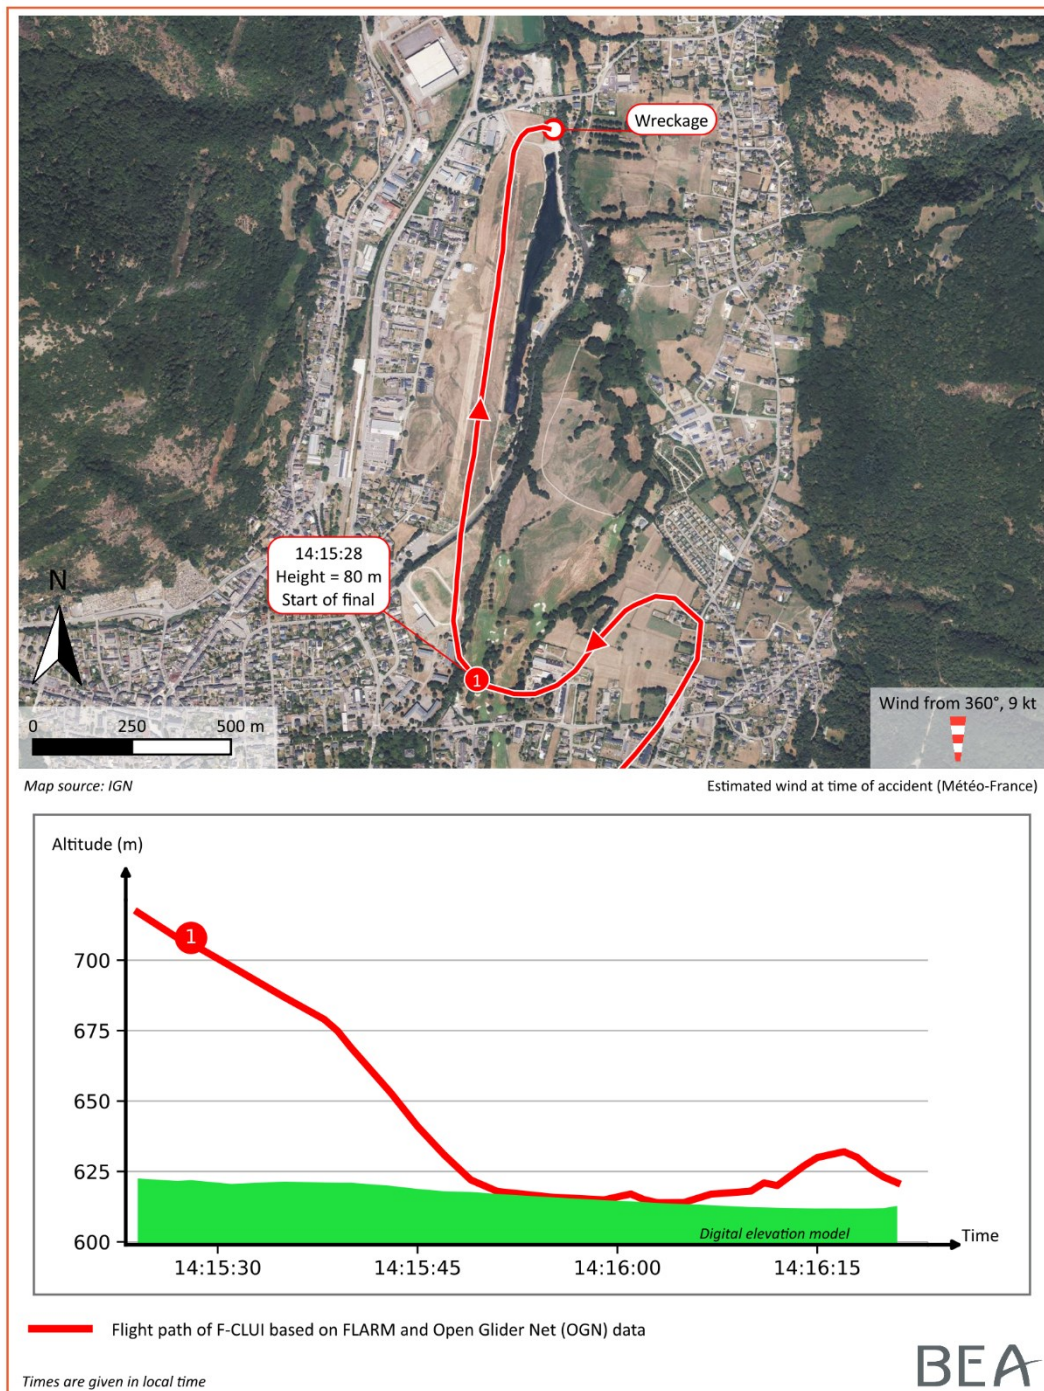
He joined the end of the downwind leg for runway 01². He configured the glider for landing. The approach seemed stabilized to him with a speed of around 115 km/h for an aiming point at the runway threshold. When flaring, the instructor was surprised that he was unable to absorb the speed and land. The glider flew over the runway at one metre from the ground before bouncing mid-runway. On arriving at the end of the runway, the instructor pitched up to avoid the perimeter fence and then banked the glider to the RH side. The glider touched down and then performed a ground loop before coming to a stop perpendicular to the runway. The fuselage broke.

Figure 1: flight path of F-CLUI

The ground speed was estimated based on the data from the OGN and the glider's FLARM. A steady increase in speed was observed during the final approach, up to a maximum speed of around 130 km/h during the flare. The presence of gusts means that it is not possible to accurately determine the glider's air speed during this flight phase; if we take a mean speed of 9 kt for a wind from 360°, we can estimate that the air speed reached 145 km/h during the flare.

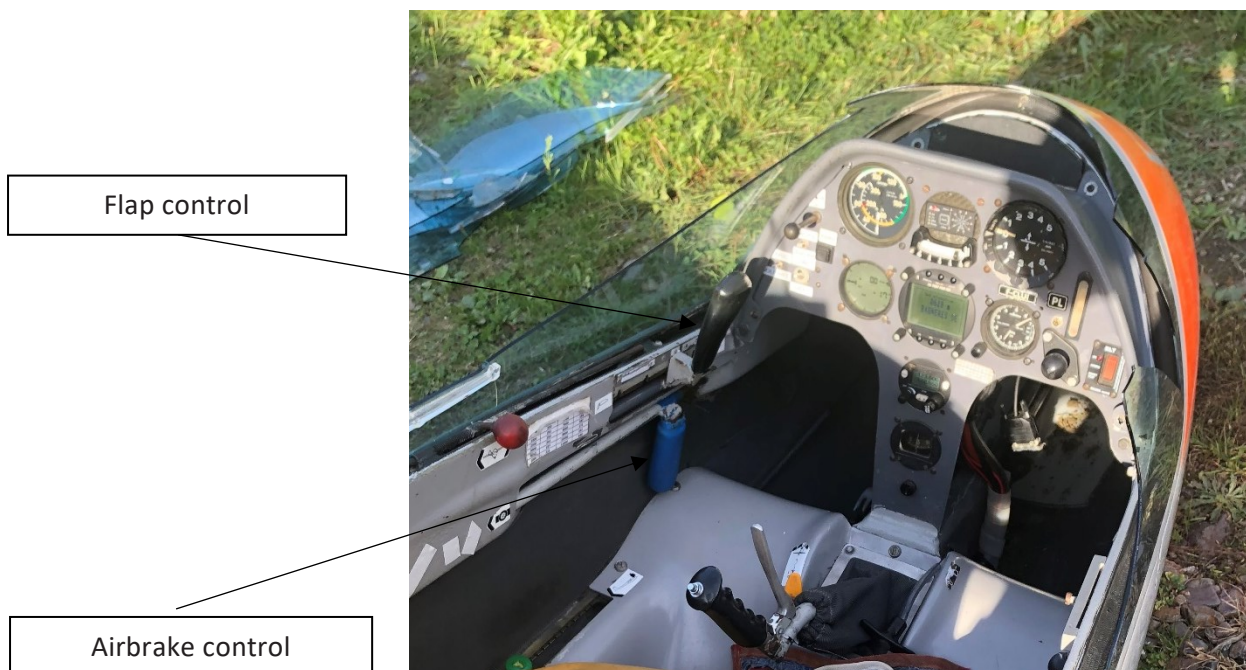
The airbrake control is located on the LH side of the cockpit, pointing downwards. When it is in its forward position, the airbrakes are retracted and locked. When it is pulled by around four centimetres, the airbrakes are unlocked. Beyond this distance, the airbrakes are extended according to the position of the control. There is no detent. The feedback provided by the French glider federation (FFVP) during the investigation indicated that on this type of glider, if the handle is not held in position, the airbrakes can move slowly towards the retracted position.

The flap control is positioned above the airbrake control, and points upwards. There are five detents³ for the five configurations: landing, +8°, 0°, -4° and -7°. When the control is in its forward position, the flaps are in the landing configuration.

Figure 2: photo of forward cockpit

The instructor terminated the flight shortly after taking off as he believed that the conditions were not suitable for an instruction flight. During the final approach, after positioning the flaps in the landing configuration, he very probably kept his hand on the flap control instead of returning it to the airbrake control. The airbrakes, half open in the base leg, very probably retracted without the instructor realising this. During the flare, the instructor was unable to land. The glider bounced and flew over the length of the runway. After passing over the fence at the end of the runway, the instructor banked the glider so that the right wing would touch the ground and the glider would make a ground loop in order to stop before the obstacles.

In 2015, the FFVP published an article entitled "[La confusion des commandes, comment s'en protéger](#)" discussing how controls may be confused and how to avoid this.
