Accident to the ROLLADEN SCHNEIDER - LS4
registered **F-COKE**
on 15 August 2022
at Aillon-le-jeune

Collision with trees on a ridge, in slope soaring flight

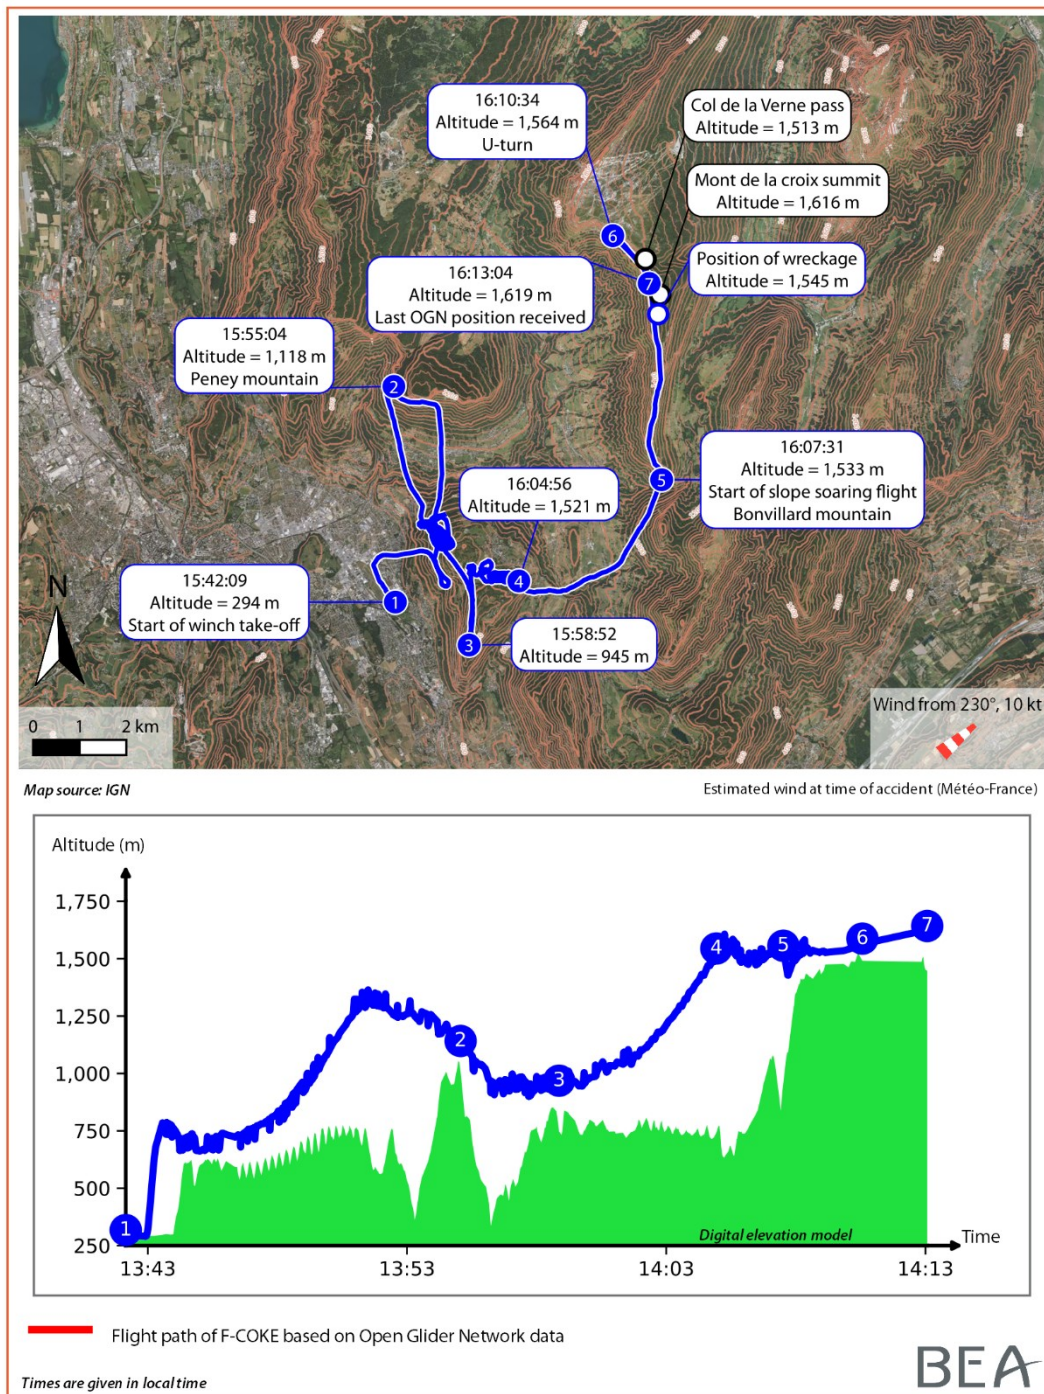
The pilot carried out a winch take-off (see *Figure 1*, point ①) at around 15:45 from Chambéry – Challes-les-Eaux airport. After using an uplift and reaching an altitude of approximately 1,350 m, the pilot headed towards Peney mountain ②, but in the absence of uplifts, started back towards the airport. He managed to use a new uplift up to 1,600 m ④ before heading towards the west slopes of Bonvillard mountain ⑤ and tracking in slope soaring flight north. The pilot carried out a U-turn ⑥ and still in slope soaring flight headed south. He had just flown over the Col de la Verne pass (1,513 m) ⑦ when the glider's wing caught tree tops situated on the ridge close to the summit of Mont de la Croix (1 616 m). The destabilised glider collided with trees and then the ground. The pilot, slightly injured, was able to contact the flying club by telephone and help guide the rescue services to his position.

Figure 1: flight path followed by pilot (source: BEA)

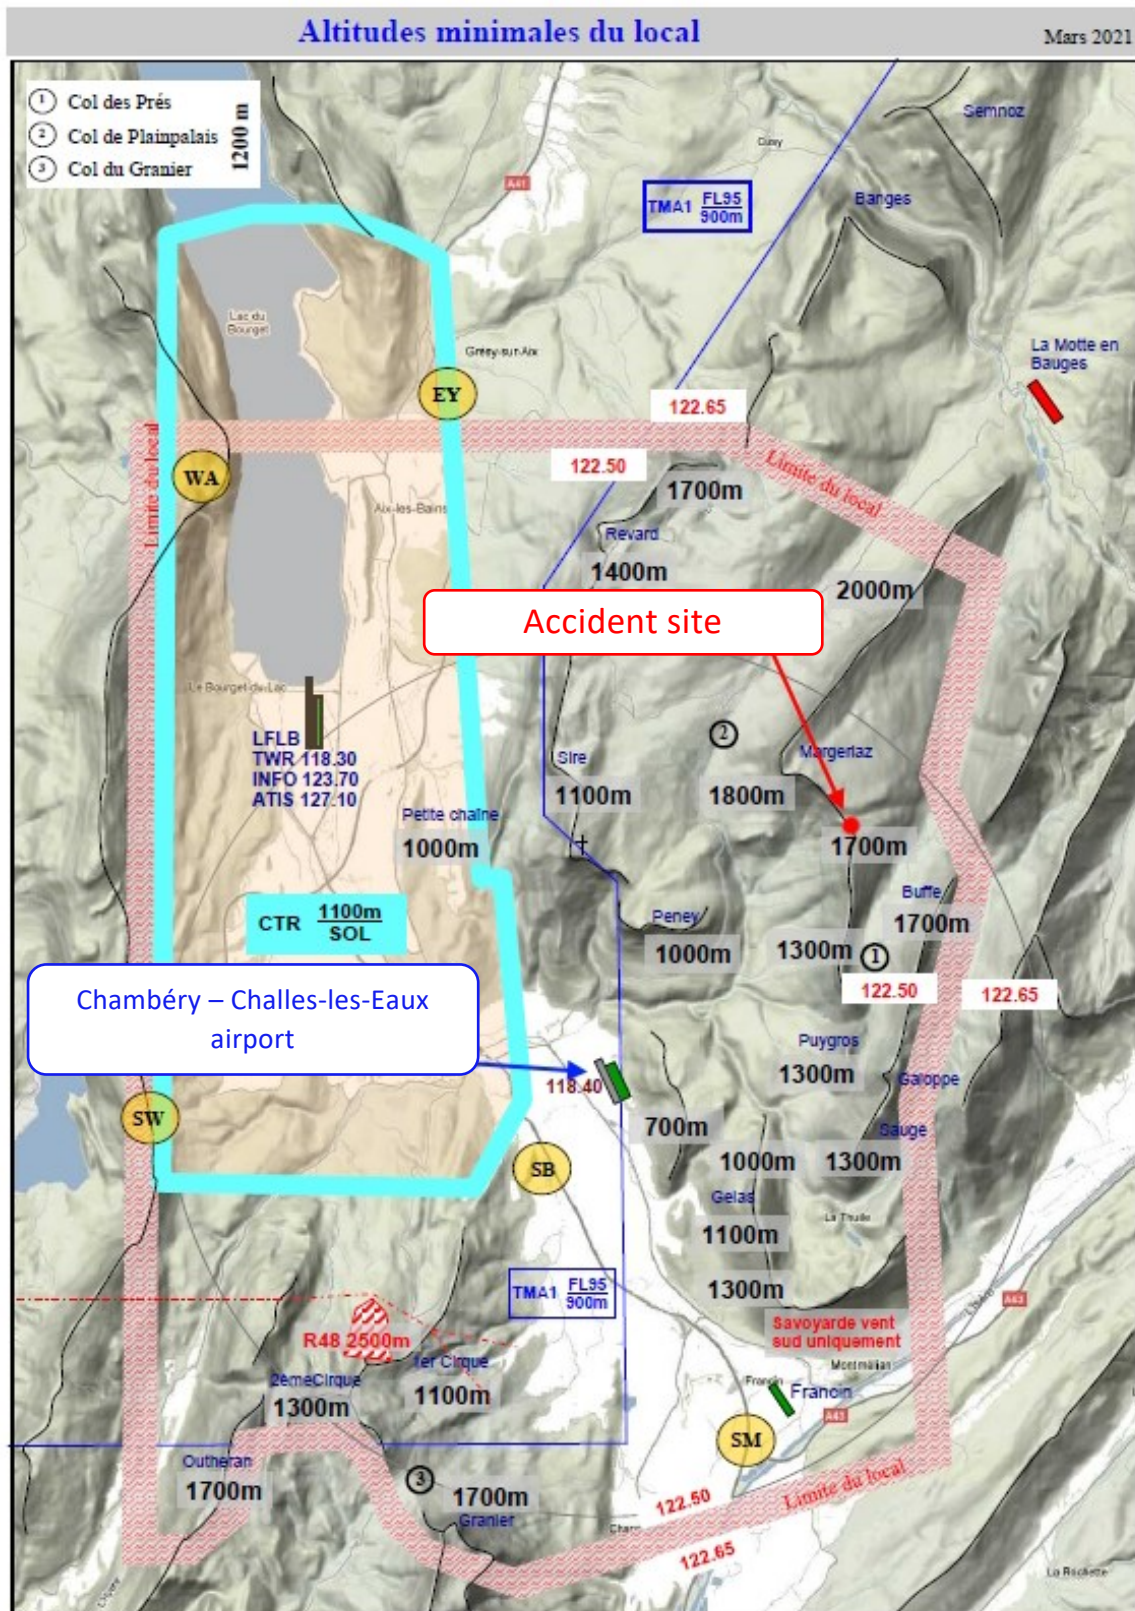
The flying club, CSVVA, given the mountainous environment around the airport, had defined on a map of the region, the local flight limits and the minimum altitudes which pilots were to comply with at various key points. The pilots who do not hold a licence but do have a "Pass" must manoeuvre in the local flight volume defined on the map. The accident flight occurred in the lateral limits of the local area. However, the weakness of the uplifts encountered during the slope soaring flight along the west slopes of Montvillard mountain resulted in the pilot descending to the altitude floor of the local flight area defined by the club.

Figure 2: map showing “Minimum altitudes in local area” (source: CSVVA, annotated by BEA)
