Accident to the SCHEMPP HIRTH - NIMBUS 2
registered **F-CPAT**
on 16 August 2022
at Gruffy

Time	Around 13:40 ¹
Operator	Private
Type of flight	Local
Persons on board	Pilot
Consequences and damage	Pilot fatally injured, glider destroyed
This is a courtesy translation by the BEA of the Final Report on the Safety Investigation. As accurate as the translation may be, the original text in French is the work of reference.

Collision with trees during a precautionary landing

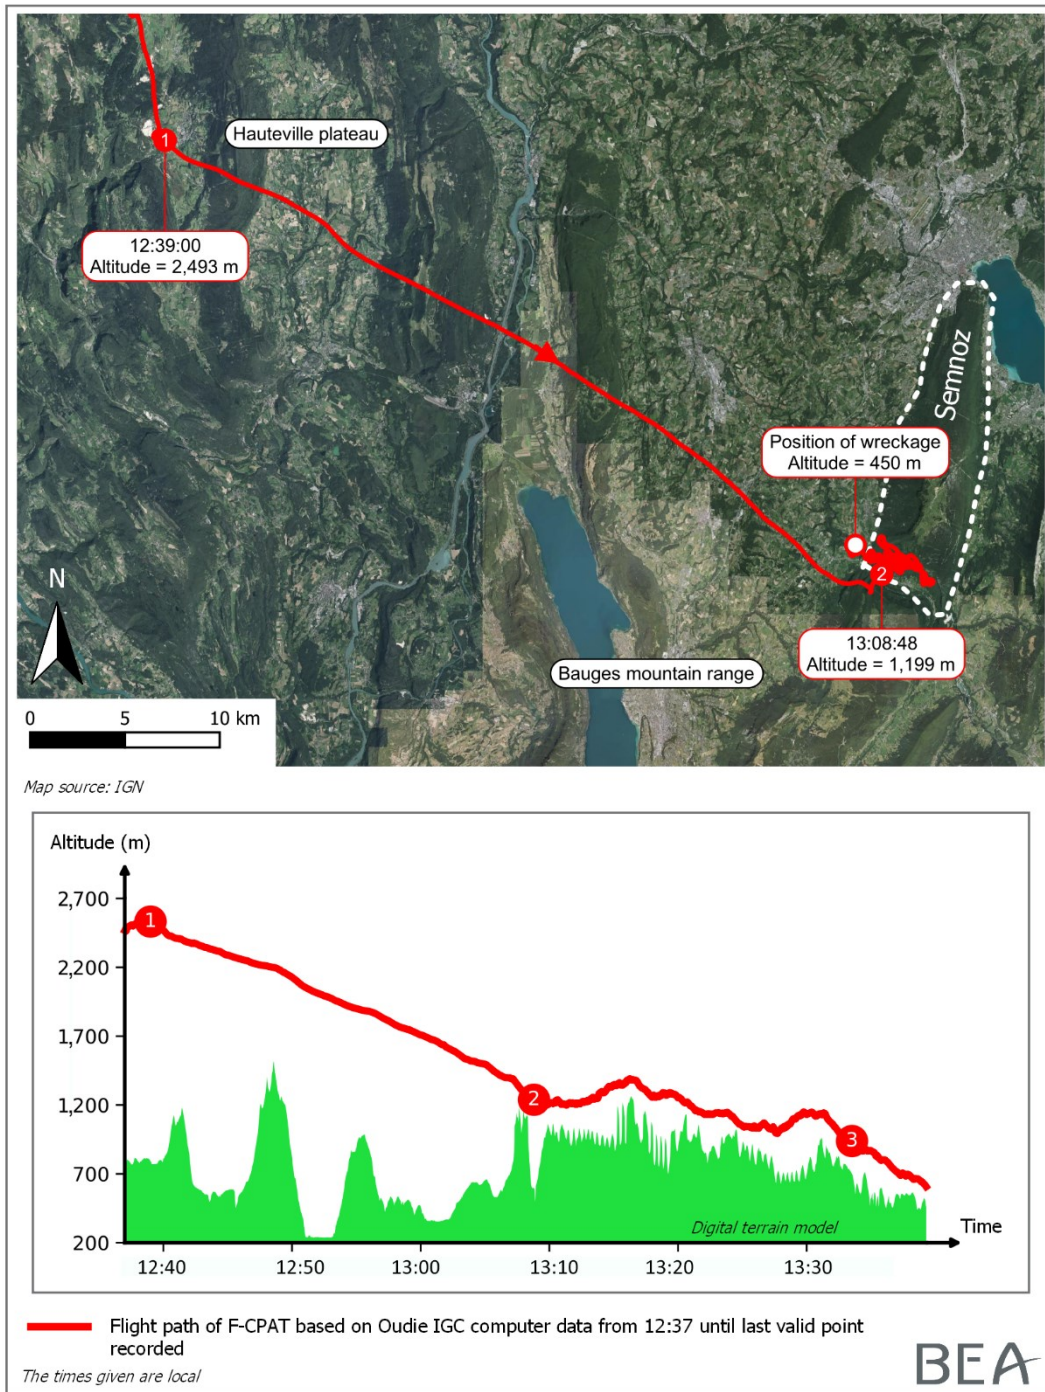
Figure 1: flight path

The pilot carried out a towed take-off at 11:45 from Oyonnax aerodrome (Ain). He headed south towards the Hauteville plateau which he reached at an altitude of approximately 2,500 m at 12:40 (see *Figure 1*, point 1). He then turned to the south-east towards the Bauges mountain range, with the glider's altitude gradually decreasing. He entered the mountain range at around 13:00, reaching the south-west slope of Semnoz mountain a few minutes later at an altitude of around 1,200 m, corresponding to a height in the order of 650 m with respect to the valley (point 2). The pilot manoeuvred over the south-west slope for more than 30 min while the glider progressively lost altitude.

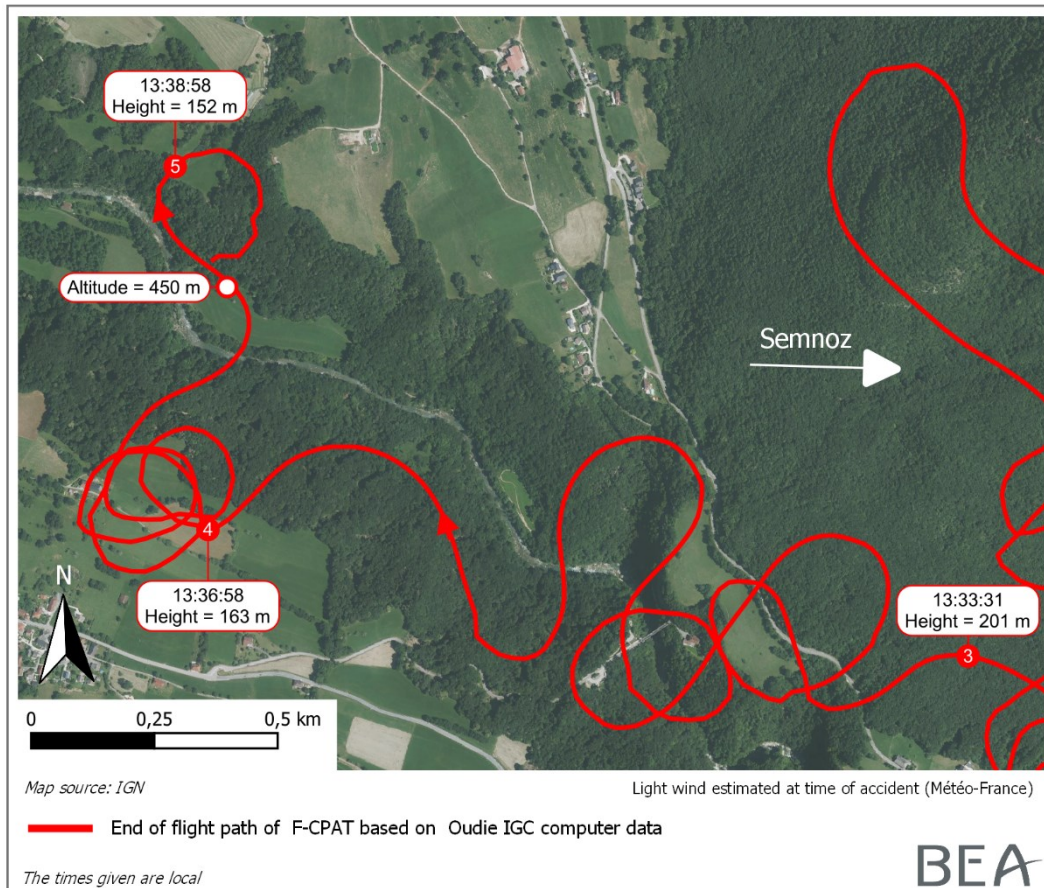
Figure 2: end of flight path

At an altitude of around 900 m (height of 450 m with respect to the valley (see *Figure*, point 3), the pilot drew away from the slope and headed towards the valley while continuing to perform manoeuvres. The glider continued to descend. The pilot carried out a series of spirals in the valley at a height of around 160 m (point 4) before heading north over a distance of approximately 600 m. He then made a right-hand 180° turn over a wood while descending (point 5) before he seemed to start a new right-hand turn. The glider collided with trees a few seconds later.

The last GNSS positions recorded show that the glider was in a turn a few seconds before it collided with vegetation.
