Accident to ROLLADEN SCHNEIDER LS6-18w
registered **F-CPRN**
on Monday 5 August 2024
at Argentine

Time	Around 15:45 ¹
Operator	Association Aéronautique Provence Côte d'Azur (AAPCA), Les Planeurs du Pays de Fayence
Type of flight	Cross country
Persons on board	Pilot
Consequences and damage	Pilot seriously injured, glider destroyed
This is a courtesy translation by the BEA of the Final Report on the Safety Investigation. As accurate as the translation may be, the original text in French is the work of reference.

Attempted off-airfield landing, collision with ground

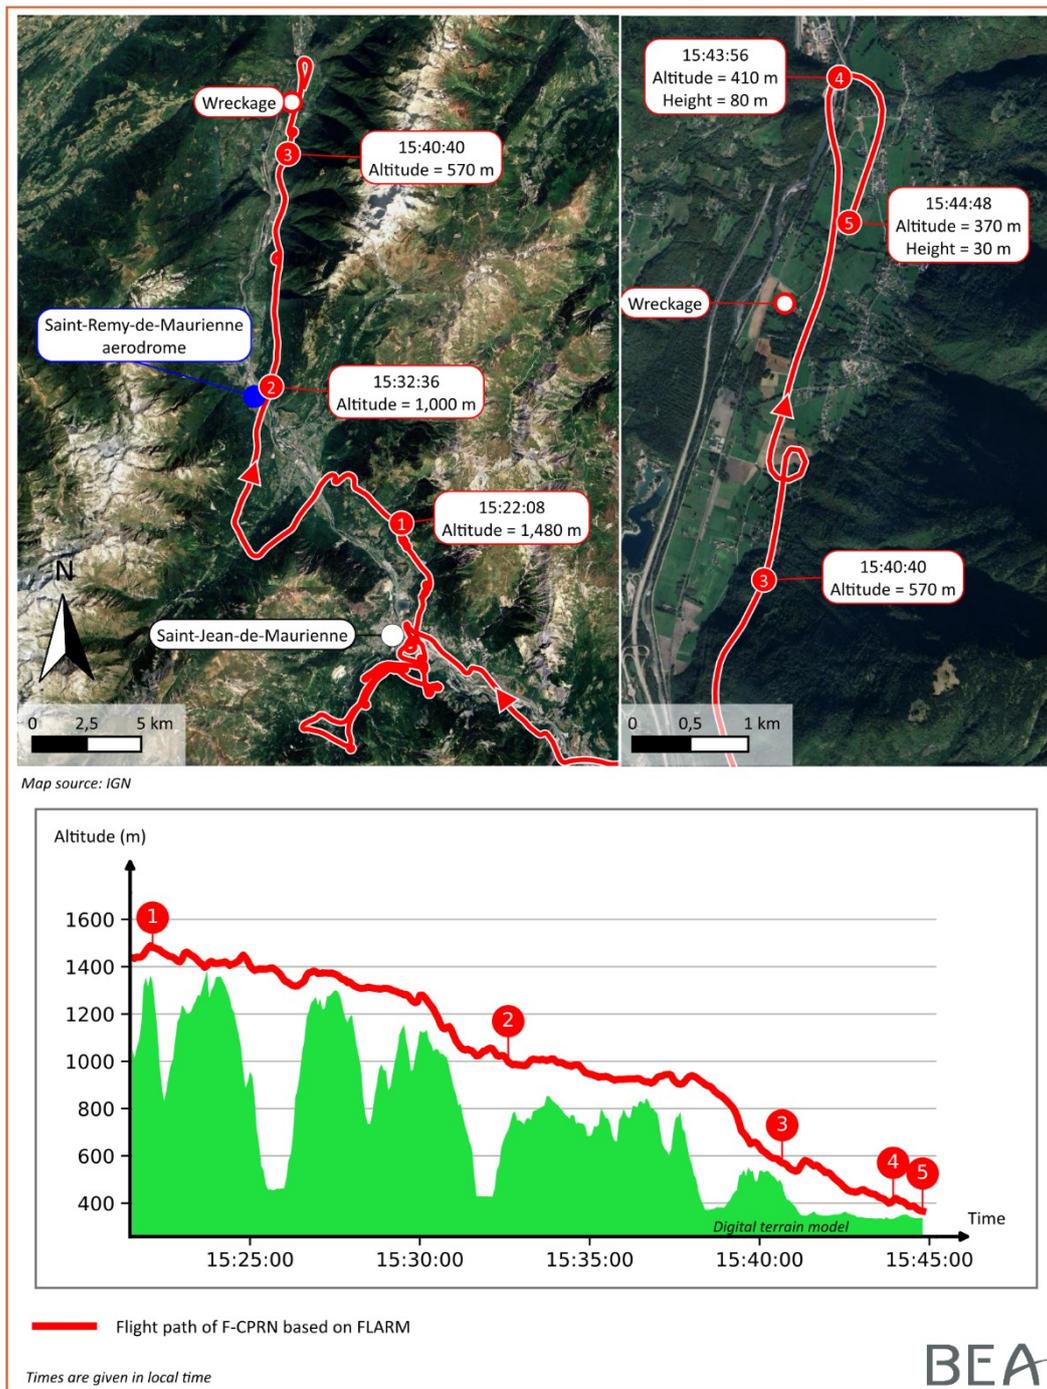
Figure 1: flight path of F-CPRN

At 11:26, the pilot carried out a towed take-off from runway 10L at Fayence - Tourrettes aerodrome. He headed north, crossing the south Alps and at around 14:00, entered Maurienne valley at an altitude of around 2,700 m. He reached Saint-Jean de Maurienne around 45 min later at an altitude of 770 m (i.e. a height of 240 m with respect to the valley) and looked for uplifts there for roughly 30 mins. He left the sector at an altitude of around 1,000 m and continued north flying along the south-west face of the terrain. He used a slope uplift which enabled him to reach an altitude of 1,480 m (see Figure 1, point ①). He then branched left into a valley in the south-west before returning to the initial valley in order to resume his flight path north. During this manoeuvre, the pilot flew over Saint-Rémy de Maurienne aerodrome and the altitude of the glider decreased to 1,000 m (point ②). The altitude then continued to progressively decrease before distinctly decreasing with a vertical speed reaching -5 m/s. At an altitude of 570 m (i.e. a height of 215 m with respect to the valley, point ③), at around 2.5 m from the site of the accident, the pilot moved away from the terrain. He turned around at an altitude of 410 m (height of 80 m, point ④). The last recorded point was situated at a distance of 900 m from the accident site, at a height of 30 m (point ⑤).

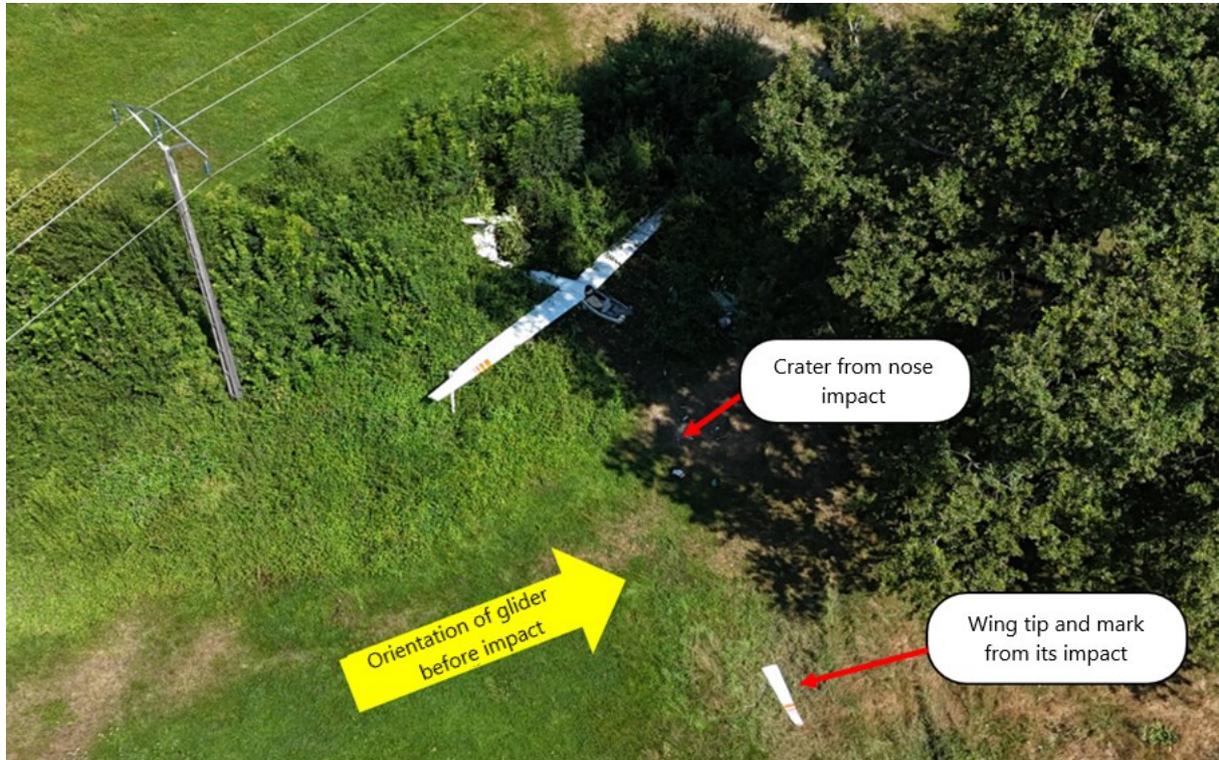
Figure 2: photo of accident site (source: GTA, annotations BEA)

The wreckage was complete and lying on its belly. It was located between a large oak tree and a power line, neither of which showed signs of an impact.

Two impact marks with the ground, at a distance corresponding to a wing span, were visible in the field close to the wreckage:

- one impact mark around one metre long corresponding to the right wing tip striking the ground; the tip was lying on the impact mark;
- a small crater corresponding to the nose of the glider striking the ground.

It is probable that the glider struck the ground with a nose-down attitude of more than 30°, a right-hand bank and a 030° heading. It then pivoted to the right around its yaw axis before coming to a halt.

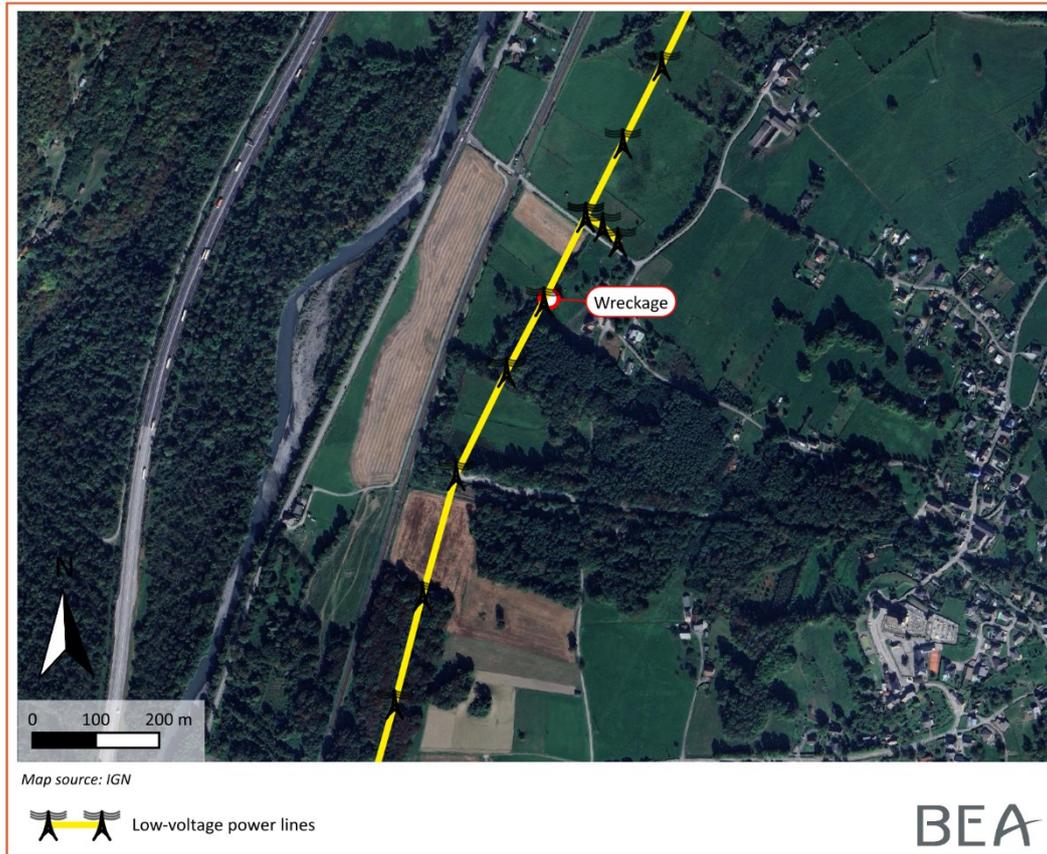
Figure 3: accident site

The accident site was surrounded by fields, most of them enclosed, and numerous low voltage power lines. Saint-Rémy de Maurienne aerodrome was situated around 14 km to the south. A field in the Aiton district, situated around 12 km north-west, was listed in the Guide to safe landing areas in the Alps (edition 4.1).

It was not possible from the examination of the site and the wreckage, to determine the strategy envisaged by the pilot for the off-airfield landing.
