Accident to the SCHEMPP HIRTH - JANUS CM¹
registered **F-CVAS**
on Thursday 25 August 2022
at Albertville

Engine failure during self-launch take-off, loss of control in initial climb, collision with ground

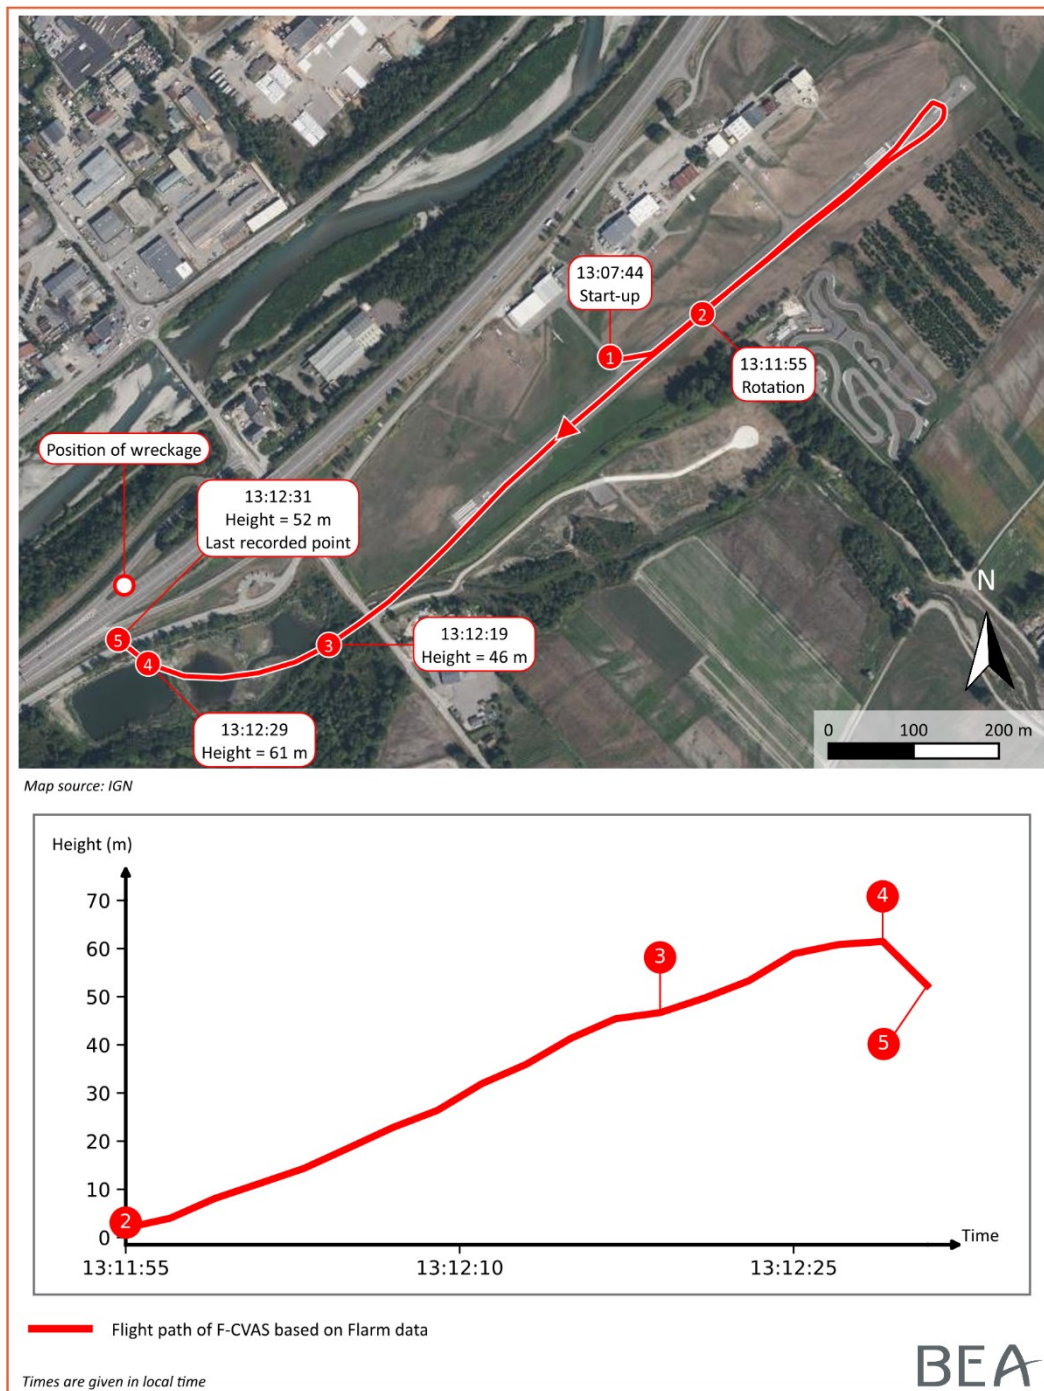
At 13:07, the pilot, accompanied by a passenger, started up the glider's engine on the apron (see Figure 1, point ①). He backtracked the runway of Albertville aerodrome, lined up on runway 23, and then took off (point ②). During the climb, at a height of around 50 m, he started a RH turn (point ③). Ten seconds later, the glider reached a maximum height of around 60 m (point ④). A witness on the ground heard the engine stop. The glider started to descend before pitching down and colliding with the ground at the edge of the A43 motorway.

Figure 1: accident flight path

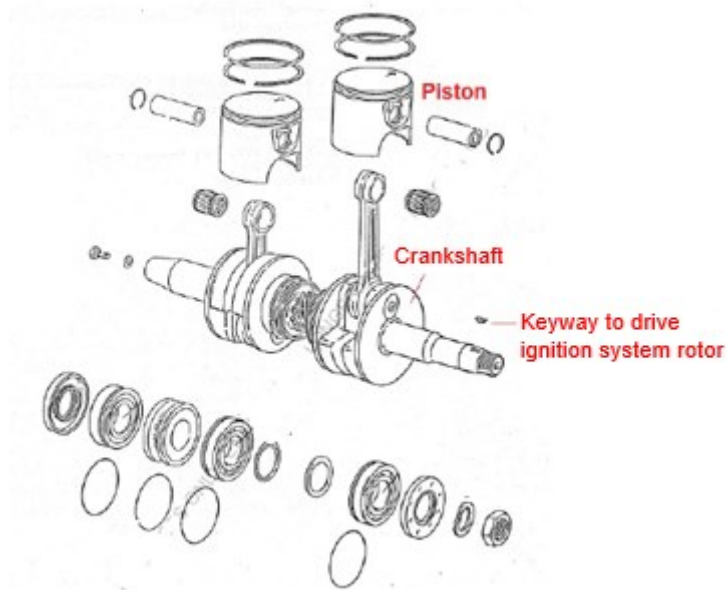
- that the rotor of the electrical generator and the crankshaft were no longer mechanically coupled together due to the rupture of the keyway which participates in connecting the rotor and the crankshaft;
- that the nut holding the rotor on the conical end of the crankshaft was loose and that there were no signs of Loctite type thread lock;
- rubbing (fretting) marks over all the contact surface between the rotor and the crankshaft, indicating progressive loosening of the nut.

The keyway would therefore have been subject to shear stress each time the engine was started up due to the progressive loosening of the nut. These stresses very probably led to the rupture of the keyway during the flight thus causing the malfunction of the ignition system (rotation of the electrical generator rotor stopping) and as a consequence, the in-flight shutdown of the engine.

Figure 2: sub-assembly of Rotax 535C engine block (source: Rotax, annotations BEA)

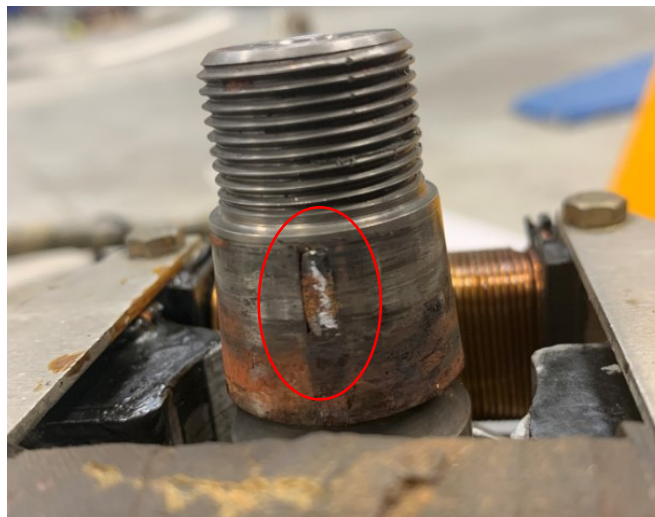
Figure 3: sheared keyway at end of crankshaft (source: BEA)

After taking off, in climb at a height of around 60 m, during a RH turn, the glider's engine shut down. The keyway which participates in connecting the electrical generator rotor and the engine crankshaft probably ruptured, leading to a failure of the ignition system and then the engine shutdown. Thread lock had not been applied to the nut holding the rotor on the end of the crankshaft. This led to the progressive loosening of the nut and finally to the rupture of the keyway (see paragraph 2.1.2). The pilot quickly lost control of the glider which collided with the ground.
