Accident to the SCHEMPP HIRTH - ARCUS
registered **F-CVMP**
on Saturday 22 July 2023
at Puigmal

Collision with terrain while slope soaring, in instruction

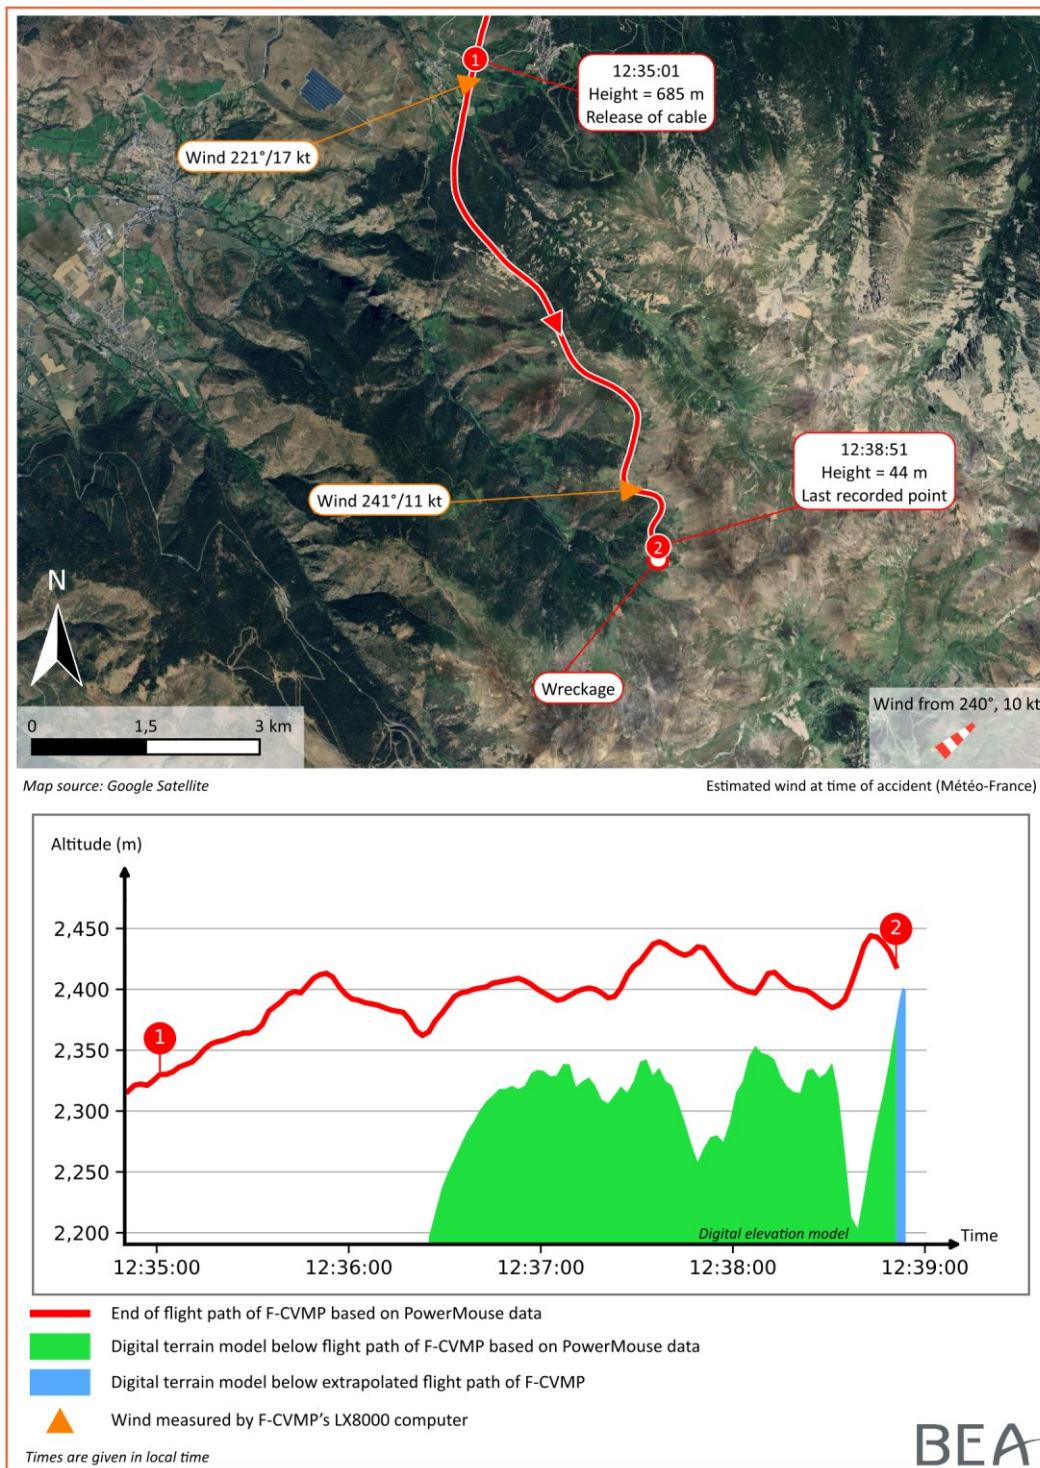
Figure 1: end of flight path of F-CVMP (Source: BEA)

The instructor and the pilot in instruction carried out a towed take-off from La Llagonne - La Quillane aerodrome (Pyrénées-Orientales) at 12:29. They released the cable at 12:35 (see **Figure 1**, point ①) at an altitude of around 2,300 m and headed south following the terrain of the right side of Llo valley.

A short time later, the instructor took the controls in order to show the pilot how to best use the uplifts which are weak at the entrance to the valley. He perceived a rocky outcrop (spur) on the flight path and thought he would be able to fly over it at a low height. He believed that after this obstacle, he would be able to use the uplifts in the cirque further on. He indicated that shortly before arriving over the spur, a downdraft caused the glider to drop. The instructor could not avoid the collision with the terrain, the fuselage struck the ground and the left wing was immediately torn off. The glider slid down the steep slope, coming to a stop against a fir tree 150 m further down.

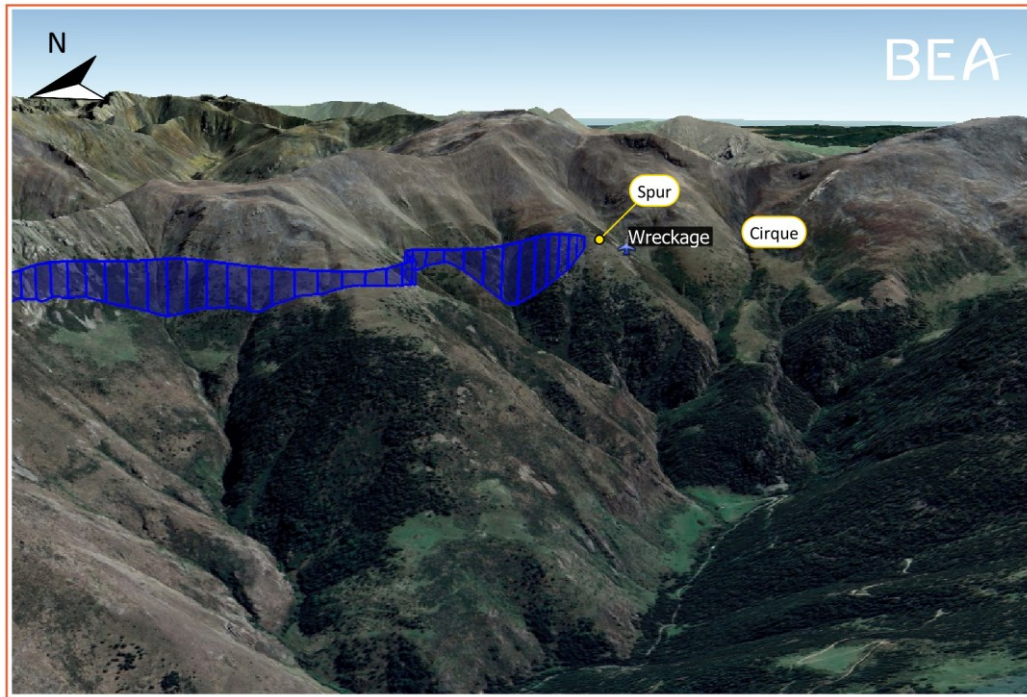
Figure 2: 3D view of end of flight path of F-CVMP (Map source: Google Earth)

After slope soaring for about five minutes, with aerological conditions that were difficult to use to gain altitude, the instructor approached a low-height spur. The glider then found itself downwind in a descending south-westerly flow. The instructor had no margin left to divert towards the valley. He lost control of the glider's flight path and was unable to avoid the collision with the ground.

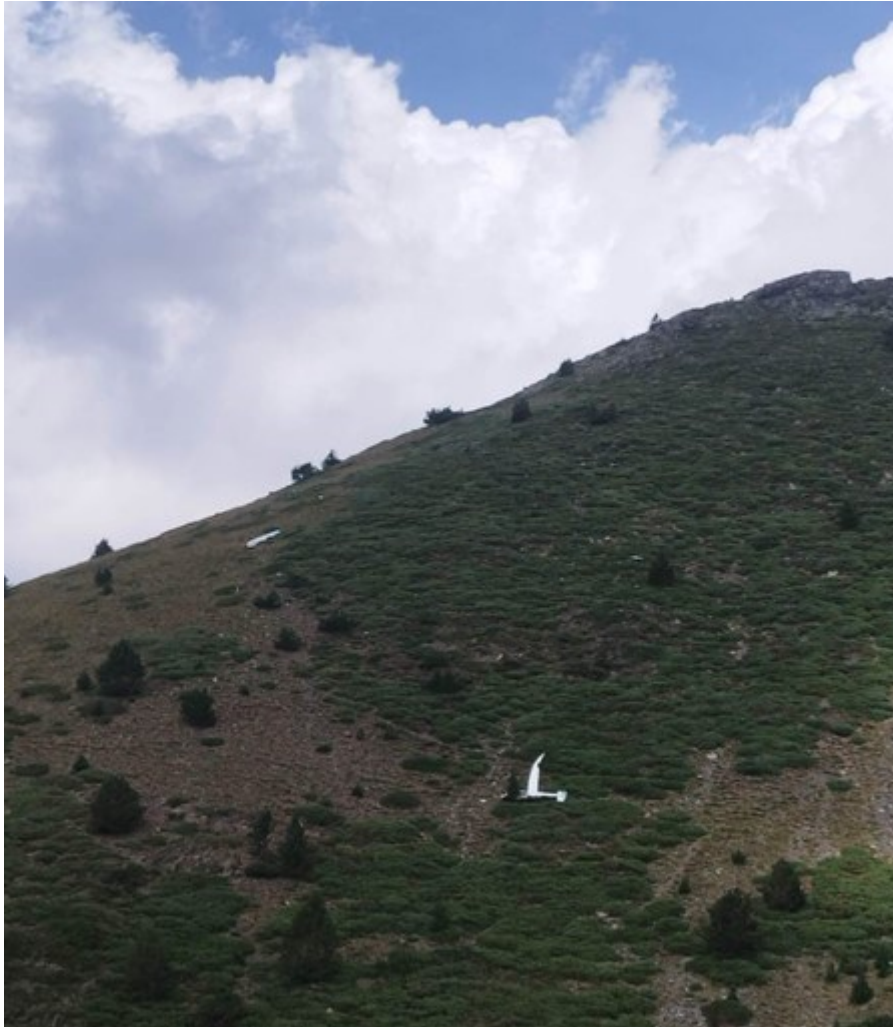
Figure 3: position of wreckage (Source: Gendarmerie)

The wreckage was lying at 2,400 m on a steep slope covered with grass, stones and a few trees. The airframe and right wing, still integral with the fuselage, were wedged against a tree. The left wing was lying about 50 m further up the slope from the wreckage (see **Figure 3**).

As the accessibility was limited, the BEA investigators did not join the site. No malfunction was identified during the examination of the wreckage after it had been moved. The pilots did not report any abnormal behaviour of the glider prior to the accident.
