Accident to the SCHEMPP HIRTH - DUO DISCUS
registered **F-CXBD**
on 22 April 2022
at Col du Portillon mountain pass

Time	Around 15:40 ¹
Operator	Aéroclub de Luchon
Type of flight	Introductory flight
Persons on board	Pilot and one passenger
Consequences and damage	Glider substantially damaged

Collision with terrain, in soaring flight, during an introductory flight

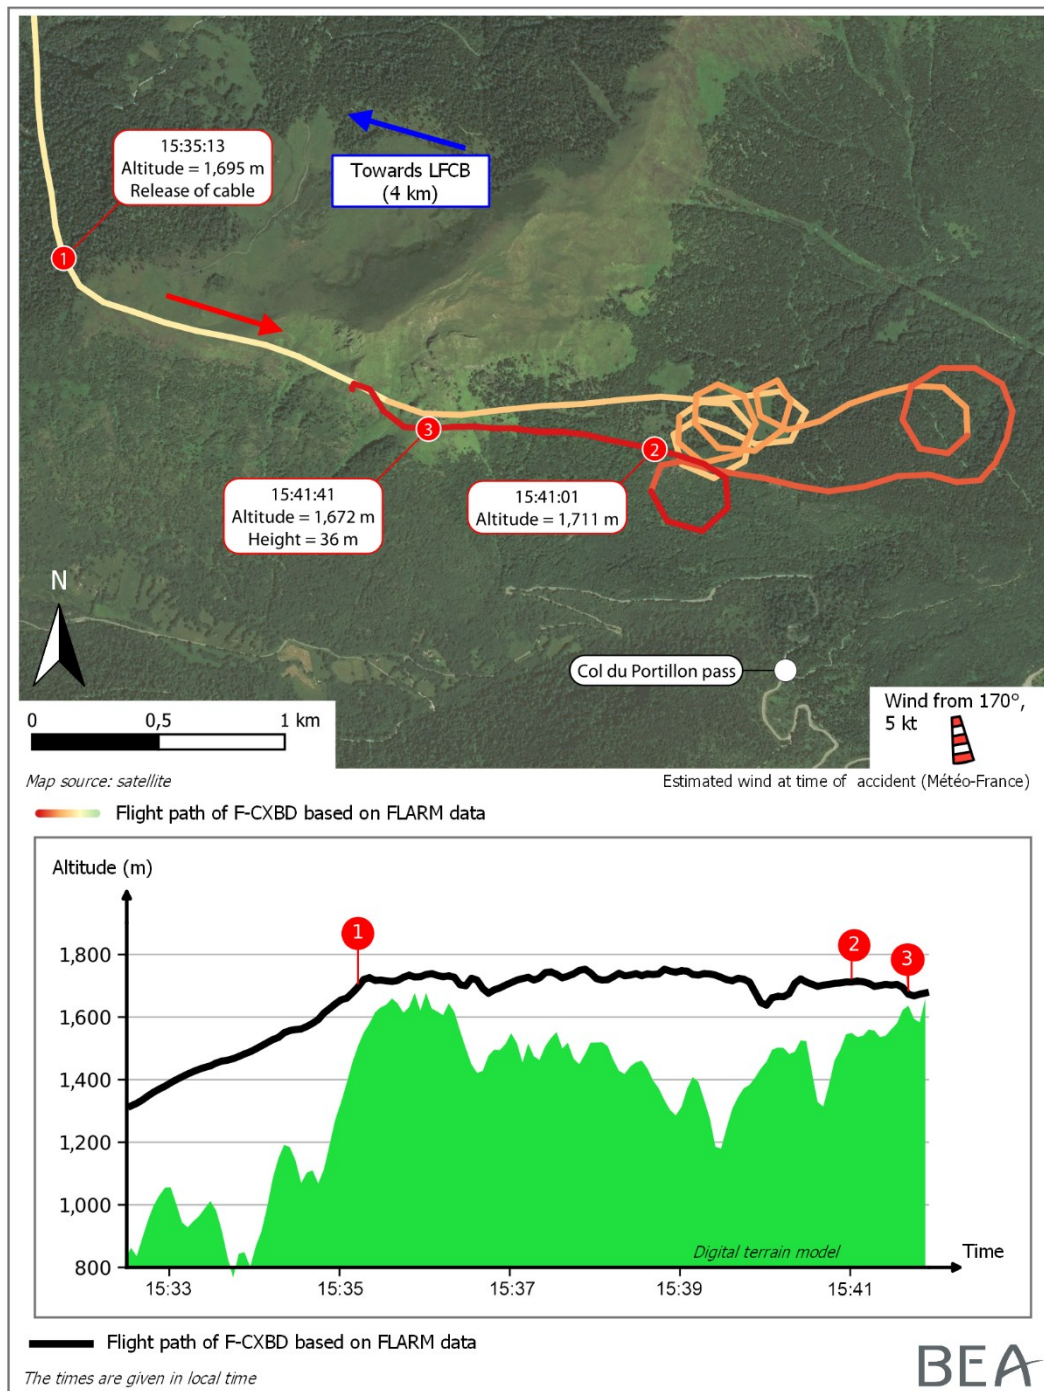
The pilot, accompanied by a passenger, carried out a towed take-off from Bagnères-de-Luchon aerodrome at 15:25. He released the cable at an altitude of approximately 1,700 m (see Figure 1, point ①) and flew alongside the terrain to the north of the Col du Portillon mountain pass. He then performed a few spirals. The glider did not gain altitude and the pilot found the conditions too turbulent. He decided to turn around and return to the aerodrome.

While flying alongside the terrain, he lost control of the glider. The glider hit the ground and bounced before coming to rest on the slope.

Figure 1: flight path

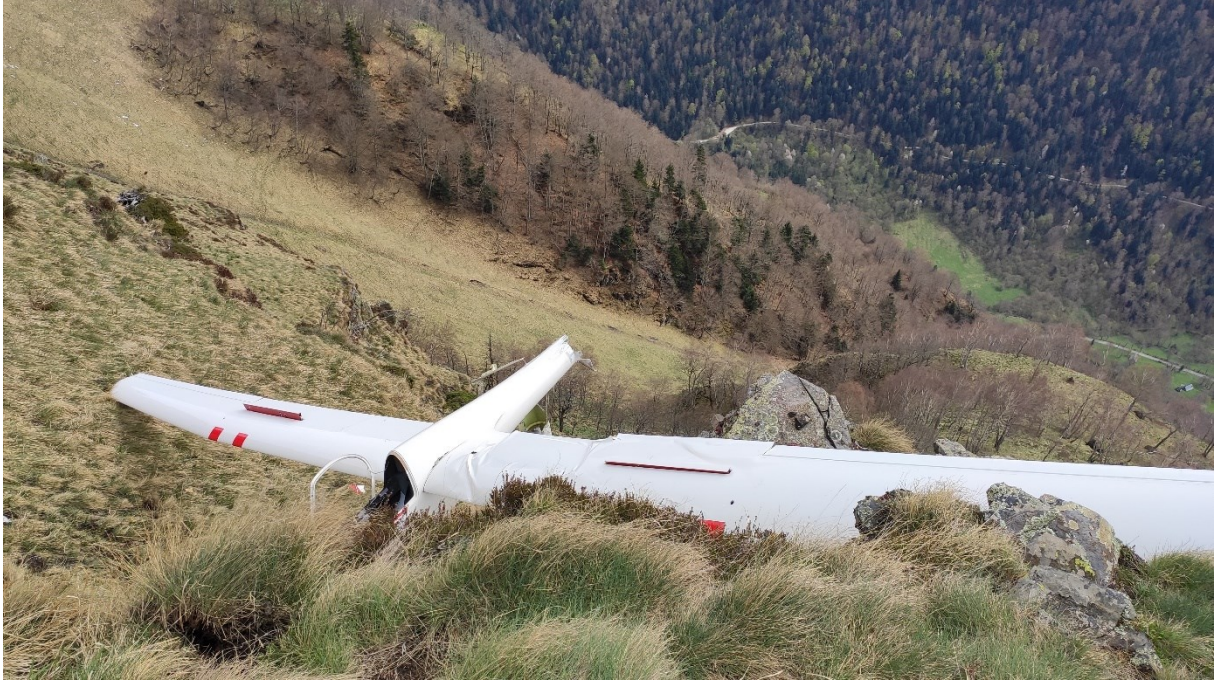
The wreckage was balanced on a slope at an altitude of 1,660 m: the left wing was held by a rock, the right wing and the nose touched the ground. The tail of the glider was broken and the canopy was cracked. Due to the difficult access conditions, no examination could be carried out on site.

Figure 2: photo of wreckage (source: aéroclub de Luchon)
