Accident to the CESSNA - F177RG
registered **F-GAAC**
on 24 February 2021
at Veuzain sur Loire

Time	14:18 ¹
Operator	Private
Type of flight	Cross country
Persons on board	Pilot and passenger
Consequences and damage	Pilot slightly injured, aeroplane substantially damaged

Loss of power en route, forced landing

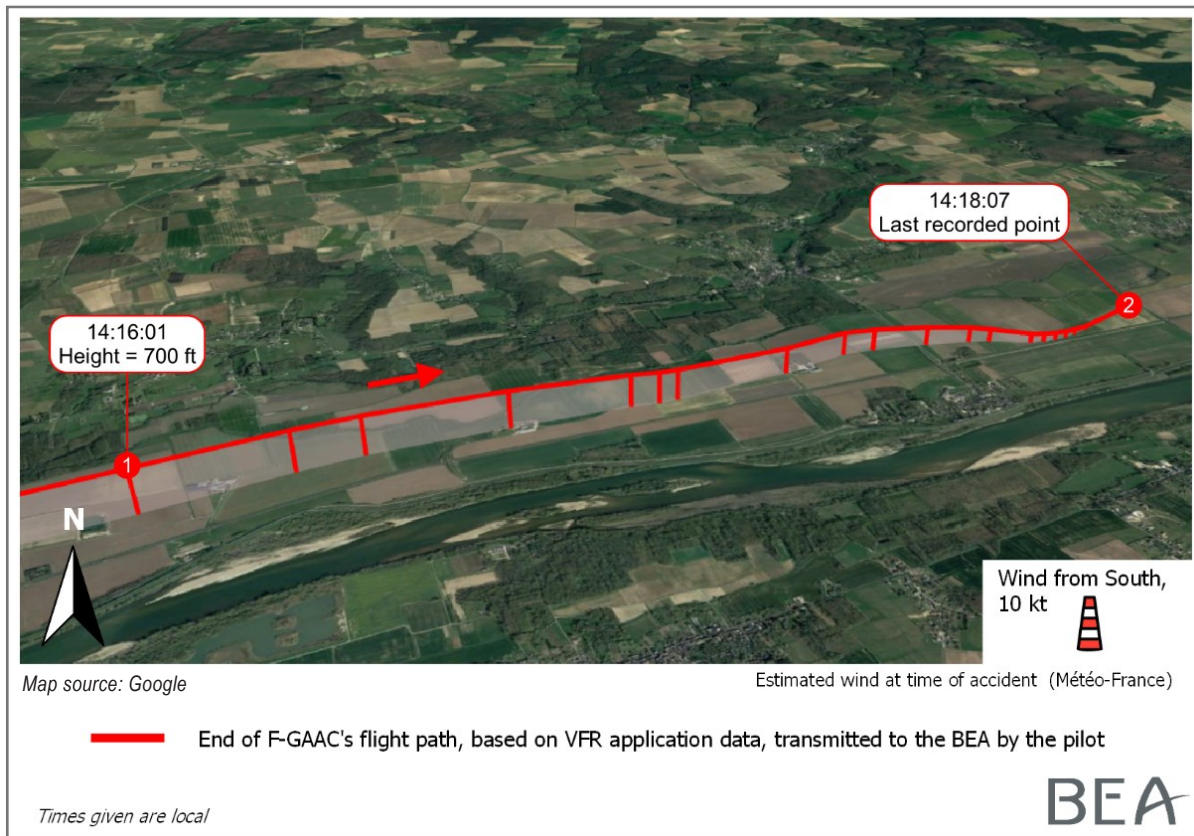
At 14:16, at a height of 700 ft, the pilot detected engine spluttering. He started troubleshooting, but his actions had no effect on the engine, which was gradually losing power. Losing altitude and realising that, given his height he had no other choice, the pilot then directed the aeroplane into an area roughly ahead of him to make an emergency landing.

Figure 1: flight path of F-GAAC

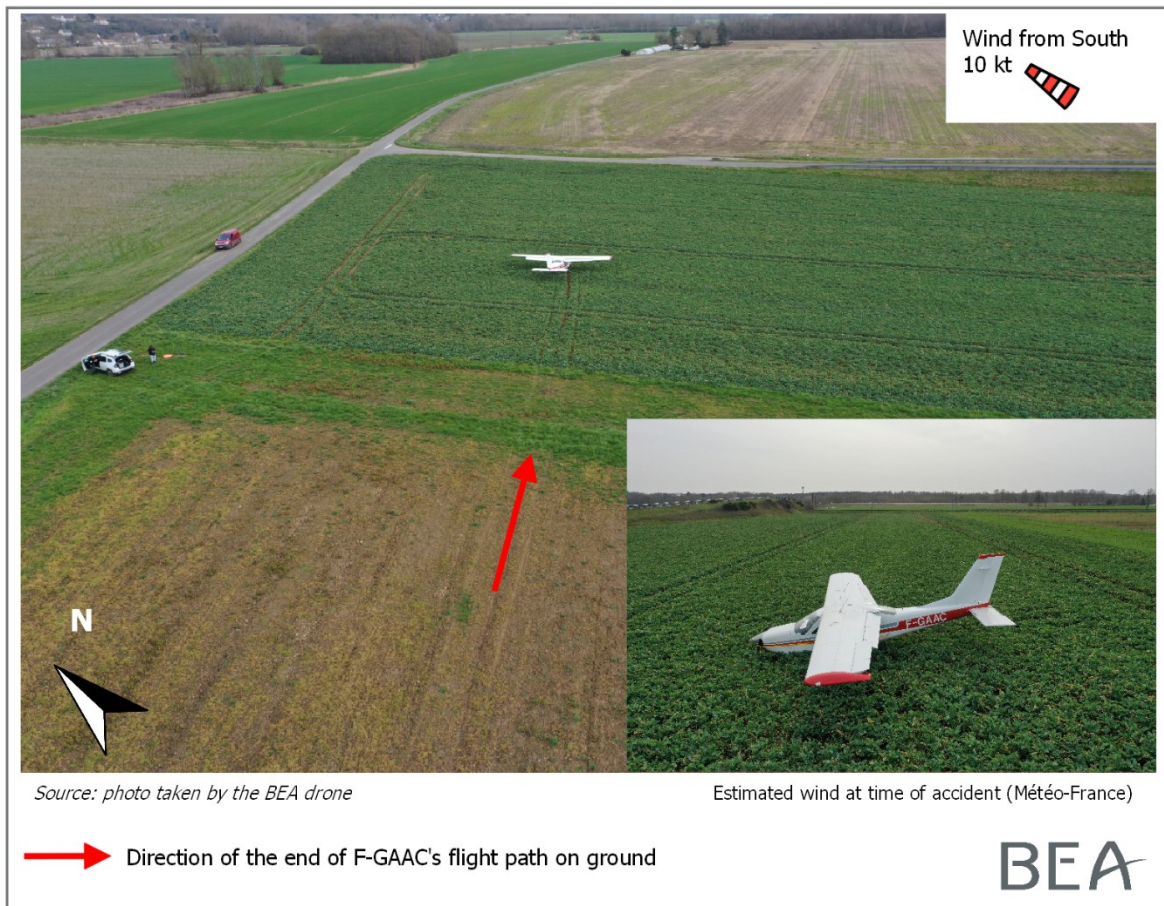
landing area. After a few metres, the nose wheel collapsed due to the aeroplane's quick deceleration because of the change in the type of soil. The pilot struck the sunshield and suffered a superficial injury to his forehead. His passenger was unharmed.

The aircraft was located in the middle of a field with a zero slope and a clear approach roughly oriented 055°, between a railway track on the right and two B roads, one on the left and the other, 50 m further on.

Figure 2: overview of accident site

The aircraft's nose gear had ruptured and one of the two propeller blades was bent, consequences of the forced landing. No other damage was found on the aeroplane. An estimated quantity of 80 to 100 l of fuel was found in the tanks. The integrity of the fuel system up to the engine was checked, as well as the operation of the electric fuel pump.
