Accident to the ROBIN DR400-160
registered **F-GABZ**
on 23 October 2023
on Saint-Quentin - Roupy aerodrome

Time	Around 15:15 ¹
Operator	Aéroclub de l'Aisne
Type of flight	Introductory flight
Persons on board	Pilot and two passengers
Consequences and damage	Aeroplane substantially damaged, one passenger slightly injured

Runway overrun on take-off in the scope of an introductory flight

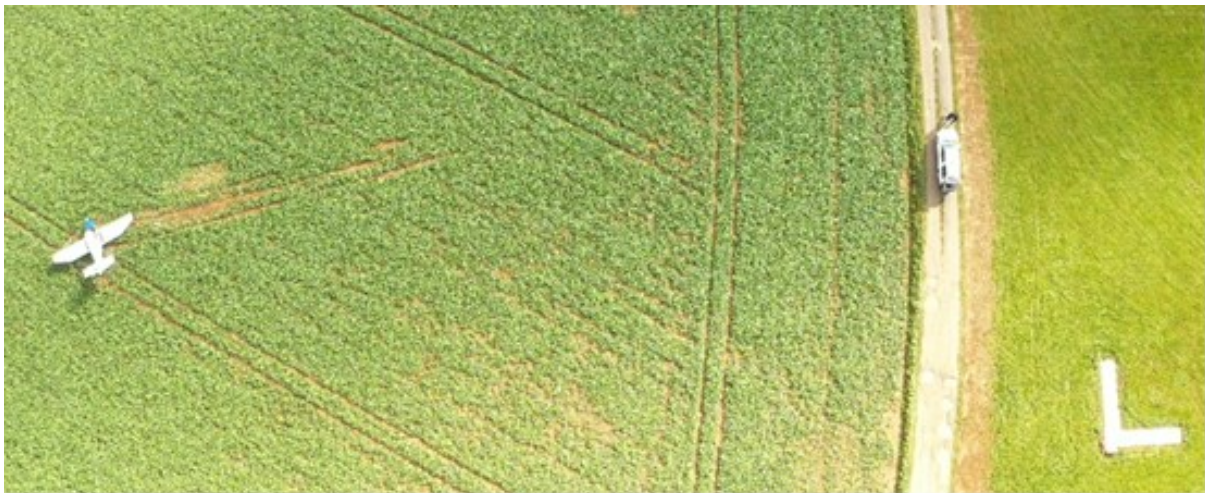
The wreckage was located in a field at around 90 m from the end of runway 04.

The nose gear, the RH main landing gear, the propeller and the RH wing were damaged.

Figure 1: aerial view of the site and the wreckage (Source: BEA)

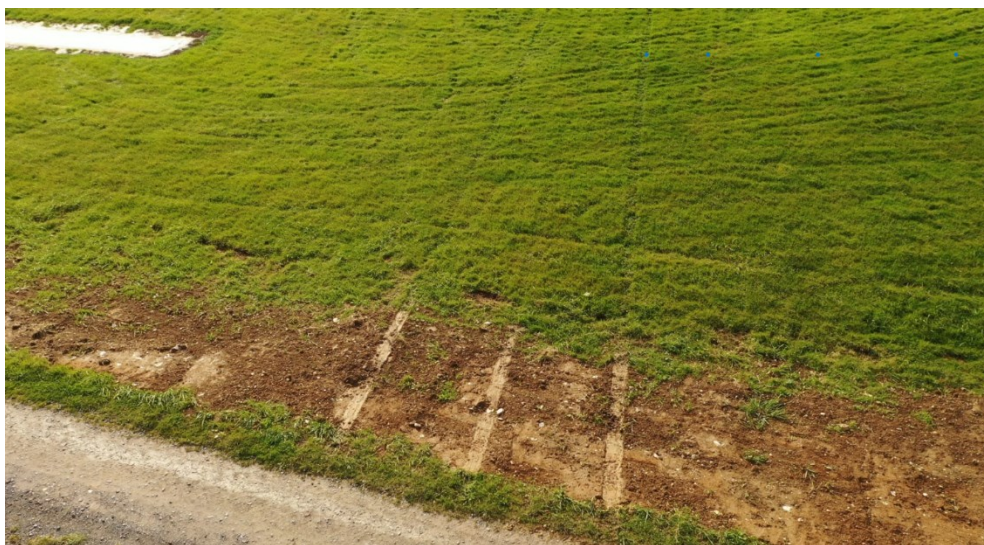
Run marks visible in the grass and at the edge of the country road situated at the end of the runway showed that the aeroplane had not left the ground when it ran off the runway (see **Figure 2**). At around 40 m on the other side of the road, marks were also visible in the crop and showed that the aeroplane had run on its main landing gear on a heading of 30°.

Figure 2: run marks at the end of the runway (Source: BEA)

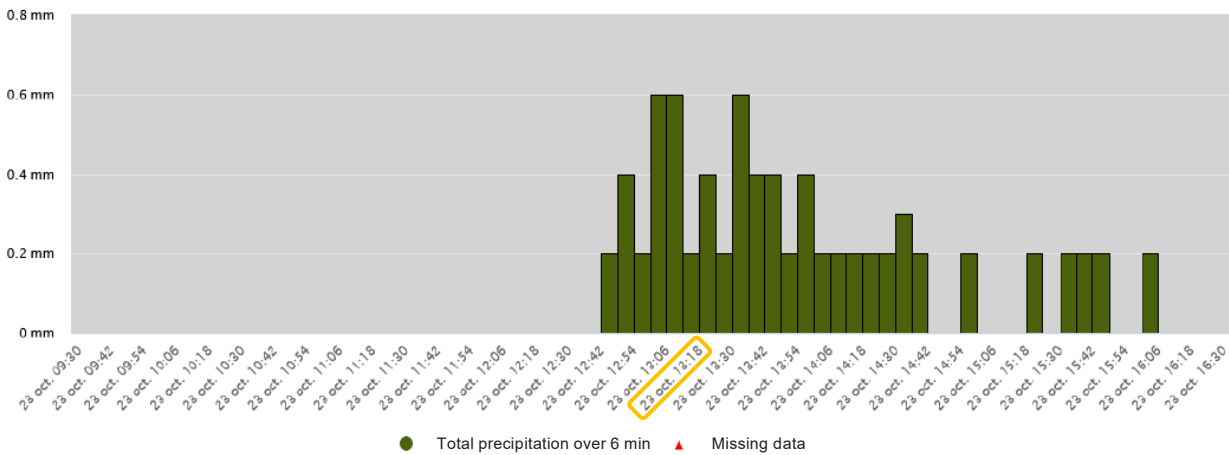
At the time of the accident, the Saint-Quentin weather station recorded a mean wind direction of 100° with a mean speed of 8 kt. There was light, continuous rain. Around 2 mm had fallen in the 30 min preceding the accident. Prior to this rain, the last precipitations had been the night of 21 to 22 October when 1.4 mm had fallen.

Figure 3: total precipitation at Saint-Quentin, 23 October from 09:30 UTC to 16:30 UTC (Source: Météo-France. Two hours should be added to obtain the local time.)
