**Accident** to the BELL 47G-2  
registered **F-GANY**  
on Tuesday 2 May 2023  
at Thouars-sur-Garonne

## **Fuel supply failure, forced landing**

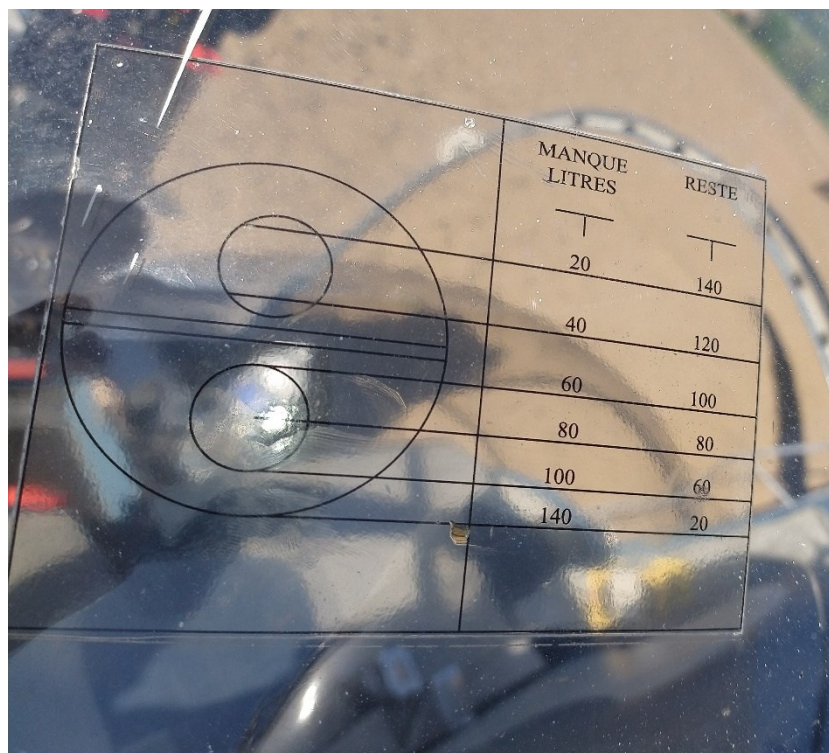
The task specialist waits for the fuel tanks to balance before visually checking the level using a diagram placed on the bubble sight (see below).

Figure 1: diagram placed on bubble sight of helicopter used as a reference to visually estimate the quantity of fuel by looking inside the left-hand fuel tank (source: BEA)

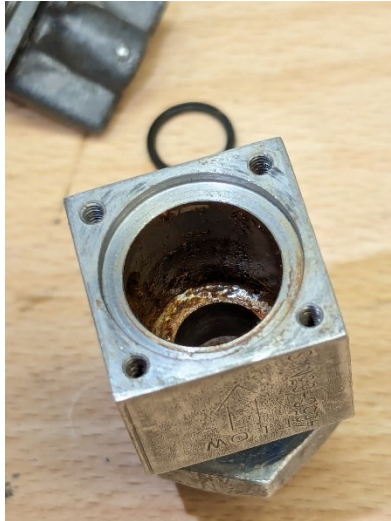
*Figure 4: opened right-hand bleed valve (source: BEA)*

The right-hand bleed valve was disassembled, it did not contain debris.

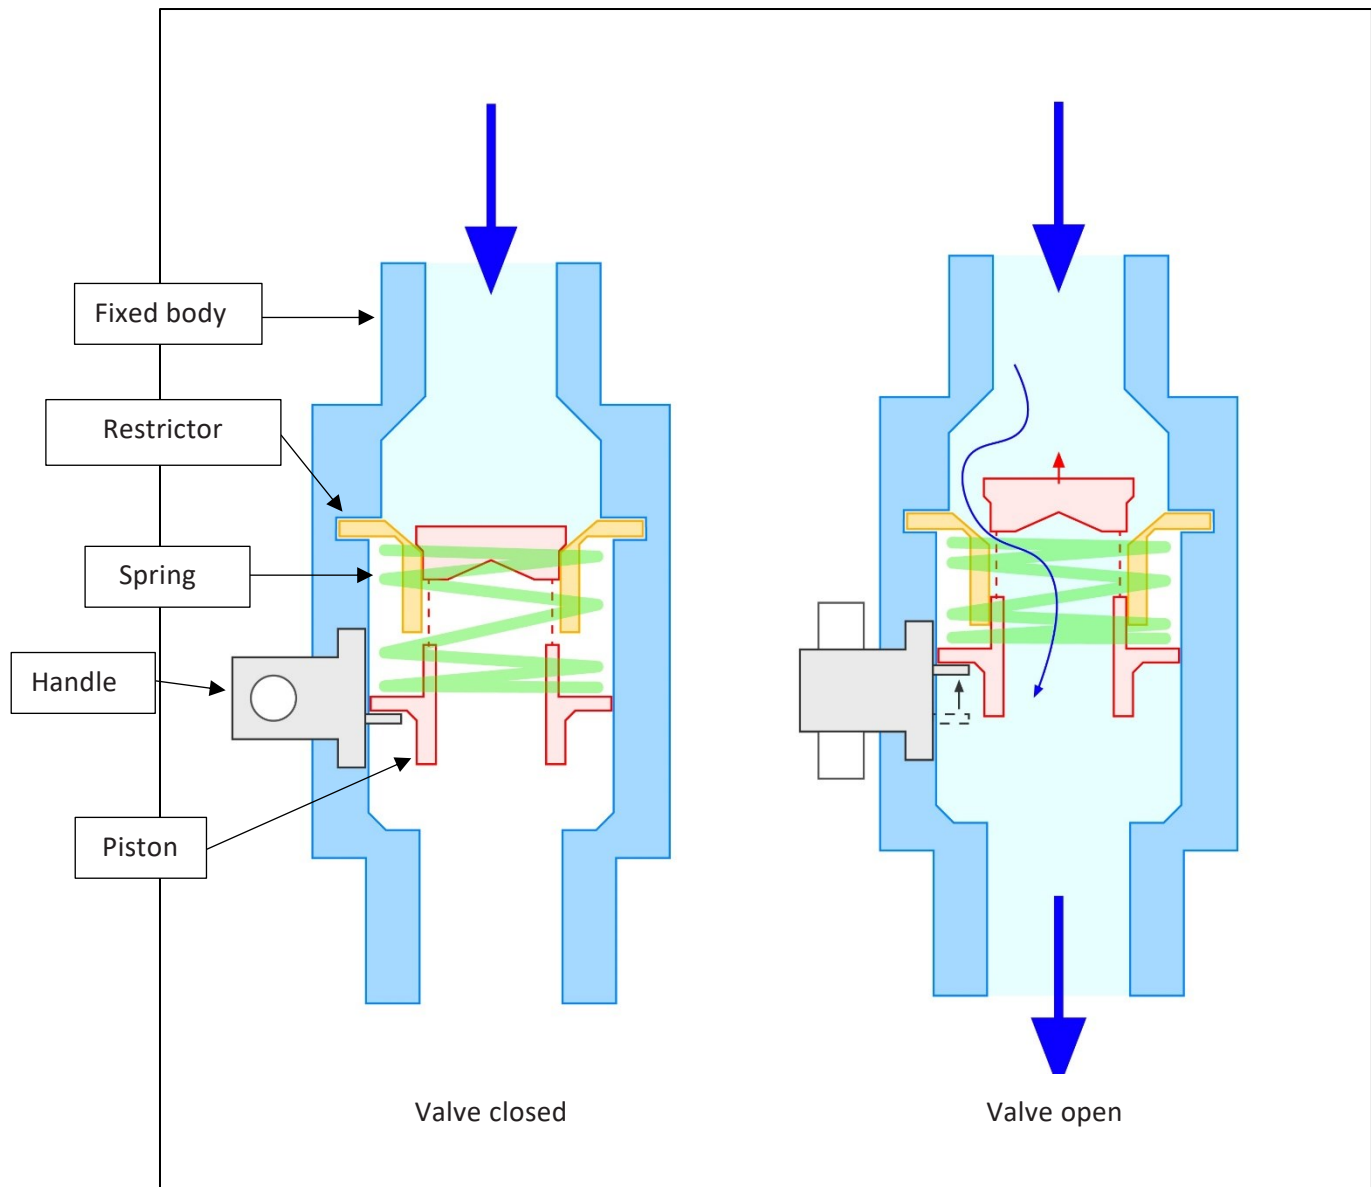
Figure 5: diagram showing operation of left-hand bleed valve (source: BEA)

The operation of the left-hand bleed valve is different to that of the right-hand bleed valve.

When the handle is actioned to open the valve, this raises the piston by compressing the spring and allows the fuel to flow through the piston orifices.

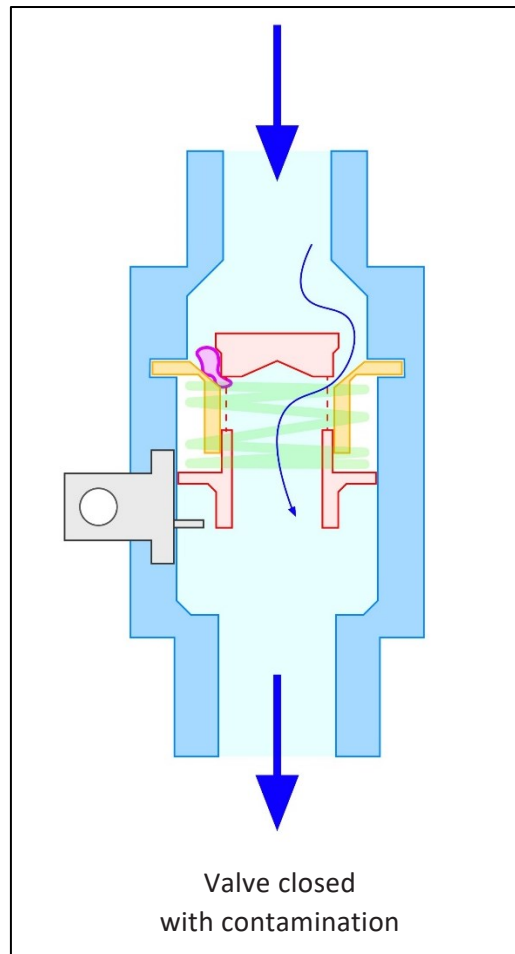
Figure 6: incomplete closure of valve with the presence of debris (source: BEA)

The left-hand bleed valve was disassembled, it contained several pieces of debris. On closing the valve, the presence of debris caught between the restrictor and the piston may then prevent the piston from being correctly repositioned. In this case, the fuel can then continue to flow at a rate which will vary according to the size and position of the debris. This observation is consistent with the fuel flow found the day on which the helicopter was examined.

During the examination by the BEA after the accident, a large leak was observed on the left-hand bleed valve: impurities were found inside the bleed valve and may have kept the valve partially open. This leak was very probably present before the accident (see paragraph 2.8) and contributed to an excessive fuel consumption which was not detected by the pilot. The engine shutdown may then be explained by fuel exhaustion due to the depletion of the fuel tanks.

Refuelling a helicopter with the rotor turning may introduce various impurities into the fuel tanks. In this context, during the various maintenance acts, it is particularly important to check that the fuel tank is clean in order to prevent any contamination, including the possible blocking of the bleed valve by debris.

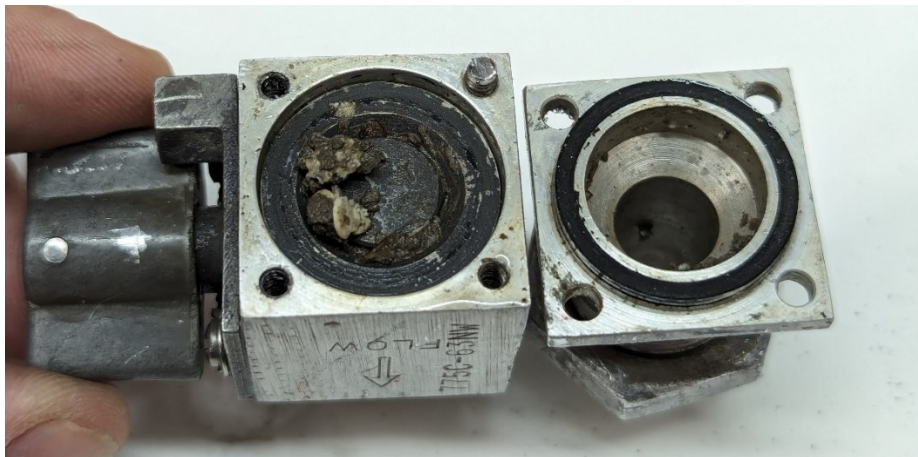
Figure 7: disassembled left-hand bleed valve (source: BEA)
