Accident to the ROBIN - DR400 - 120
registered **F-GBUY**
on 18 November 2022
at Couhé-Vérac

Collision with vegetation on final approach

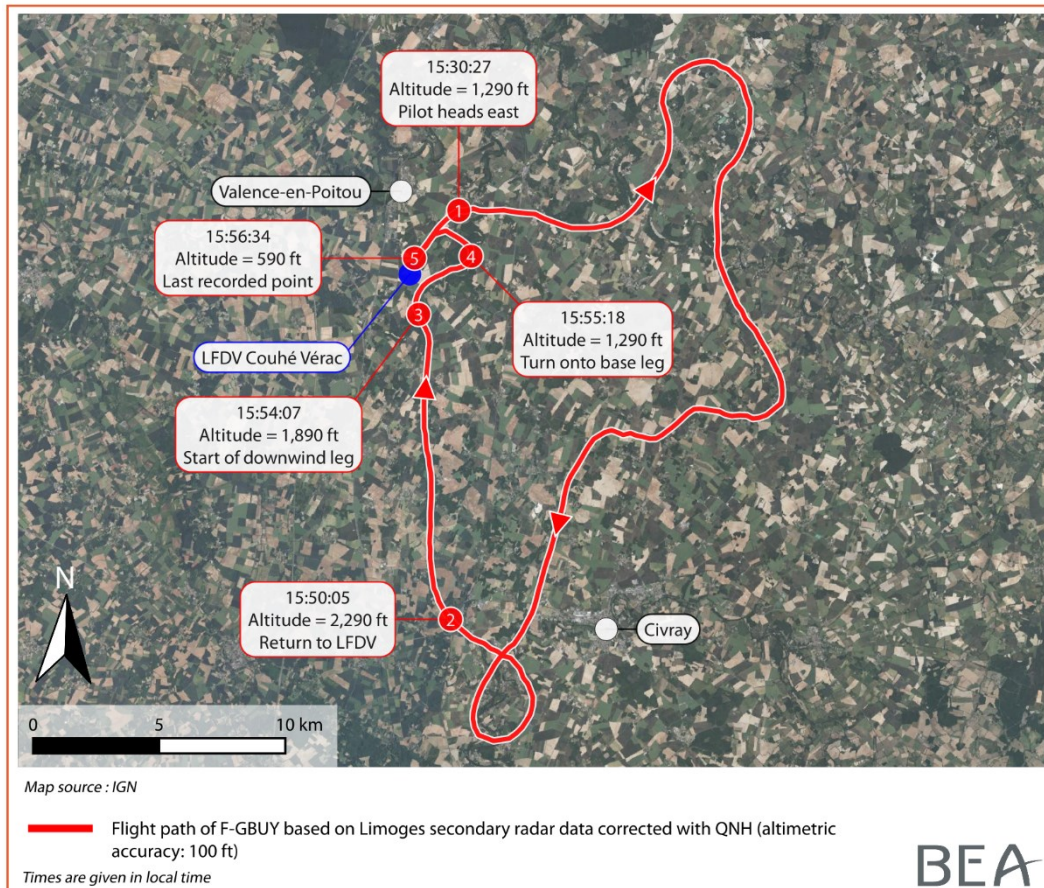
Figure 1: path of F-GBUY for the entire flight

At approximately 15:50 (see **Figure 1**, point **2**), she took a northerly route to fly back towards her departure aerodrome. At 15:54 (see **Figure 1** and **Figure 2**, point **3**), about 500 m from the threshold of runway 02, she turned right to join the start of the downwind leg, in a left-hand circuit for runway 20.

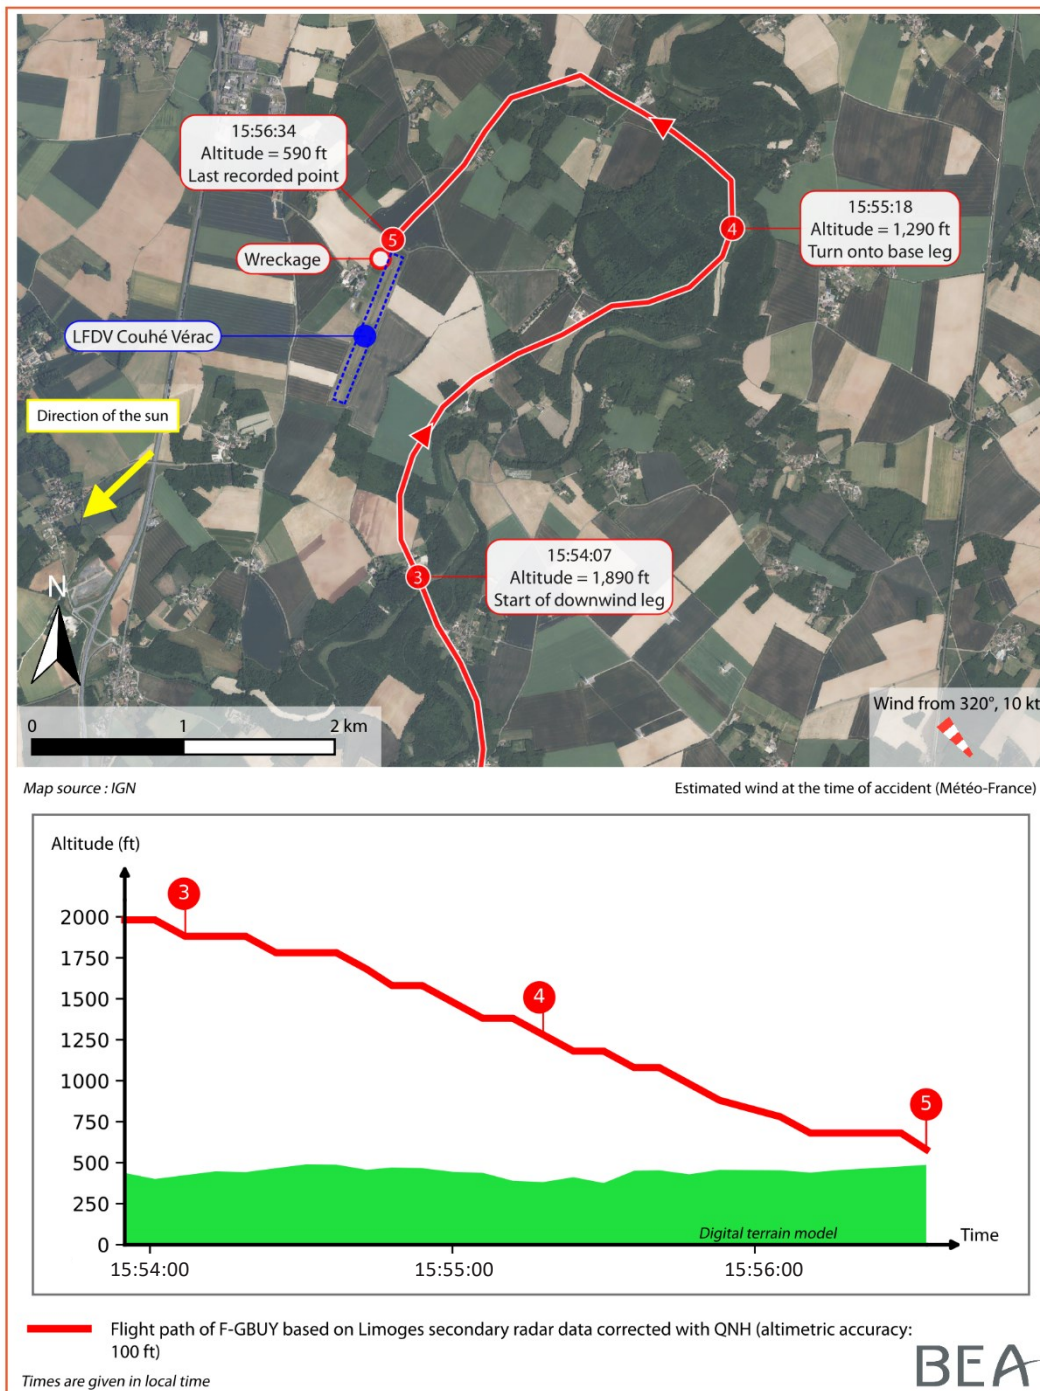
Figure 2: path of F-GBUY for the end of the flight

The pilot flew the downwind leg along a path deviating from the extended runway and then turned onto the base leg at 15:55 (see **Figure 1** and **Figure 2**, point 4). On final, the aeroplane's path was not aligned with the runway. The pilot continued her descent. The aeroplane collided with chestnut trees bordering a path located around 50 m to the right of the edge of runway 20.

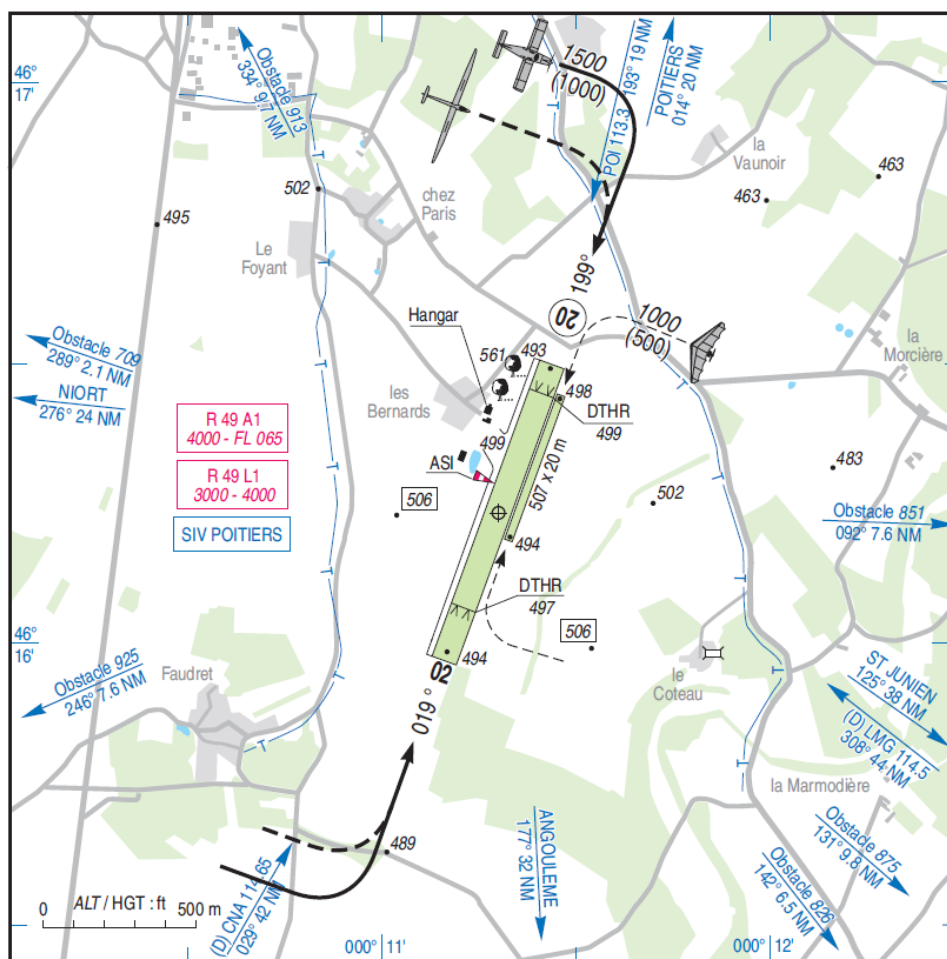
Figure 4: VAC chart for Couhé-Vérac (source: AIS)

The row of trees with which F-GBUY collided (see para. 2.5) is indicated on the VAC chart, on the right side of the runway. The altitude of the highest of these tree tops is reported to be 561 ft, i.e. 62 ft above the altitude of the displaced threshold of runway 20. The French civil aviation safety directorate (DSAC) carried out an audit at Couhé-Vérac aerodrome in 2021, which did not identify any discrepancies concerning these trees.

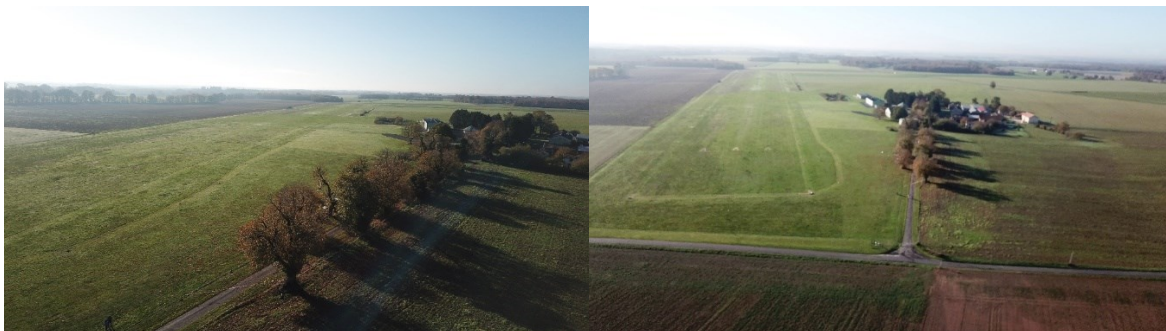
Figure 5: views of runway 20 on 19 November 2022 from a drone (source: GTA)

Based on the photos taken with a drone in good light and visibility conditions the day after the accident (see **Figure 5**), the approach end of the runway and displaced threshold markings, the runway side boundaries and the taxiway adjacent to the runway appeared to be barely visible with few contrasting elements for a pilot on approach. The grass runway barely contrasted with the surrounding plots.

The DSAC 2021 audit identified a discrepancy concerning the runway side markings, which at that time were missing or had faded. In response to this discrepancy, the aerodrome operator carried out work to restore these markings. However, the colour of these new markings was identified as “sand” by the DSAC, which does not comply with the applicable regulations³ requiring white markings.

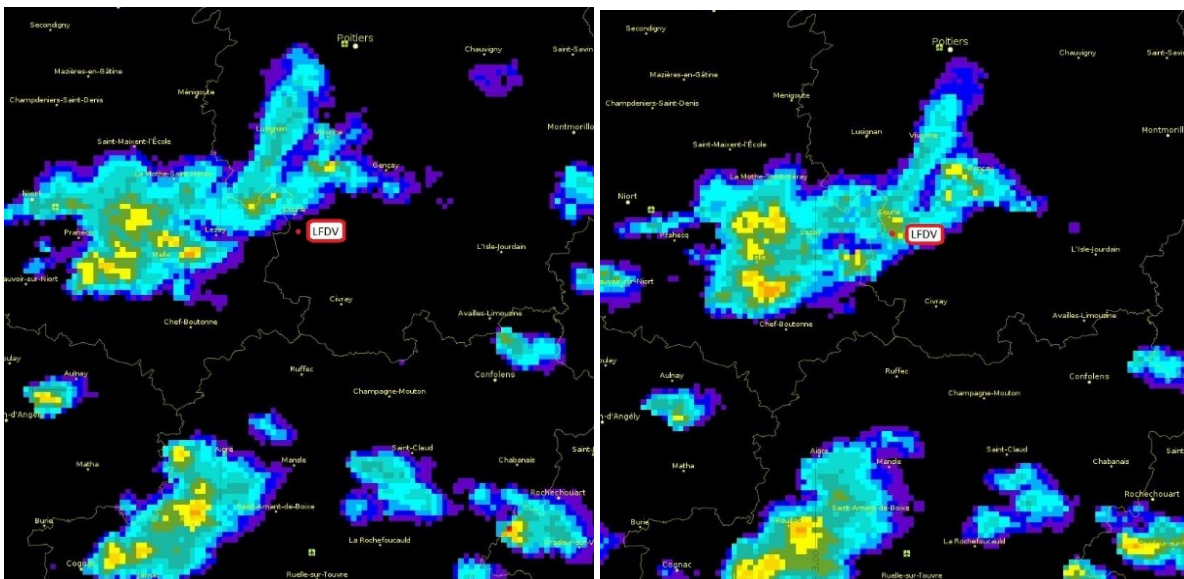
Figure 6: estimated instantaneous rainfall based on radar reflectivity at 15:45 and 16:00
(source: Météo-France)

The radar picture showed a rainfall episode moving over the aerodrome between 15:45 and 16:00 (see **Figure 6**). This disturbance arrived from the north-west of the aerodrome.

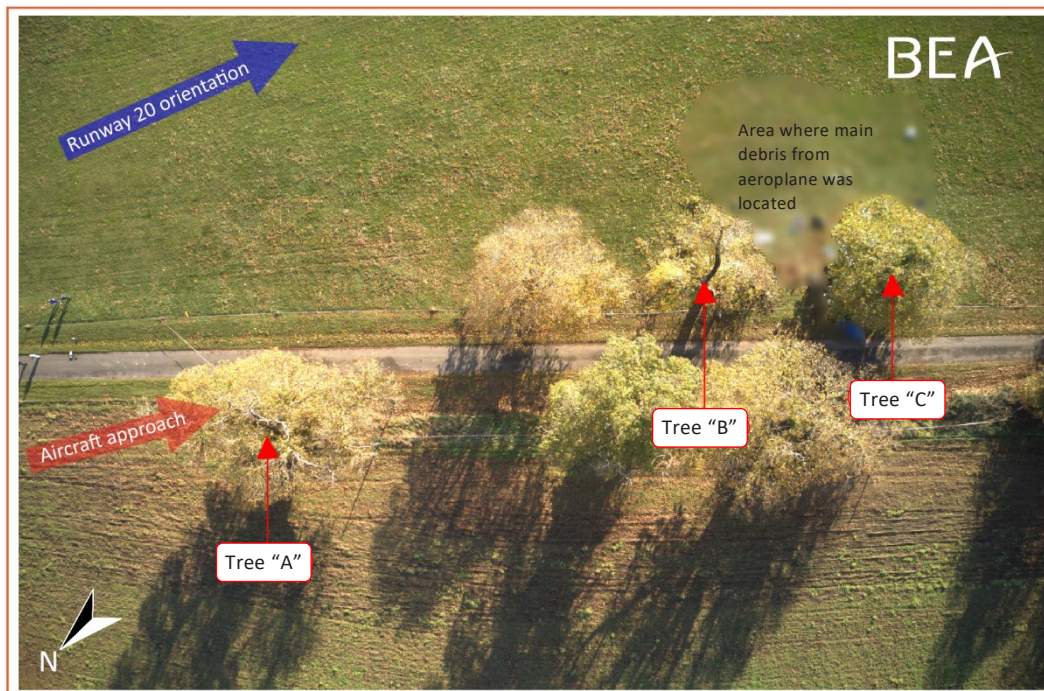
Figure 8: view of the accident site from a drone (source: BEA)

- tree "A", which was the first to be struck by the aeroplane (see **Figure 8**), had branches damaged at the top (at a height of around 20 m);
- tree "B", located about 30 m further on, had very large branches (50 cm) torn off. The impact with the tree seemed to have occurred at a height of around 10 m;
- tree "C", located about 10 m further on, at the foot of which most of the wreckage was laying.

The damage observed on the trees and the torn off branches indicated that the aeroplane struck the vegetation with a high level of kinetic energy. The propeller blades also showed marks resulting from contact with wood and/or bark.
