Accident to the Cessna F172N
registered **F-GCHO**
on Sunday 30 June 2024
on the A4 motorway, near Lognes - Émerainville aerodrome

Collision with a power line, then with the ground

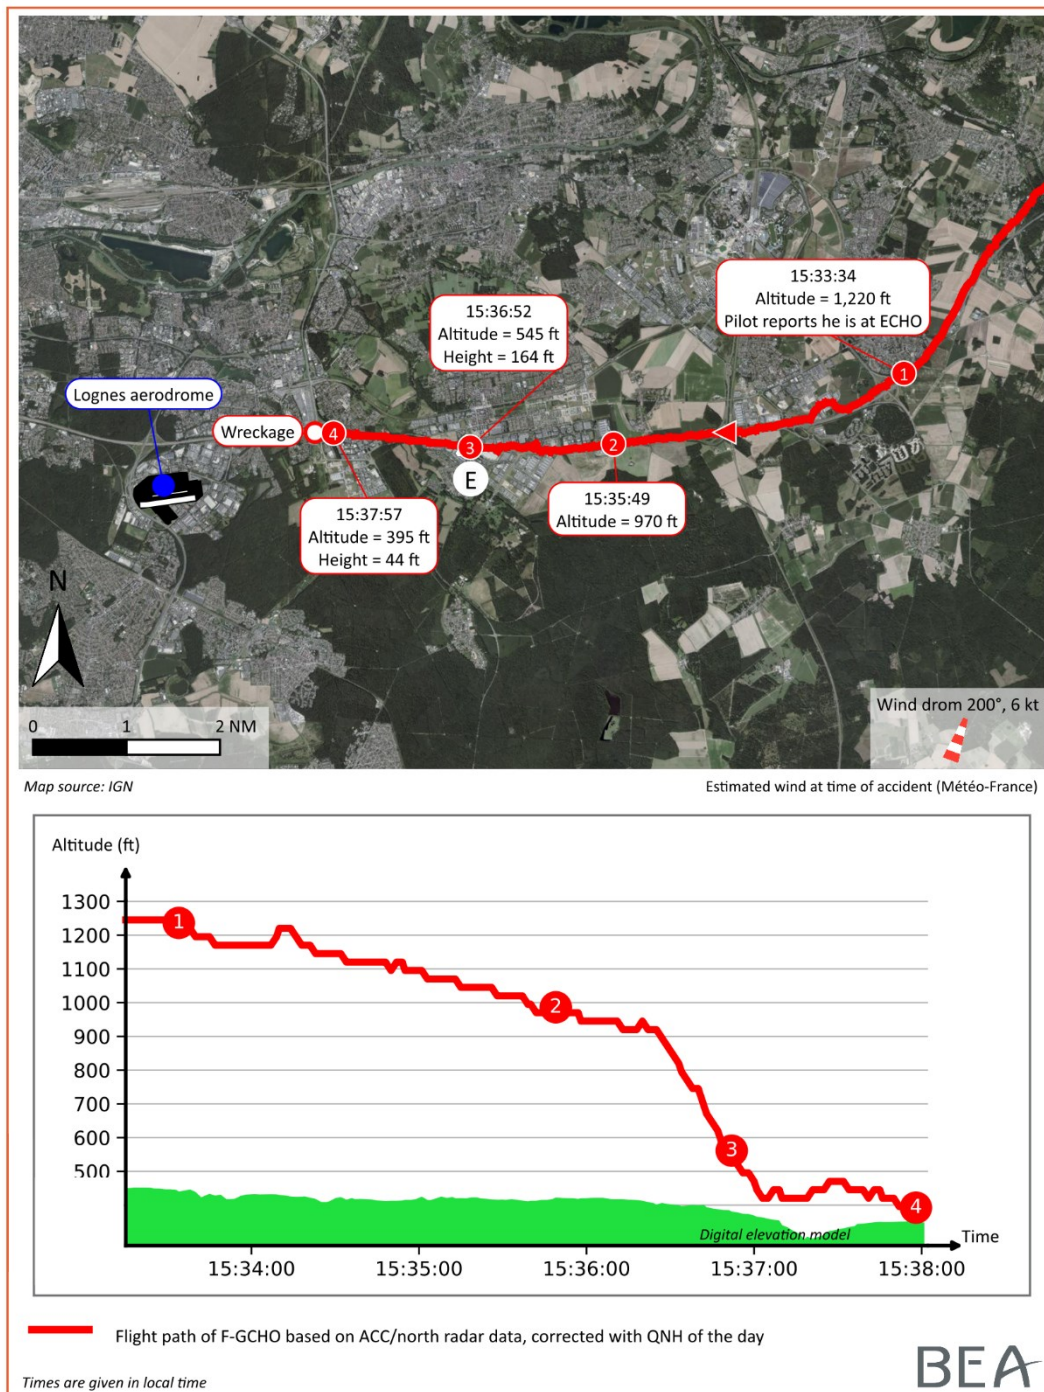
Figure 1: path of end of flight

At 15:33:34 (see **Figure 1**, point **①**), at an altitude⁴ of 1,220 ft, the pilot announced that he was at point ECHO. The controller replied to the pilot that he (*Fox Hotel Oscar*) was not at all at point ECHO, but at the toll, and that point ECHO was 4 NM west from his position. The aeroplane was flying over the A4 motorway, in a slight descent, at a rate of approximately 200 ft/min. The aeroplane's ground speed was around 85 kt.

At 15:35:49 (point **②**), at an altitude of 970 ft and still in descent, the pilot asked the controller if he had passed point ECHO. The latter replied to the pilot that he (*Fox Hotel Oscar*) had still not passed point ECHO, that this point was still 1 NM ahead of him, and that, on passing point ECHO, he would be able to carry out a straight-in approach to grass runway 26. The controller then rectified this information, telling the pilot (*Fox Hotel Oscar*) that, on passing ECHO, he had to call

One minute later, at 15:36:52 (see **Figure 1** and **Figure 2**, point 3), the aeroplane was overhead point ECHO at an altitude of 545 ft. The aeroplane flew over the motorway bridge located at the intersection of the A4 motorway with the D35 road, at a height of less than 170 ft⁵, i.e. less than 50 m.

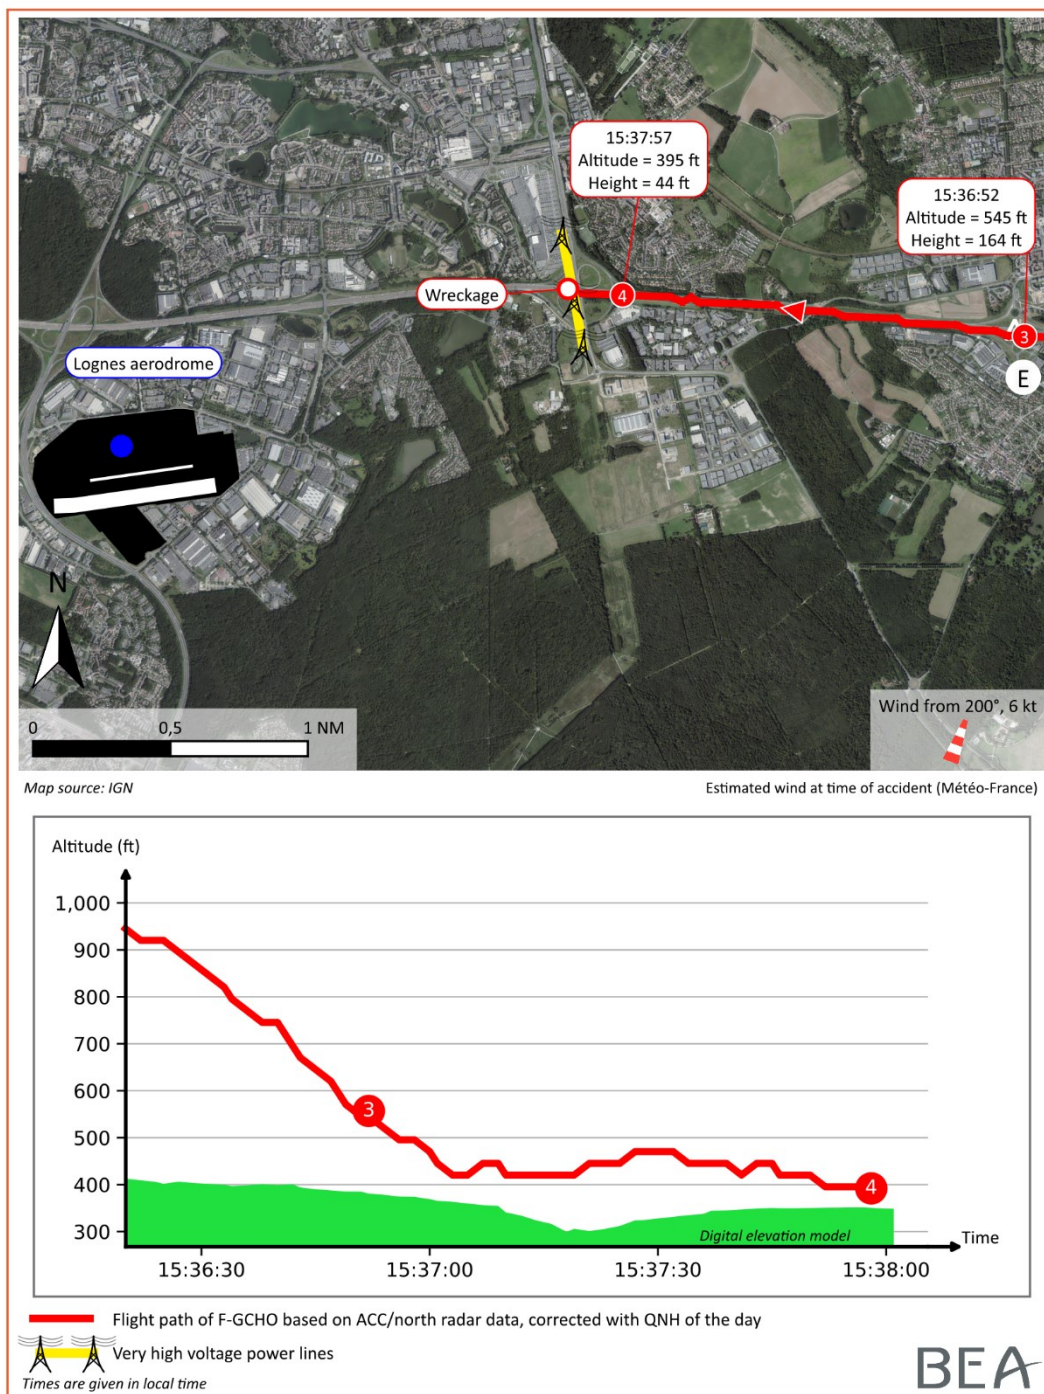
Figure 2: zoom on the last minutes of the flight

At 15:37:57 (point 4), the controller spoke to the pilot, saying that he (*Fox Hotel Oscar*) had to call back overhead the aerodrome at 1,500 ft and had to avoid flying along the motorway on coming back from ECHO, as he would then be in full conflict with the outbound traffic. There was no response from the pilot to this message.

At 15:38:05, the aeroplane flew over the first motorway bridge of the A4/A104 intersection at a height of less than 50 ft, i.e. less than 20 m. In the seconds that followed, it flew over the main bridge of the intersection, remaining relatively stable in level flight with its wings flat, before colliding with the very high-voltage power line located behind it. The controller made several unsuccessful attempts to contact the pilot, before calling the emergency services.

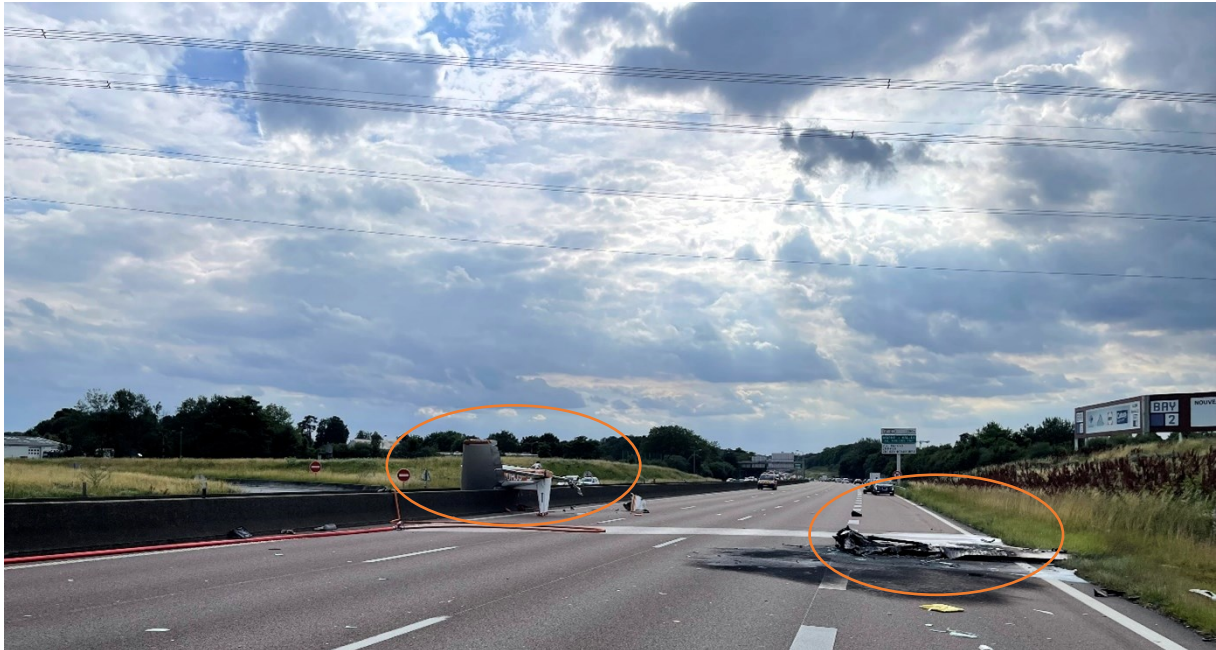
The main wreckage of the aeroplane was located on the median strip of the A4 motorway, around 10 m after the very high-voltage power lines. The aeroplane's left wing separated from the airframe when the aeroplane collided with the power line and caught fire. It burned for around 40 min on the motorway entry slip road. Four electrical cables on the very high-voltage line were frayed, but not broken.

Figure 3: main wreckage of the aeroplane, left wing and very high-voltage lines (Source: BEA)

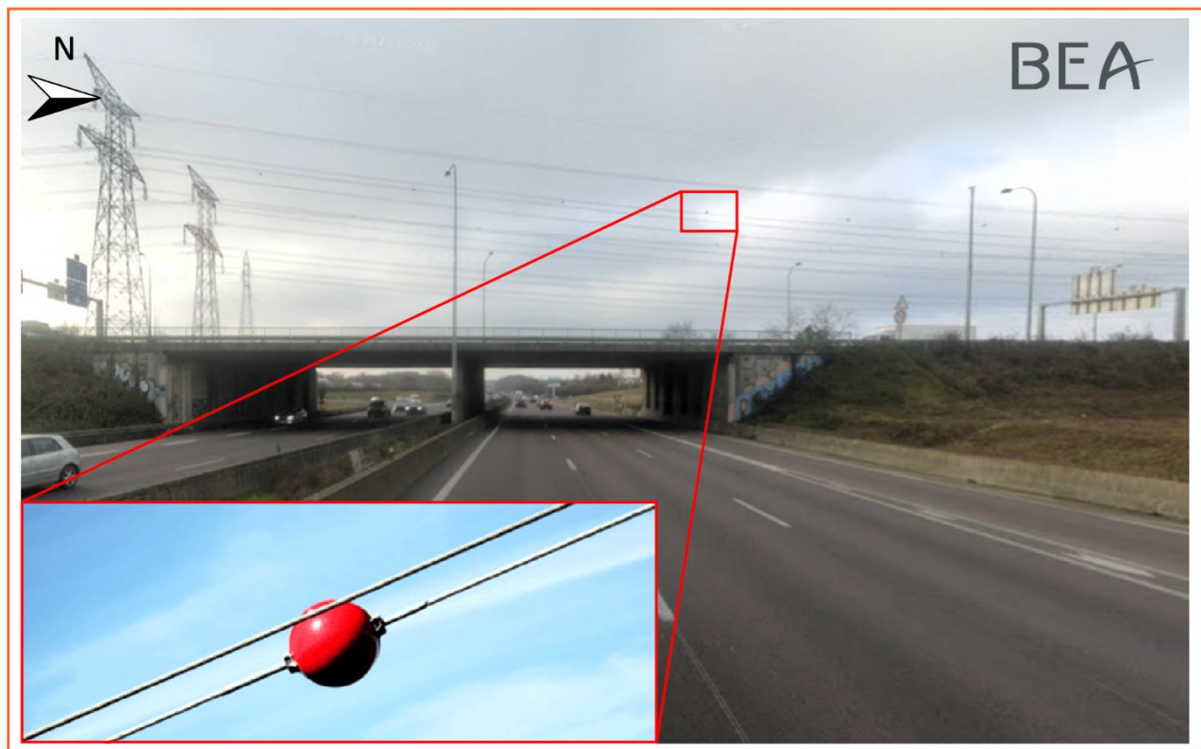
This electrical infrastructure consists of three very high-voltage power lines (one 400 kV at the centre and two 225 kV on either side) with a total of 42 cables. Two of these cables, located on the central line, are fitted with aeronautical lighting visible during the day (see **Figure 4**) in accordance with the regulations applicable in the vicinity of aerodromes.

The tops of the pylons located in the immediate vicinity of the motorway are respectively at a height of 48 m, 51 m and 47 m, in the direction of flight of the aeroplane. They are clear of any vegetation and clearly visible from onboard an aeroplane following the path of F-GCHO.

*Figure 4: view of the power lines, in the direction of flight of the aeroplane (Source: Google) -
Insert: aerial lighting (Source: RTE)*

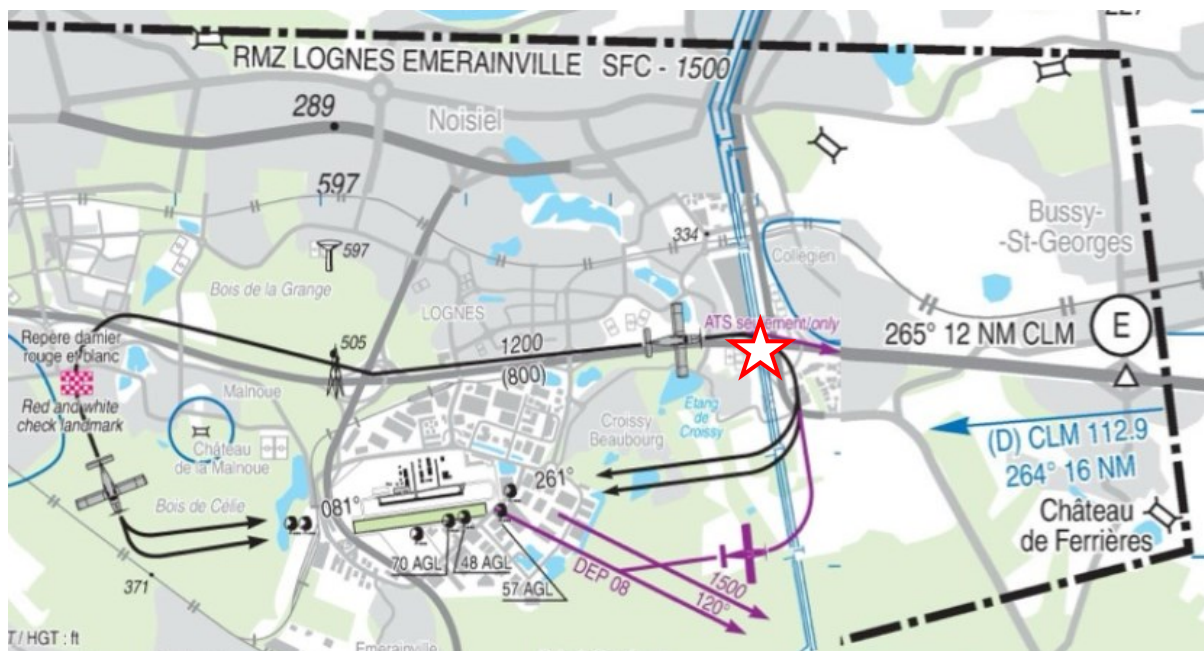
The special instructions in the aeronautical publication of the AIS (Aeronautical Information Service) stipulate that, for arrivals from the east, the tower should be contacted at least 2 min before point ECHO (identified **E** on **Figure 5**), at 1,200 ft and approach the aerodrome circuit with a speed of less than 100 kt.

Figure 5: aerodrome circuit and accident site ☆ (Source: AIS VAC chart)
