Accident to the SOCATA - TB20
registered **F-GDNU**
on 22 May 2023
at Langogne-Lespéron

Time	Around 12:20 ¹
Operator	Private
Type of flight	Cross-country
Persons on board	Pilot and four passengers
Consequences and damage	Aeroplane substantially damaged

**Insufficient acceleration during take-off,
attempted take-off, runway overrun**

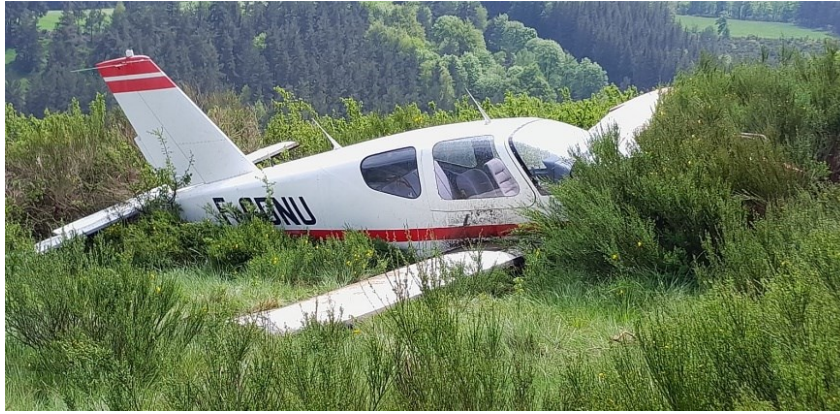
The aeroplane came to a stop in a thicket about one metre high. The three landing gears were ruptured. The flaps were retracted.

Figure 1: photograph of F-GDNU after the accident (Source: local flying club)
