**Serious incident** to the PILATUS PC6 B2H2  
registered **F-GEBS**  
on Sunday 23 March 2025  
at Saint-Etienne Loire

<b>Time</b>	Around 10:00 <sup>1</sup>
<b>Operator</b>	LYON BRON PARACHUTE TANDEM
<b>Type of flight</b>	Skydiving activity
<b>Persons on board</b>	Pilot
<b>Consequences and damage</b>	Aeroplane slightly damaged

## **Jamming of elevator trim control, precautionary landing**

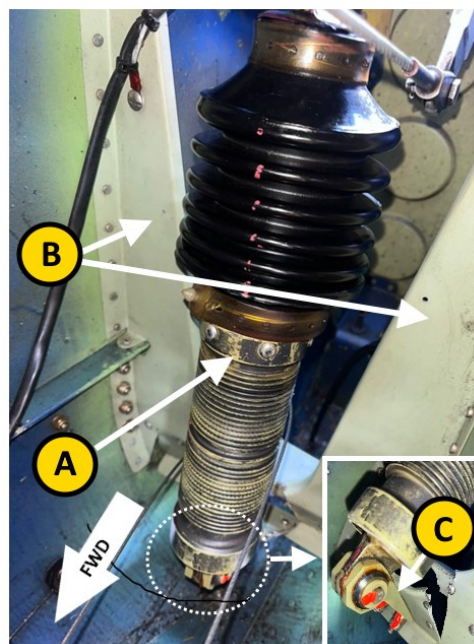
*Figure 4: view of frame FR12A, elevator trim actuator and connecting piece (source: BEA)*

The examination of the aeroplane principally concentrated on the tail section where the elevator trim actuator is situated (see **Figure 4**, detail **A**) and in particular, on structural frame FR12A (detail **B**) holding the lower connecting piece (detail **C**) of the elevator trim actuator.

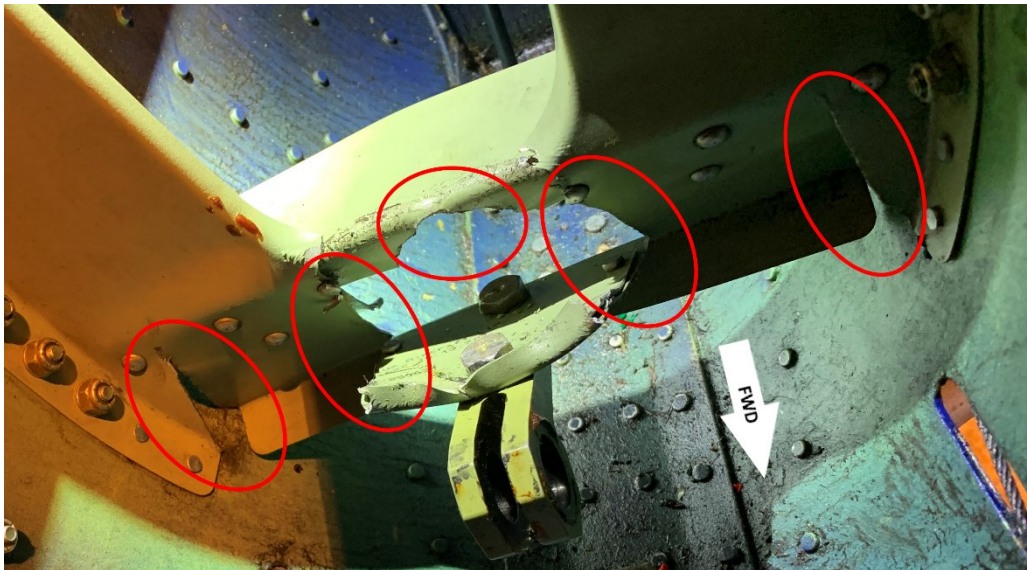
*Figure 5: view of frame FR12A and damage (actuator removed) (source: BEA)*

The elevator trim actuator was no longer correctly fastened to frame FR12A and had moved forwards and downwards, resulting in the slackening of the cable which controls the actuator. The structural frame was damaged and torn in several places (see **Figure 5**).

The incorrect assembly of the connecting piece of the trim actuator led to the application of out-of-plane loads, corresponding to a mode of stress for which frame FR12A has lower mechanical strength than under normal conditions (attaching part installed in the correct direction). The introduction of an unintended stress component in the sheet metal elements caused deformation and then tearing of part of the frame which then propagated.

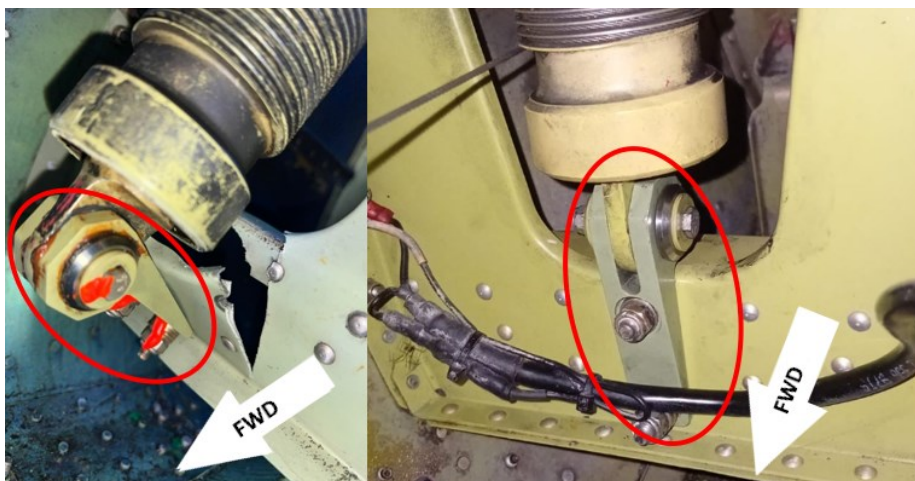
*Figure 6: installation observed (on LH side), correct installation (on RH side) (source: BEA)*

The examination found that the lower connecting piece of the elevator trim actuator was incorrectly positioned. This connecting piece had been installed in the wrong direction.

At the end of this inspection during which no anomaly was identified, the mechanic attached the connecting piece to the frame without realising that he had positioned it in the wrong direction. The elevator trim actuator was then attached to the connecting piece. As it is a hinged connection and the actuator is movable, it was possible to position the actuator on the connecting piece.

The maintenance workshop added a supplement to the job card to illustrate the correct positioning of the connecting piece and put the task on the list of critical tasks requiring a specific check

The aeroplane manufacturer decided to modify the maintenance documentation for this operation to better document the positioning of the connecting piece and to warn of the possibility of its incorrect installation.

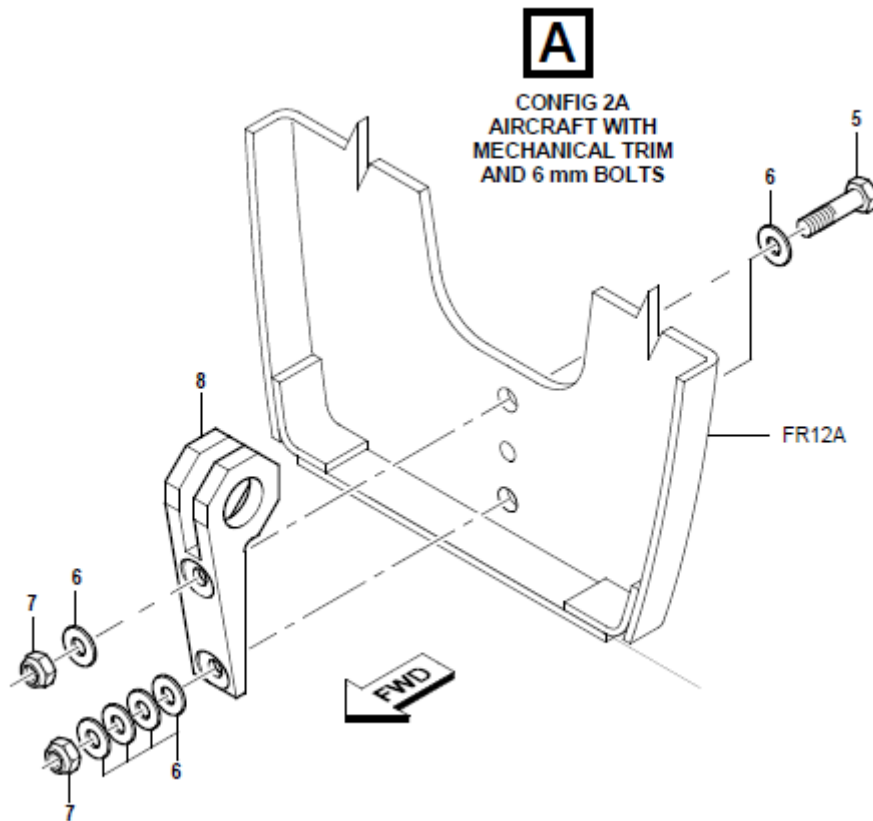
Figure 7: excerpt from Figure 601 of AMM 53-30-00 (source: Pilatus)

The title of the chapter which covers the connecting piece installation operation refers to Figure 601 (see Figure 7) which identifies the components and includes the three possible configurations according to the trim control (one for the electric trim, two for the manual trim). In the case of F-GEBS, it was configuration 2A.

The text associated with the operation to install the connecting piece on frame FR12A (see **Figure 8**) does not specify the installation direction and does not warn of the possibility of inverting the direction.

- maintenance documentation that contains no mention warning of the possibility of incorrectly positioning the connecting piece, this risk not having been anticipated;
- a maintenance task that was not identified as critical and that did not give rise to any specific check.

These modifications were introduced with the publication of Revision No 40 of the Aircraft Maintenance Manual of 30 November 2025.
