Accident to the Schweizer 269C
registered **F-GEXN**
on Friday 12 May 2023
at Saint-Julien-de-Concelles

Time	Around 16:20 ¹
Operator	AIRAGRI
Type of flight	Agricultural flight
Persons on board	Pilot
Consequences and damage	Pilot injured, helicopter destroyed
This is a courtesy translation by the BEA of the Final Report on the Safety Investigation. As accurate as the translation may be, the original text in French is the work of reference.

Power line strike during aerial work, collision with ground

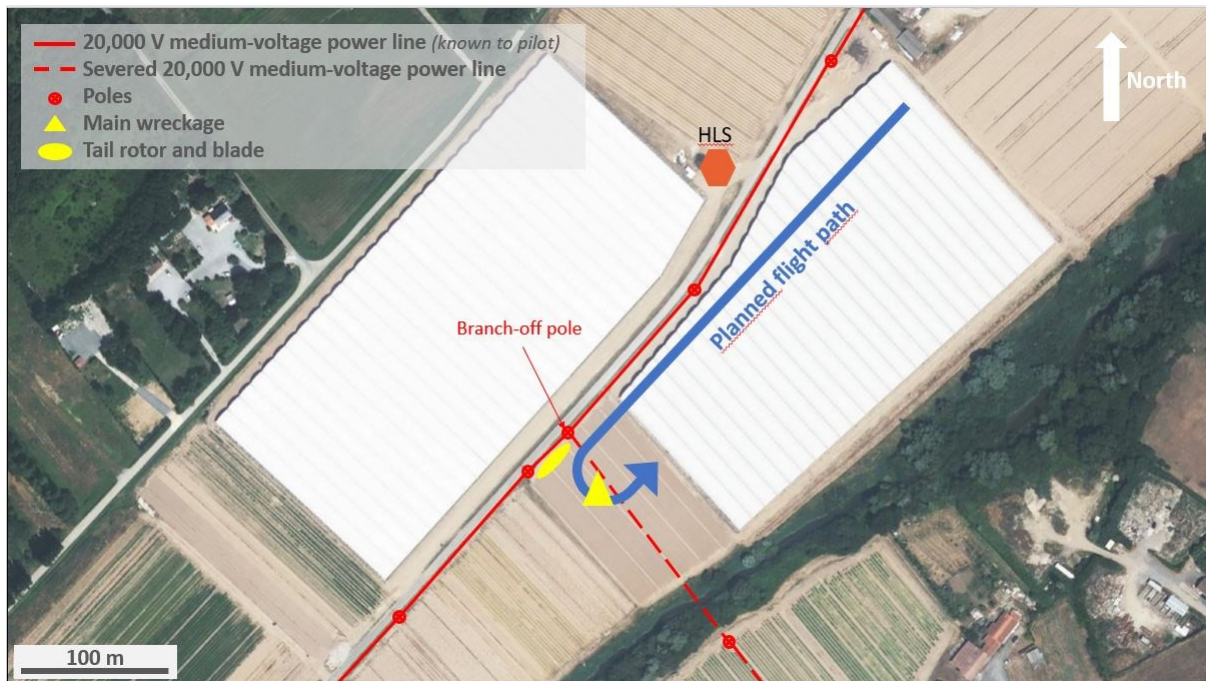
Figure 2: presumed flight path of helicopter (Source: Géoportail, annotations BEA)

After whitening the polytunnels lengthwise (north-west/south-east direction), he continued spraying, flying overhead the tunnels in a south-westerly direction, starting along the edge of a main road bordered by a medium voltage (MV) power line of 20,000 V.

At the end of the first flight overhead the polytunnels, at the beginning of the LH turn for a second pass towards the north-east, the pilot felt the helicopter's left skid catch on something. The helicopter which was at a speed of between 45 and 50 kt, quickly slowed down. The pilot then understood that he had struck the cables of a power line (see **Figure 2**). Two of the three cables of the MV power line broke. The third cable which did not break caused the helicopter to turn over

onto its back. The pilot was unable to stabilise the helicopter which collided inverted, with the ground after the power line in a field of crops. The pilot shut down the engine and exited the helicopter unaided with a few injuries (mainly bruises and pains)

The wreckage was lying on its back at around 50 m from the edge of the road (see **Figure 2**) and 15 m after the power line that had been struck (at 45 m from the polytunnel that was to be sprayed). The helicopter was destroyed (see **Figure 3**). All of the damage observed was the result of the helicopter striking the MV power line cables and the collision with the ground.

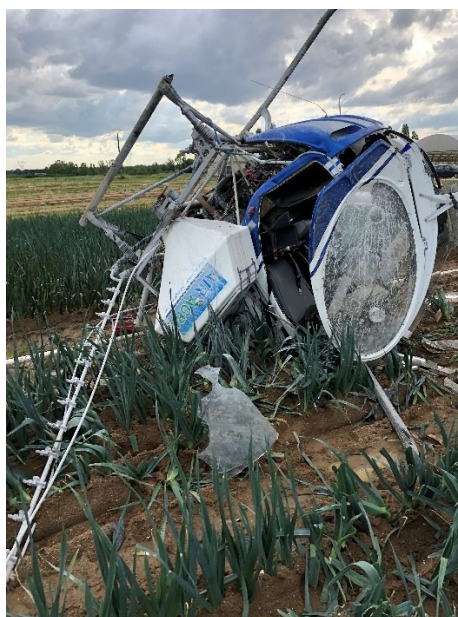
Figure 3: main wreckage (Source: BEA)

One of the three blades of the main rotor had penetrated the canopy and the cockpit on the LH, passenger's seat side. The tail rotor and a second blade from the main rotor was found near a pole belonging to the part of the MV power line running alongside the road next to the polytunnel to be sprayed white (south-west/north east).

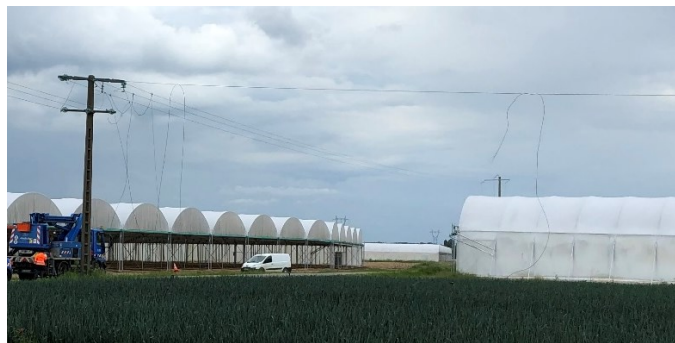
Figure 4: branch-off pole and severed cables (Source: BEA)

One of the poles of this power line, situated at around 30 m from the polytunnel, at the edge of the road, is the branch-off of the MV power line severed by the helicopter (see **Figure 4**). Another pole located at around 150 m south-east from the branch-off pole, behind a row of trees by the side of Boire de la Roche water course, carries the three cables of this power line (see **Figure 2**). Consequently, this power line is nearly parallel to the polytunnels at a distance of around 30 m from them. The left skid of the helicopter struck the power line cables at a height of around 7 m and a distance of around 6 m from the lowest point of the span. Two cables were severed³.

When the pilot had come to the end of a polytunnel and started his turn for a new spraying operation, still at low height, the helicopter's left skid came into contact with the MV power line cables which the pilot had forgotten about. In addition to this, the pole which was carrying the three cables of this power line was on the pilot's LH side, it was also probable that it was outside his field of vision.

- systematic reconnaissance of the work sites;
- slower speeds for work at low height;
- regular breaks to limit the effects of routine and tiredness.
