Accident to the PIPER PA28-181 Archer II
registered **F-GFGO**
on 16 February 2020
at Creissels

Loss of control in flight in adverse weather conditions for visual flight, collision with the ground

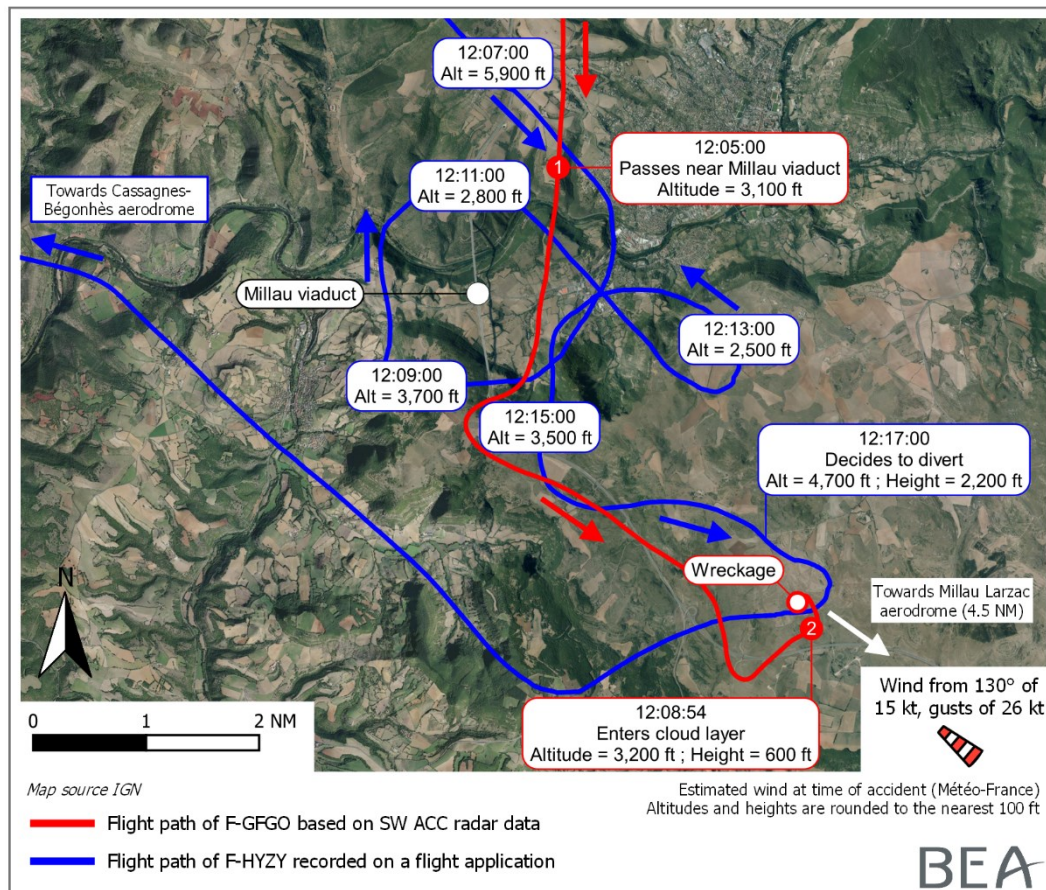
At 12:05, the PA28 arrived at the Millau viaduct² (see Figure 1, point ①), about three minutes before the Cessna 172.

At 12:08:54 (see Figure 1, point ②), the pilot of the PA28 entered the cloud layer at an altitude of 3,200 ft (height of 600 ft) and lost control of the aeroplane in less than 10 s. The aircraft adopted a

Figure 1: flight paths of the PA28 and the Cessna 172 on approach to Millau-Larzac aerodrome

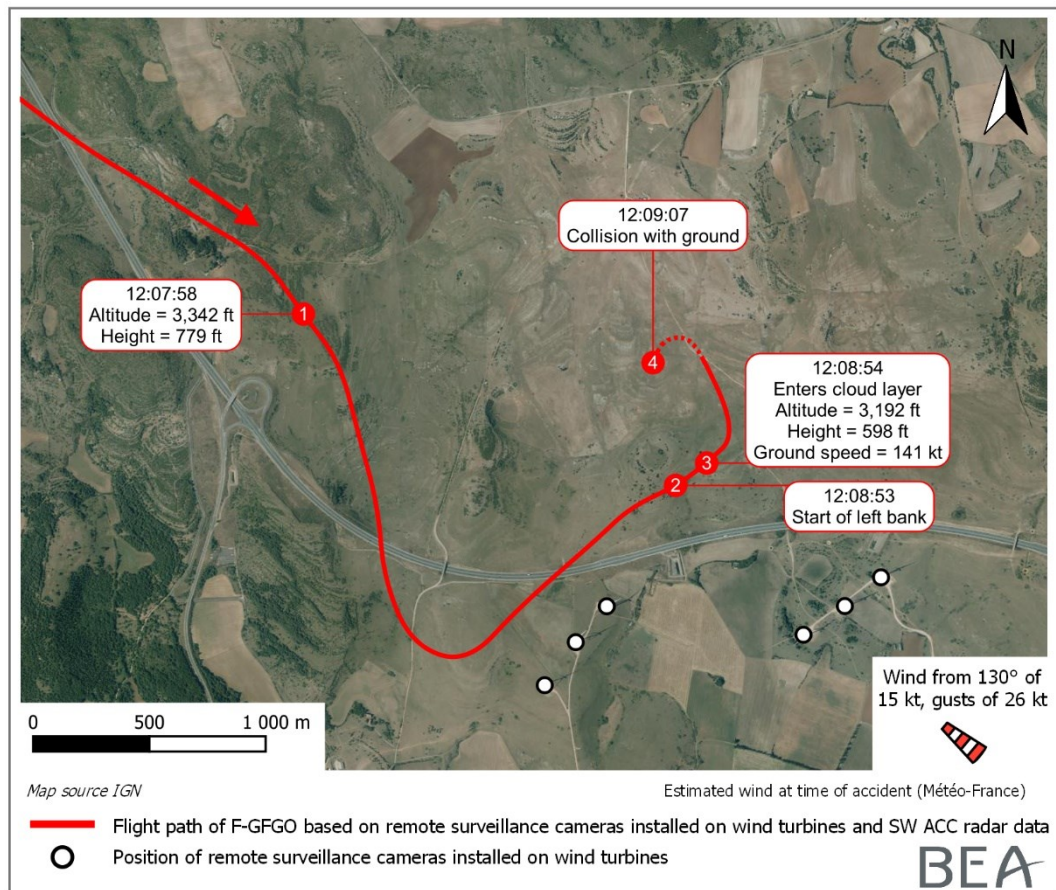
Figure 2: flight path of the PA28 near the accident site

The analysis of the images from the remote surveillance cameras determined that the PA28 entered the cloud layer at an altitude of 3,192 ft, a height of 598 ft and a ground speed of 141 kt (see Figure 2, point 3).

When it became visible again as it emerged from the cloud layer, the PA28 had a steep nose-down path. It was not possible to determine the aeroplane's attitude during this fall.

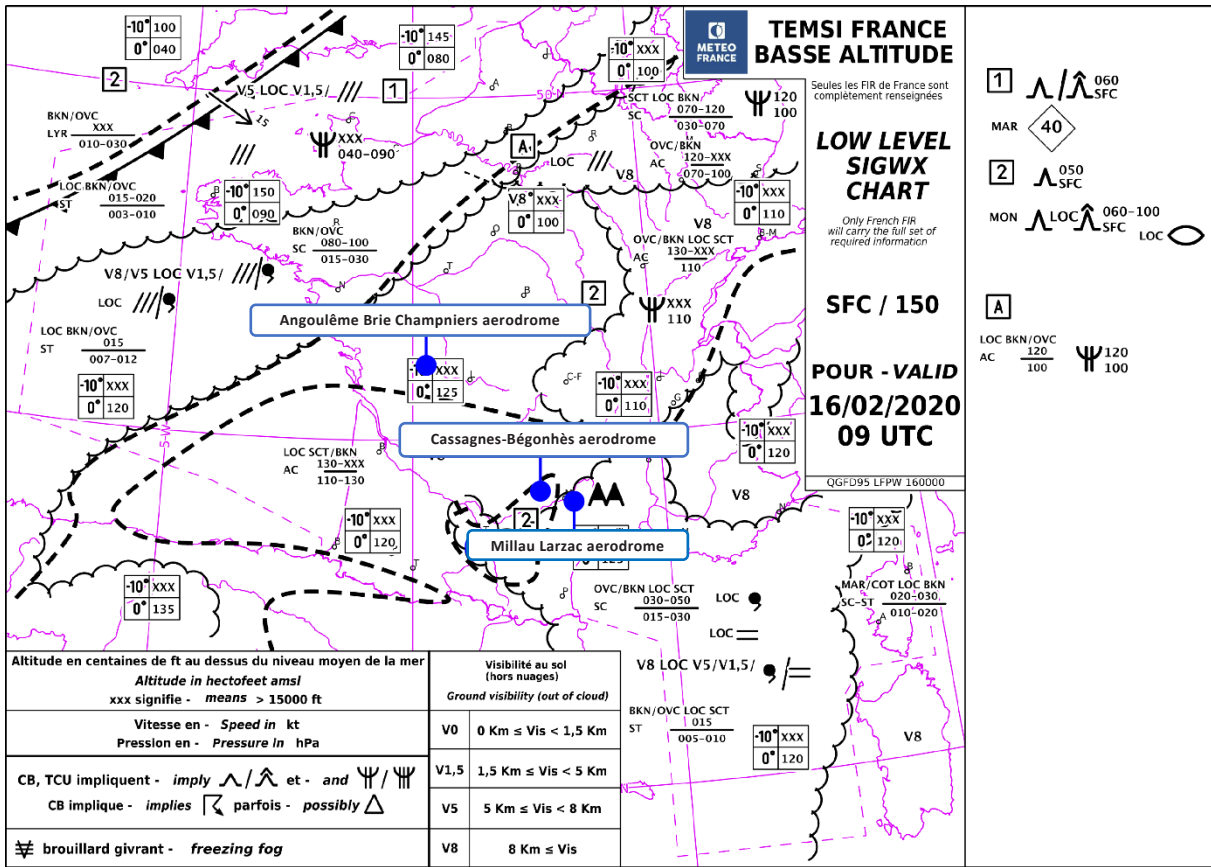
Figure 3: SIGWX chart (Source: Météo-France)

- visibility greater than 8 km but locally between 1.5 and 8 km;
- local presence of drizzle and mist;
- mountain obscuration⁴;
- 5 to 8 oktas (locally 3 to 4 oktas) of stratocumulus with a base between an altitude of 1,500 ft and 3,000 ft and a top between an altitude of 3,000 ft and 5,000 ft;
- 5 to 8 oktas (locally 3 to 4 oktas) of stratus with a base between an altitude of 500 ft and 1,000 ft and a top at an altitude of 1,500 ft.

The wind and temperature charts (WINTEM) for 09:00 UTC, 12:00 UTC and 15:00 UTC, all three of which were made available at 00:00 UTC, showed that no major change was expected with respect to the direction and intensity of the warm airstreams from the Atlantic and cold airstreams from the Mediterranean. In addition, the TAF messages presented above did not show any notable change over the day. All these elements could indicate that the scalloped area incorporating Millau-Larzac aerodrome (see Figure 3) was unlikely to be resorbed.

To conclude, the meteorological information available at the time of flight preparation showed that adverse weather conditions for visual flight were forecast for the approach to Millau-Larzac aerodrome.

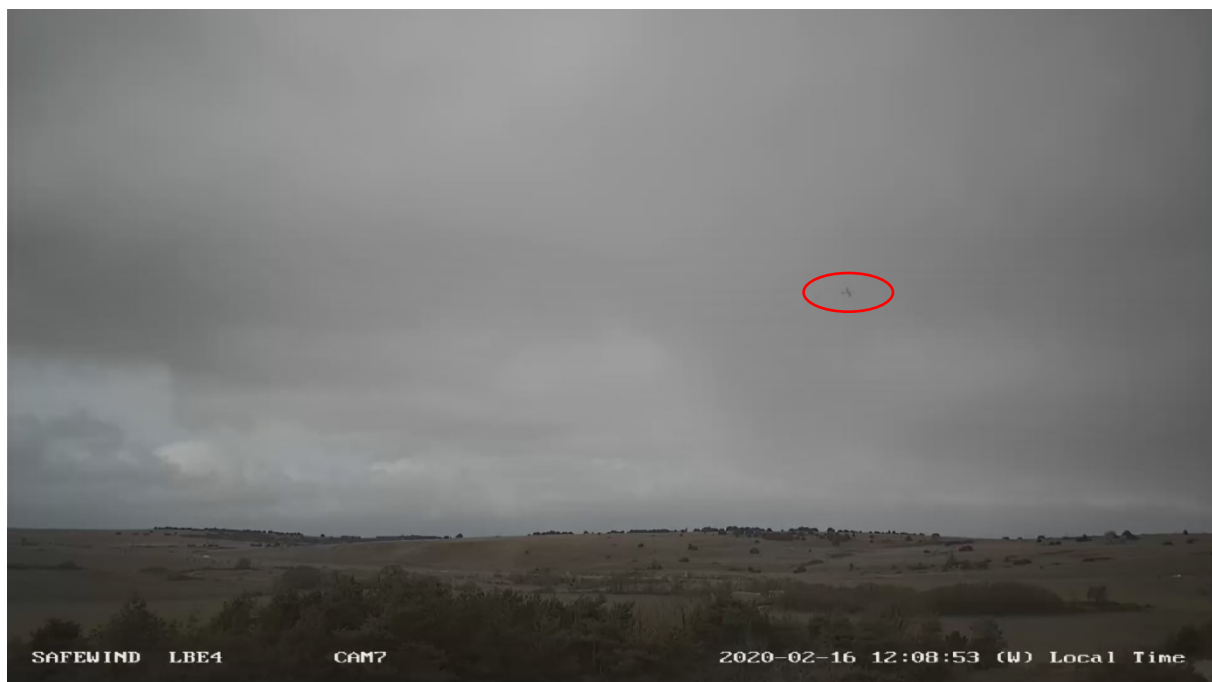
According to the statements of the people on board the Cessna 172, the situation was CAVOK from the beginning of the flight until about 15 NM north-west of Millau-Larzac aerodrome. For the rest of the flight, a low-level stratus layer (see Figure 4) was present. This layer was also present at Millau-Larzac aerodrome.

Figure 4: meteorological situation near the accident site.

On this recording taken from the wind farm, F-GFGO is visible just before it enters the cloud layer (Source: remote surveillance camera)
