Serious incident to the ROBIN DR400-100
registered **F-GGJG**
on Friday 28 March 2025
at Lognes-Émerainville aerodrome

Time	Around 13:30 ¹
Operator	Aéroclub Aigle de Saint-Maur
Type of flight	Cross country, in solo instruction
Persons on board	Student pilot
Consequences and damage	None

Runway veer-off on landing, balked landing, flight over taxiways and ramp at low height, in solo instruction

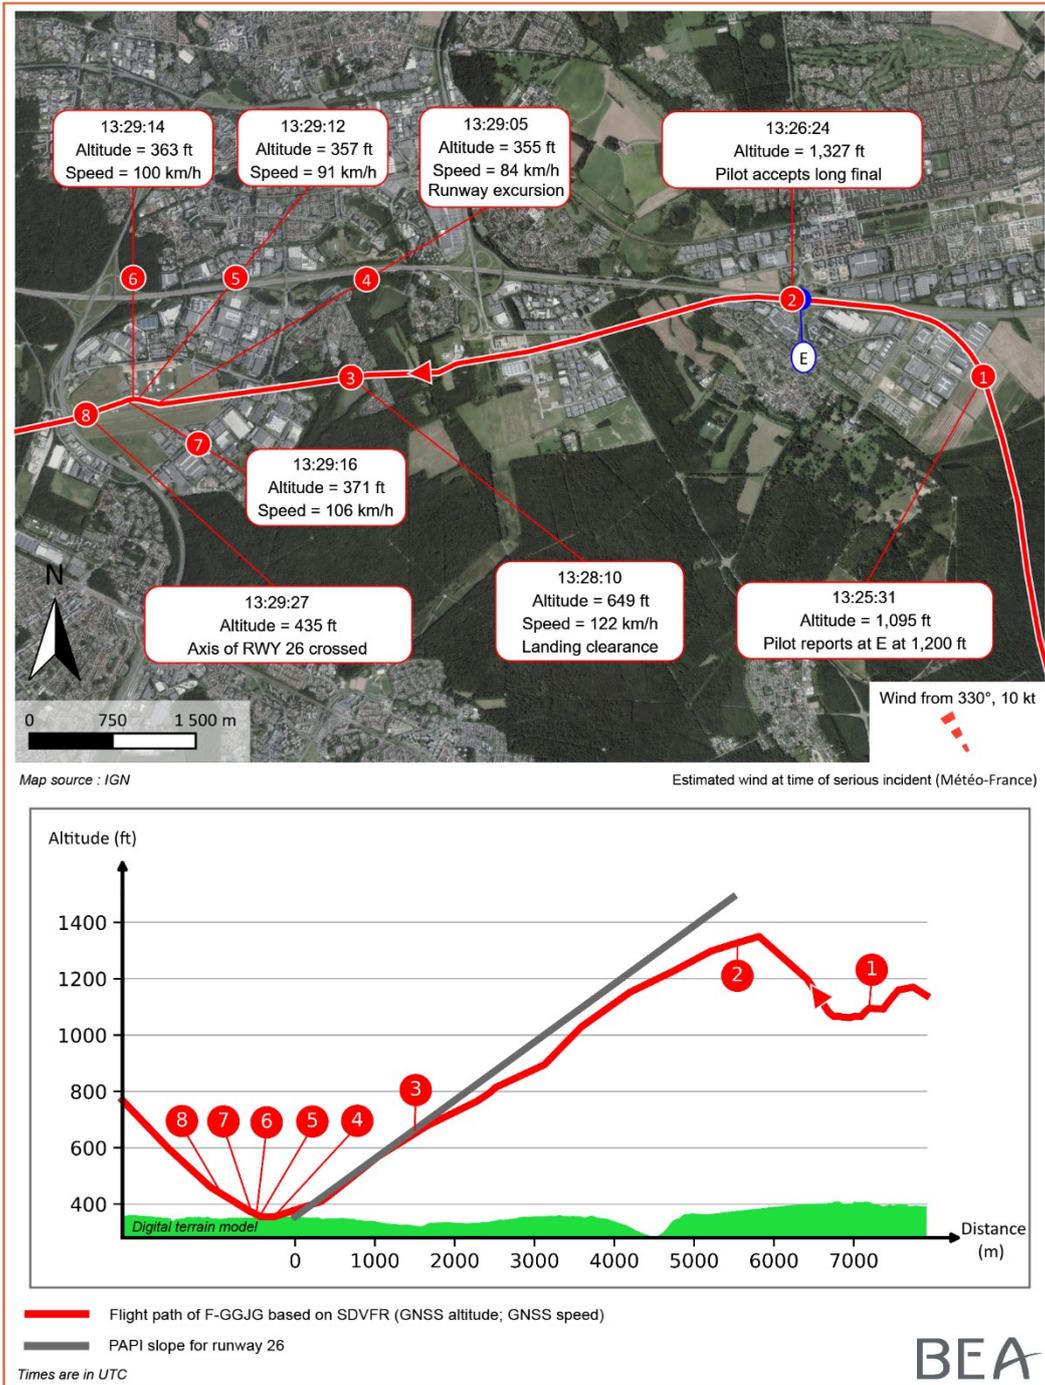
Figure 1: approach path of F-GGJG, overall view

On approaching Lognes, he checked in at 1,200 ft² at point E³, the entry point for Lognes RMZ⁴ (see point ① above). The controller in the TWR position at Lognes tower asked him to call back overhead the aerodrome at 1,500 ft due to traffic on the downwind leg.

Forty-one seconds later, the controller suggested to the student pilot of F-GGJG that he join the long final for runway 26 behind the traffic which was passing onto the base leg. The student accepted this option (point ②).

The student pilot was given clearance to land (point 3). The controller reported that the wind was from 310° and of 5 to 13 kt. The nose of the aeroplane was oriented into the wind, to the right-hand side of the runway axis. When flaring, the student pilot decrabed to the left to reorient the nose of the aeroplane onto the runway centreline. Simultaneously on touchdown, he felt the nose of the aeroplane return to the direction of the wind, toward the right.

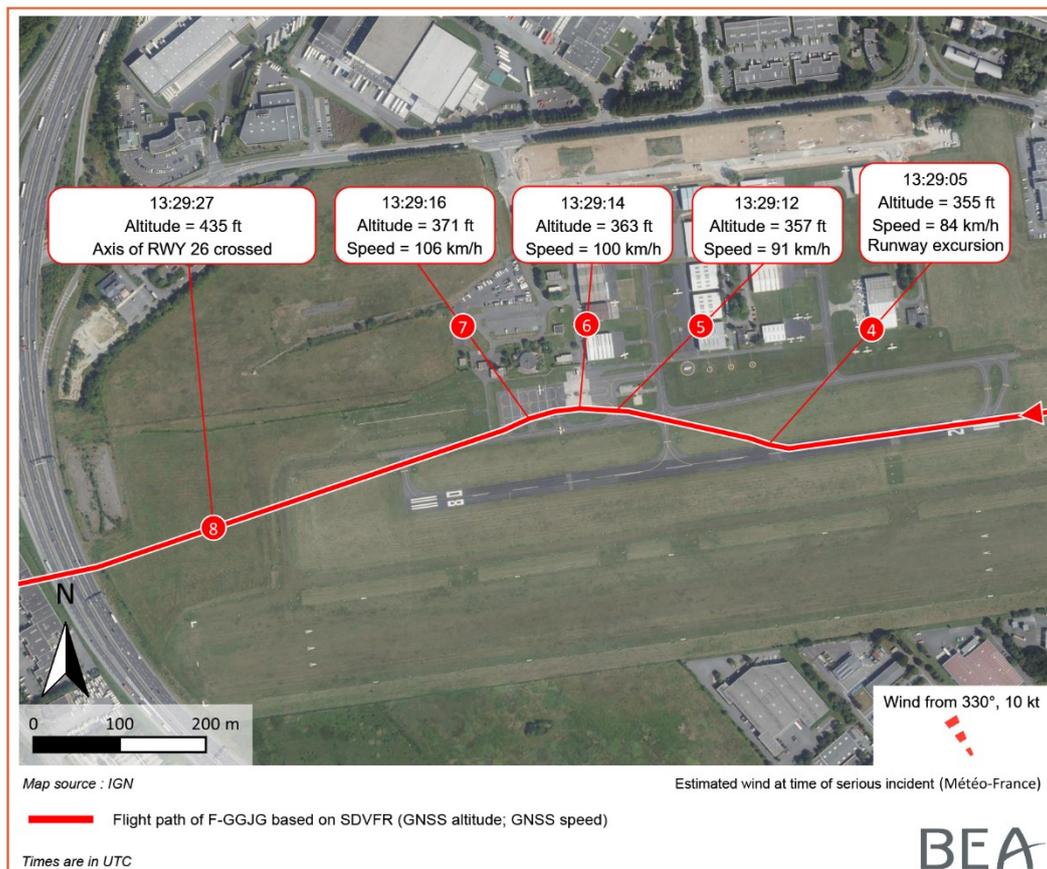
Figure 2: path after touchdown⁷

Sensing that the aeroplane was heading towards the grass, the student pilot carried out a balked landing⁵ in order to avoid a runway excursion.

The aeroplane continued on its right-hand path and left the runway at an angle of around 20° with respect to the runway centreline (see point 4 above). The aeroplane ran over the grass area between the runway and taxiway N⁶. It then crossed the intersection between taxiways N and N3 before flying over refuelling stations L2 and L4 and part of the apron facing the tower, with a low rate of climb and a height below 20 ft.

While flying over the ramp, the student pilot started a left-hand turn in order to join the runway axis. He flew over taxiway N and then N4 again at a height of around 45 ft. He joined the runway axis at around 220 m from threshold 08 (point 8).

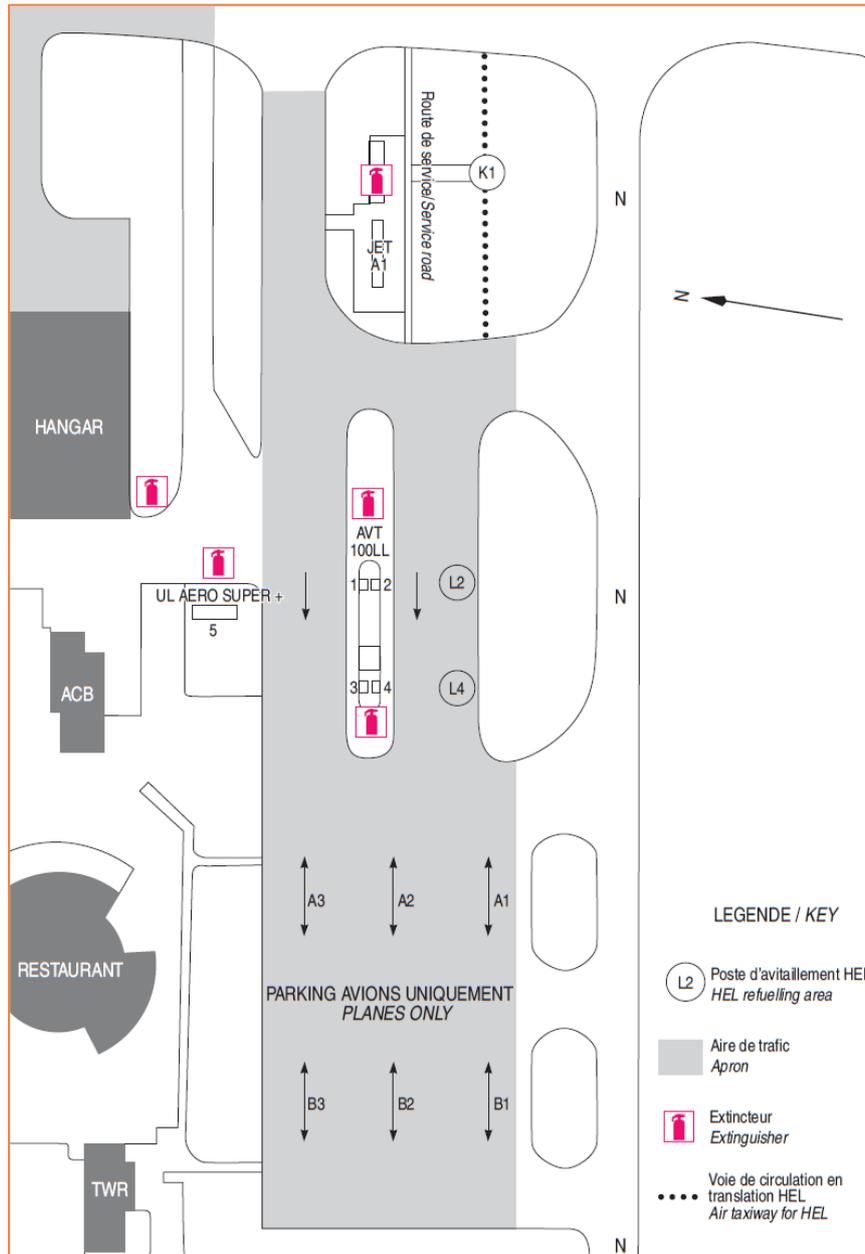
Figure 4: refuelling area and apron (source: SIA)

The refuelling area (Figure 4) is situated north of taxiway N and west of taxiways N3 and T1. In the immediate vicinity of N3/T1 and N there is the helicopter refuelling station (K1). The aeroplane refuelling area is situated to the west of this area with two taxiways leading to it, one to the north of pumps 100LL and the other to the south of these pumps (positions L2 and L4) close to taxiway N.

At the time of the incident, no aircraft was present on taxiway N, in the refuelling area or on the apron facing the control tower.
