Serious incident to the SOCATA – TB 20 registered **F-GGNS**
and to the Beechcraft - Be 58 registered **F-GNSD**
on 6 October 2021
at Saint-Yan

Near collision between two aircrafts on initial climb from parallel runways, both in instruction flight

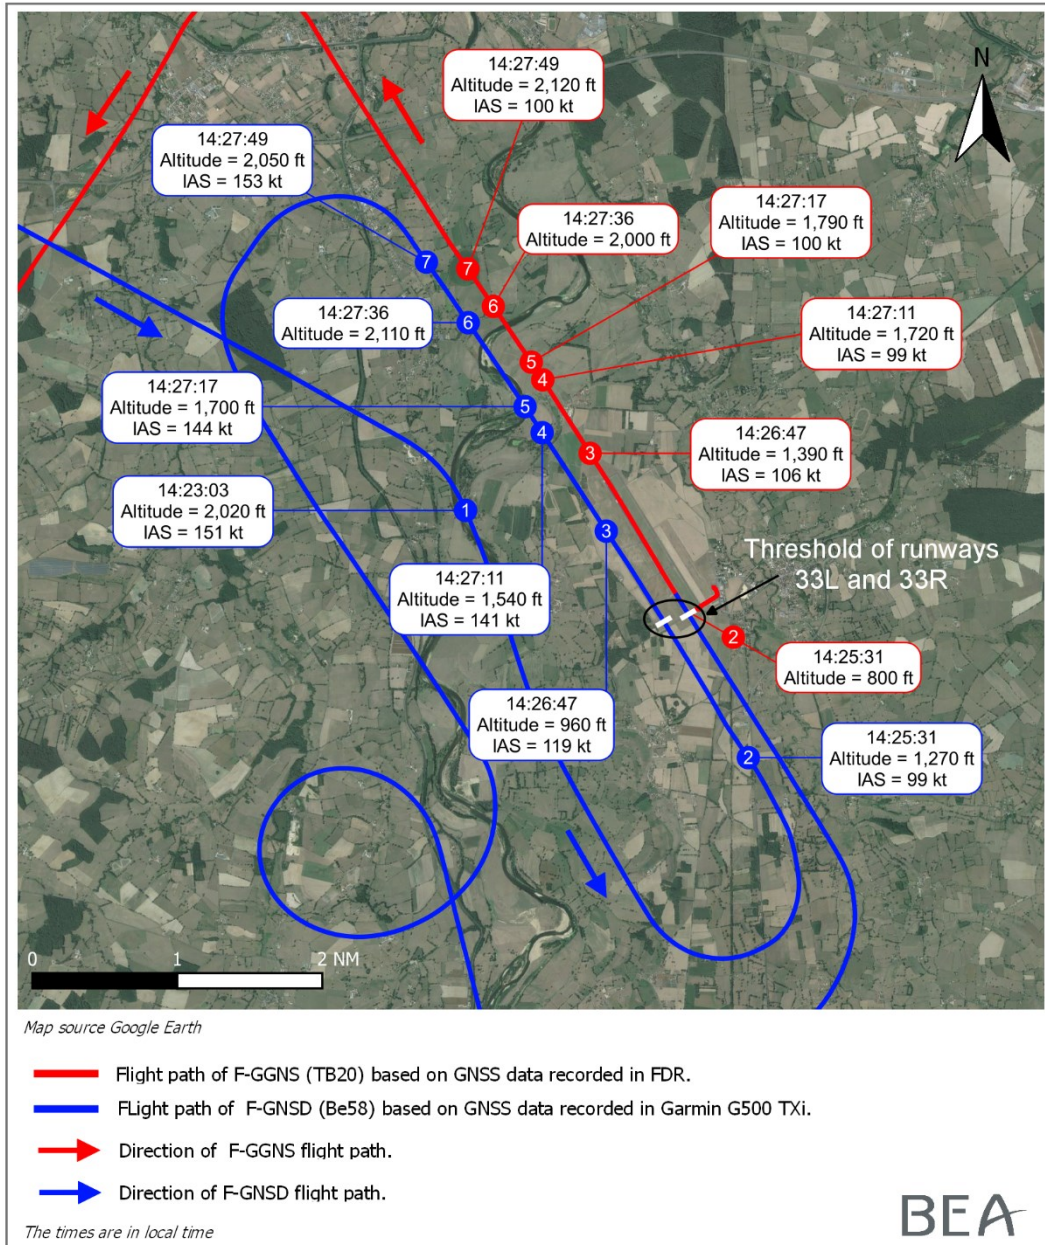
Figure 1: flight paths of the two aeroplanes

At 14:23:03, the Be 58 pilot called back on the left-hand downwind leg for a touch-and-go (see Figure 1, point ①). The controller replied that he was number 1 for runway 33L and asked him to call back on final. The pilot read this message back.

At 14:26:26, F-GOSV called back overhead the facilities. The controller asked him to call back on the left-hand downwind leg for runway 33, asked the TB 20 pilot to continue the initial climb and told him she would call him back. This request was repeated at 14:26:47 following the pilot's failure to read back the message (see Figure 1, point ③).

Eighteen seconds later, the controller asked the Be 58 pilot, who had just performed a touch-and-go, to be vigilant because the TB 20 to his right was going to turn left. The pilot answered "Ah" (see Figure 1, point ④).

Six seconds later, the TB 20 pilot indicated, in French, that he was ready to turn left towards GURGO (see Figure 1, point ⑤). The controller asked him, also in French, to hold the axis and said that she would call him back.

At 14:27:36, the Be 58 overtook the TB 20 which was then about 100 ft lower⁶ (see Figure 1, points ⑥ ⑥).
