**Accident** to the ROBIN DR400-180  
registered **F-GGQQ**  
on Sunday 7 December 2025  
at Bethmale

This is a courtesy translation by the BEA of the Final Report on the Safety Investigation. As accurate as the translation may be, the original text in French is the work of reference.

## **Loss of control, collision with terrain in mountainous region**

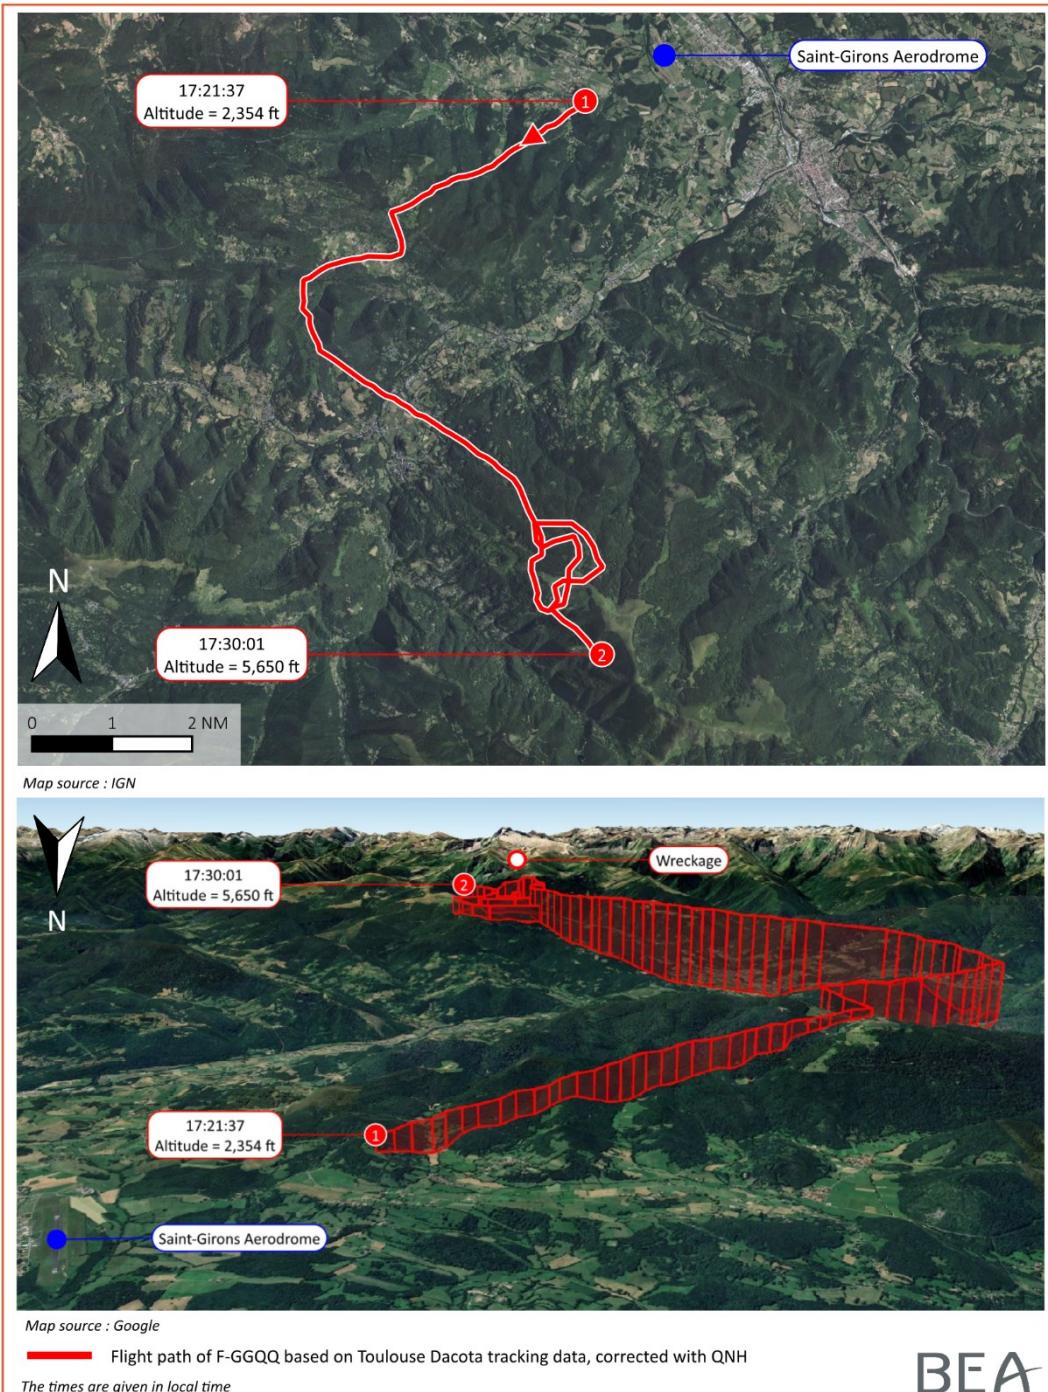
The flight path shown below is based on the radar data recording provided by the south ANS, that is to say the Toulouse DACOTA<sup>3</sup> tracking data. One of the functions of the DACOTA system is to track aircraft by merging (or rejecting) individual radar detections in order to create a single point. When it no longer receives radar data for a designated aircraft, the DACOTA system extrapolates the aircraft's position based on a few updated consecutive positions. This is why it is possible that certain points are derived from an extrapolation and do not represent the actual position of the aeroplane. However, the points shown to reconstruct the flight path are relevant and consistent. The radar track stops before the end of the flight due to the detection floor with respect to the terrain flown over.

The analysis of the Saint-Girons aerodrome radio-communication recordings made it possible to determine that the aeroplane took off at 17:19. This time was consistent with the first radar detection of F-GGQQ at 17:21.

Figure 1: flight path of F-GGQQ based on radar data (source: BEA)

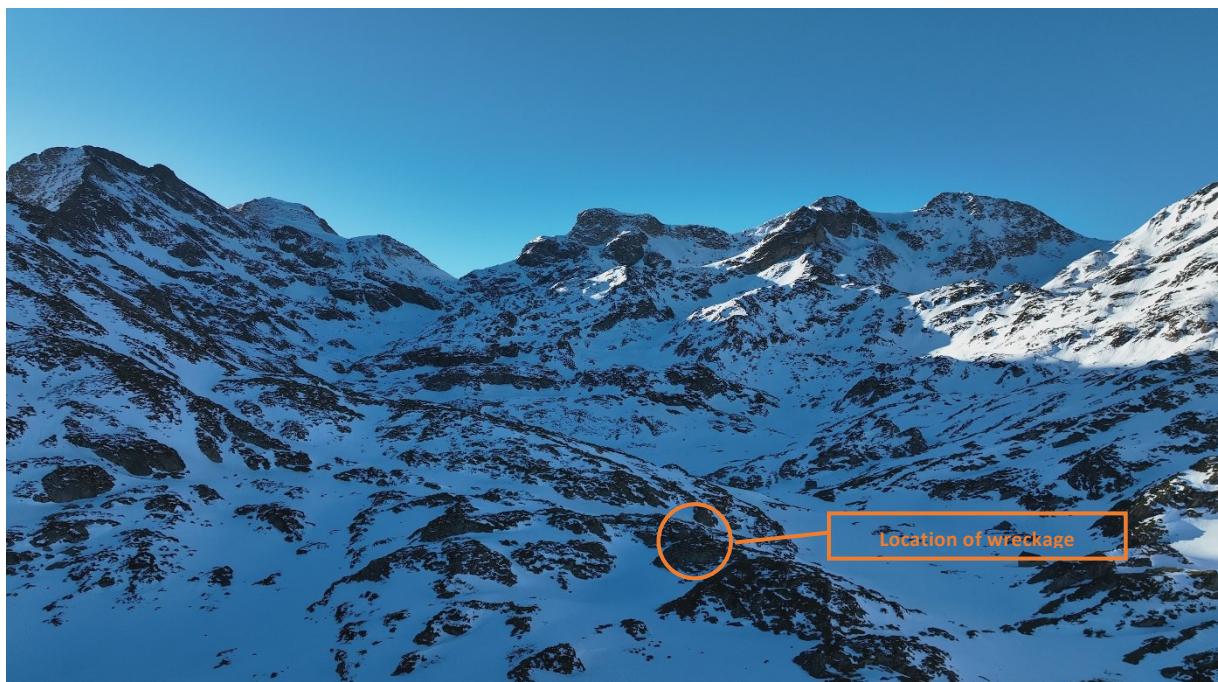
The site of the accident was in the district of Bethmale, just above Eychelle lake, level with the mountain hut of the same name, situated at an altitude of around 2,000 m.

Figure 2: accident site, photo taken in morning light (source: GTA drone)

The wreckage was lying in the middle of an ascending valley, oriented north-south, the valley ridges reaching a height of between 2,200 m and 2,300 m. It was located on a small hill, on rocky terrain partially covered with snow. No impact marks were visible near the main part of the wreckage. It was grouped together in an area approximately ten meters wide by three meters long. Some components (pieces of the rudder) had slid on the snow and were found a few meters down the slope.

The aeroplane was completely destroyed, but its main components were present. The airframe was compressed along its longitudinal axis. The wing was broken on both sides of the airframe. The horizontal and vertical stabilizers were only slightly damaged. All of the flight controls were examined. The roll, pitch, and yaw controls were continuous, from the cockpit controls (stick and rudder pedals) to the control surfaces.

The engine was embedded in the ground up to half of cylinder No 1, i.e. about 50 cm from the nose. The engine's longitudinal axis relative to the ground indicated a collision at a very steep angle (approximately 75°).
