Serious incident to the PARTENAVIA - P68
registered **F-GIEV**
on 30 July 2019
at Melun-Villaroche

Touch-and-go on an occupied runway, during a check flight

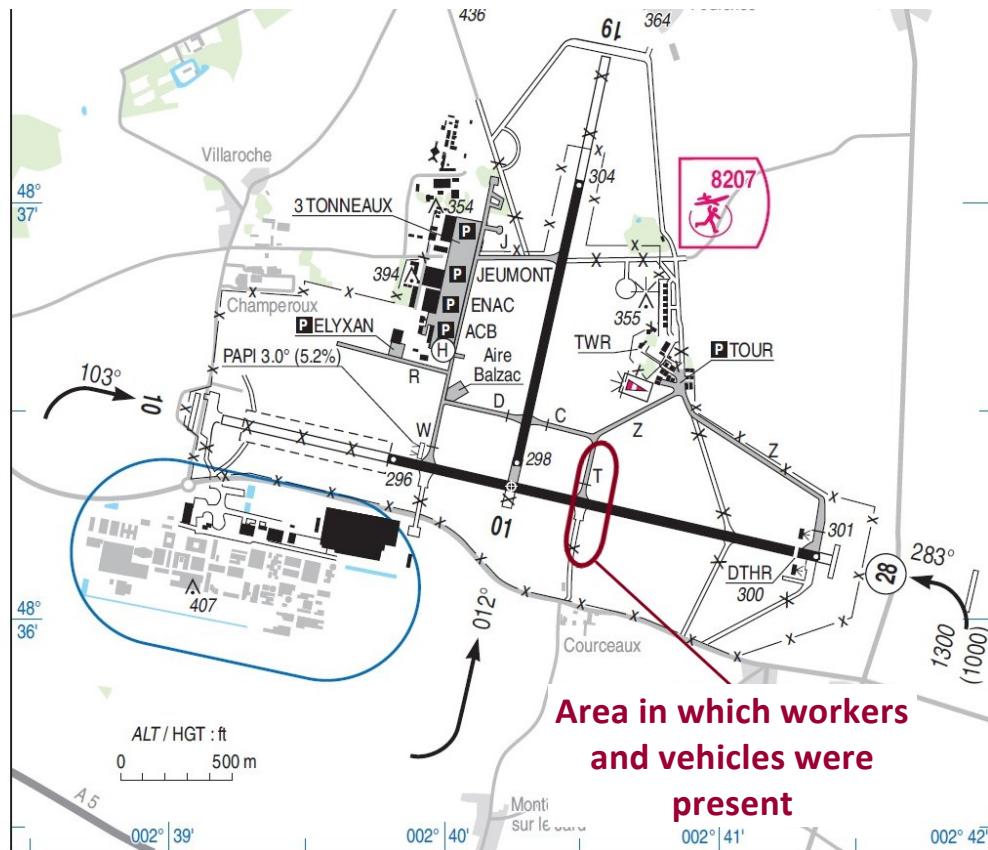
Figure 1: map of Melun-Villaroche (source: AIS)

Melun-Villaroche airport has two intersecting runways⁴ arranged in a “T” shape. The main runway 10/28 has a RNAV approach procedure for the preferred QFU 283°. The area in which workers and vehicles were present during work on runway 28 is shown in Figure 1 below.

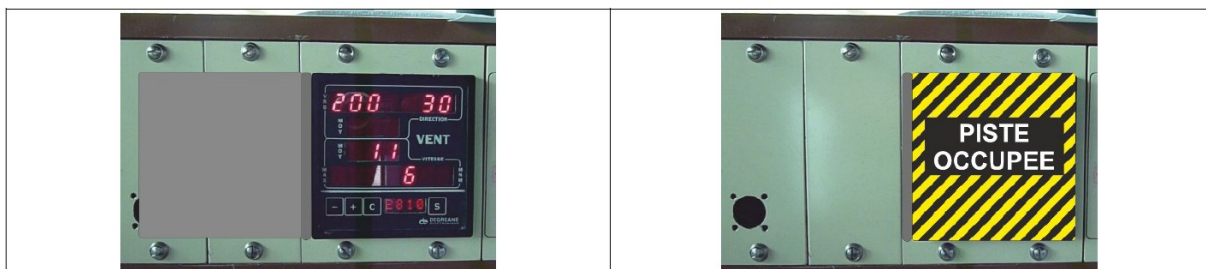
Figure 2: wind indicator and masking panel (source: Melun-Seine OM)

In particular, a panel indicating that the runway is occupied (see Figure 2) may be folded over the wind indicator when vehicles or aircraft are on the runway or in the associated safety area. This way, the controller cannot, in theory, issue a clearance, since the latter normally includes wind information, which is then no longer visible.

It should be noted that, since Melun airport has two runways, this method only applies to the occupancy of the runway in service. When folded across, the masking panel prohibits the issuance of a clearance by the LOC controller. As such, this method is not suitable for indicating that one runway is closed while the second runway is in service.

- the local management will endeavour to have the tower logbook completed before any work;
- magnetic strips indicating that runway 10/19 or runway 10/28 is closed will be placed next to the wind indicator when only one of the runways is closed;
- a standing directive (or memo) will formalise these new working methods before they are incorporated in the OM.
