Accident to the ROBIN DR400-180 “REGENT”
registered **F-GIKS**
on Thursday 12 October 2023
off the coast of Propriano

**Engine failure during climb after take-off, loss of control,
collision with the surface of the sea**

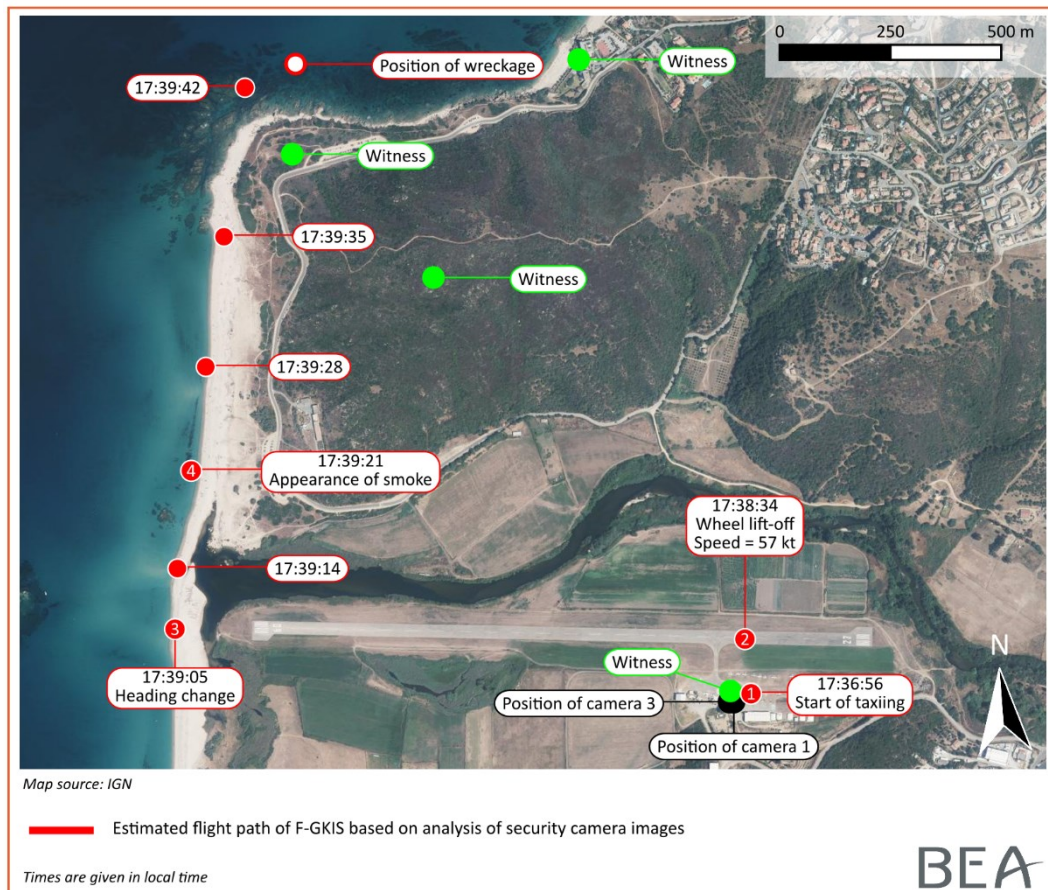
Figure 1: reconstruction of aeroplane's path

The video recordings showed the pilot taking off from runway 27 at 17:38, then turning north at the beach (see **Figure 1**). At 17:39:21, i.e. 16 s after the turn, a dark smoke release appeared behind the aeroplane. While the aeroplane was in the area of Cap Lauros, several witnesses heard variations in engine speed. The aeroplane's attitude did not seem stable on the roll axis.

The camera images made it possible to reconstruct the approximate horizontal path of the aeroplane after take-off (see **Figure 1**). It could be noted that between the two turns, the average ground speed increased, without it being possible to determine its exact value. The loss of control occurred slightly to the south-west of the position where the wreckage was found, and the aeroplane fell almost vertically to this position (the fall was practically vertical a few seconds after the second right turn). Variations in the lighting on the aeroplane suggest a wing rotation. However, the image resolution was not high enough and did not enable its attitude and rotary axis to be accurately determined.

Shortly after the turn, when the aeroplane was over the beach, a smoke release behind it suggests that the pilot experienced a failure that may have led to a partial loss of engine power. It is likely that the pilot then decided to make an adapted circuit to return to land. The statements gathered suggests that the engine's operating condition probably deteriorated up to the total loss of engine power.

In front of Propriano bay, the pilot initiated a second turn during which he lost control of the aeroplane. The statements gathered suggest that the aeroplane stalled asymmetrically. The height of the aeroplane at the time did not enable the pilot to avoid collision with the surface of the sea.

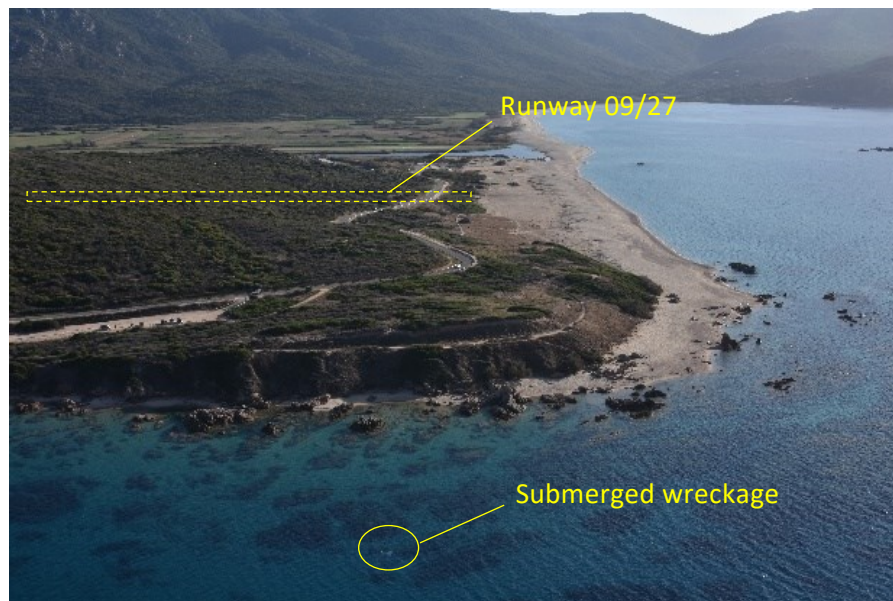
Figure 2: aerial view of the wreckage position (Source: Gendarmerie)

The wreckage was found approximately 1,300 m north of the runway. The wreckage was lying 8 m deep underwater. It was complete and not dispersed (see **Figure 2**).

It was salvaged and its examination showed that, at the time of the collision with the surface of the sea, the aeroplane had a left bank angle with a nose-down attitude, and the flaps were in the take-off position. The flight control linkages were continuous. The trim was in the neutral position. The propeller showed no evidence that the engine was transmitting torque when the aeroplane collided with the surface of the sea.
