**Accident** to the Robinson R22 BETA II  
registered **F-GJYB**  
on Thursday 11 January 2024  
at Cannes-Mandelieu

**Decrease of engine power after take-off, loss of control  
and collision with surface of sea<sup>3</sup>**

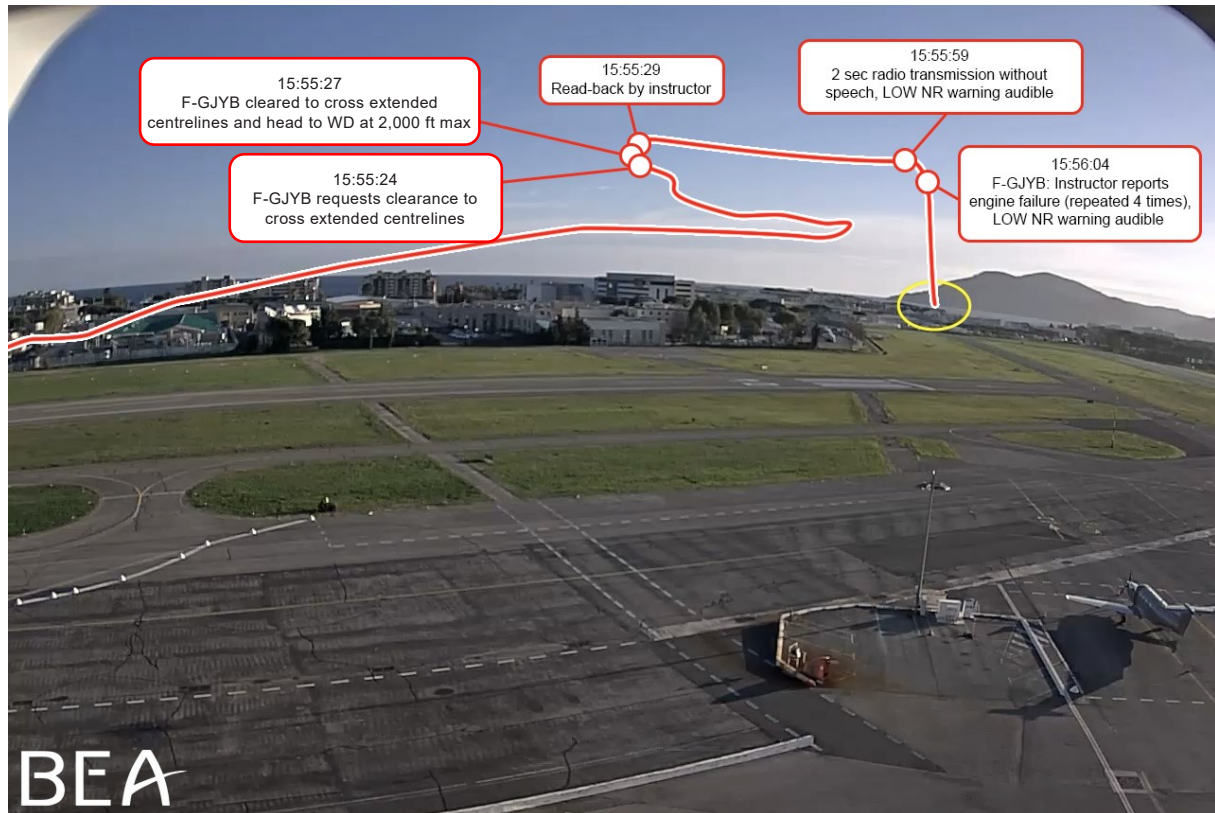
Figure 2: reconstruction of accident flight path

At 15:56:01, the helicopter suddenly lost altitude with a nearly zero horizontal speed and a high vertical speed. Three seconds later, the instructor reported that she had an engine failure. During this last recorded message, the “LOW RPM” aural warning was still audible (see **Figure 2**).

At 15:56:12, the helicopter collided with the surface of the sea and immediately sunk.

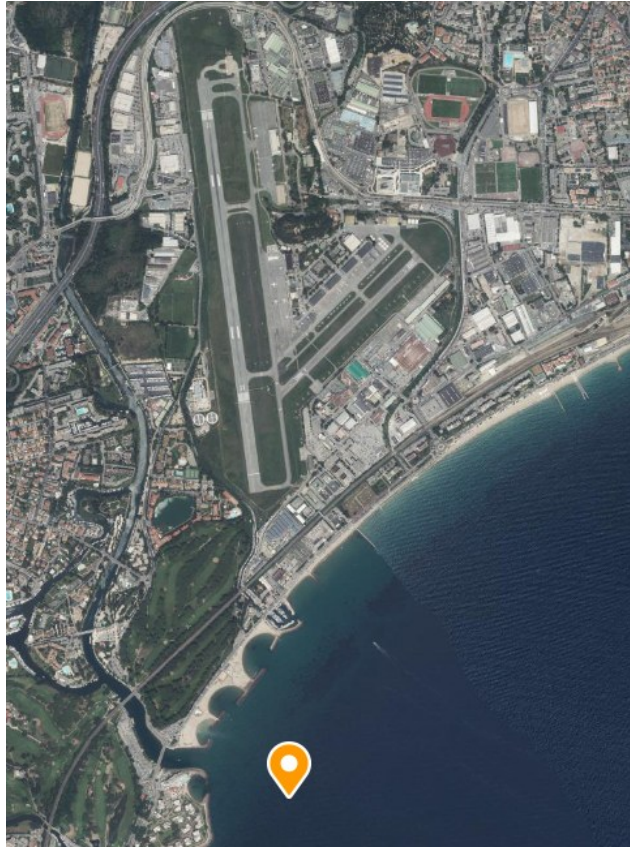
Figure 3: position of wreckage (source: Geoportail)

The helicopter was resting on its skids at a depth of around 30 m, at around 300 m from the coast and 1.3 km south of the threshold of runway 35 (see **Figure 3**). The tail boom had ruptured at two points and was still attached to the engine mount. The blades were in place as was the tail rotor. The cockpit was partially destroyed.

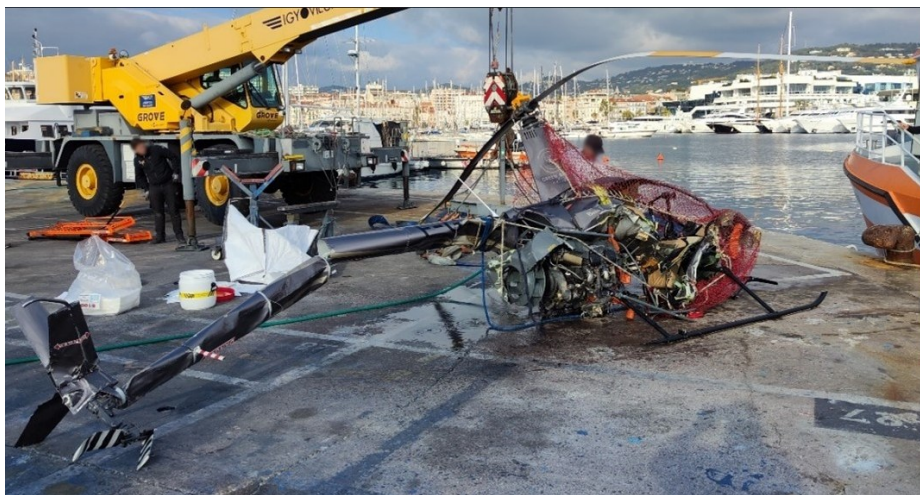
Figure 4: photograph of wreckage after being raised (source: BEA)

The visual examination of the wreckage after it had been raised found that the main damage to the helicopter was the result of the collision with the surface of the water and was consistent with high vertical energy and a nearly zero pitch attitude on impact. The damage observed on the blades of the two rotors was consistent with low energy being provided by the main rotor when it collided with the water.

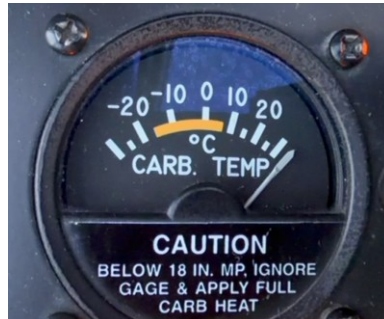
Figure 5: carburettor temperature gauge

- the test of the temperature probe at the carburettor air intake found that it was not functional. Two breaks in the probe’s internal wire were identified. The visual comparison with a similar probe revealed that this wire was slack and had broken in two places. This damage to the wire was consistent with damage resulting from the impact, without the BEA being able to affirm this. The statements from the pilots who had used the helicopter the morning of the accident flight indicating that the probe had been functional at the time is also consistent with this analysis (see paragraph 2.8);

The maintenance manual recommends that during 100-hour or annual inspections, it is checked that the indicated temperature is more or less identical to the outside air temperature. This check is carried out with the engine shut down. The last check had been carried out during the last 100-hour inspection, in September 2023.

Robinson recommends, if in doubt, using the carburettor heat to maintain the air temperature in the carburettor outside the yellow arc of the gauge and applying full carburettor heat when the manifold pressure is below 18 in. It is also recommended to verify the accuracy of the carburettor air temperature gauge with a cold engine during ground checks by comparing the temperature displayed with the outside air temperature.
