Accident to the ROBIN - DR400 - 100
registered **F-GKQE**
on Friday 29 July 2022
on Biarritz - Pays Basque airport

Bird strike on final, in instruction

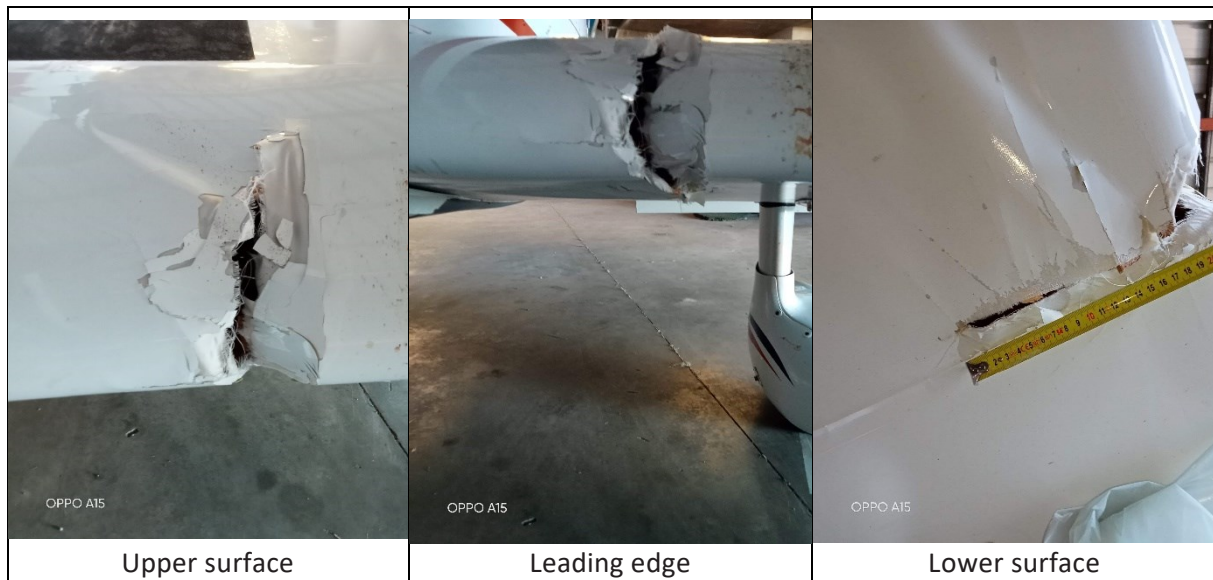
The leading edge of the LH wing was damaged at around 40 cm from the root. It was dented and torn over an approximate width of 10 cm and depth of 20 cm. The plywood of the leading edge and a rib were destroyed. The spar was not damaged.

Figure 1: photo of damage to LH wing (Source: BEA)

The aeroplane was on final when a bird struck the propeller and then the leading edge of the LH wing. The aeroplane remained controllable and the student pilot was able to land without further incident.

The low speed of the aeroplane on final and the short remaining flight time may have contributed to limiting the damage caused by the collision. These elements and there being no consequence on the controllability of the aeroplane might have led the instructor not to take the controls for the landing.
