Accident between
the ROBIN DR400-140B registered **F-GLDN**
and
the ATEC 122 Zephyr identified **44APT**
on Friday 29 November 2024
at Lunéville - Croismare aerodrome

This is a courtesy translation by the BEA of the Final Report on the Safety Investigation. As accurate as the translation may be, the original text in French is the work of reference.

Collision on final between an aeroplane and a microlight, collision of the aeroplane with the ground

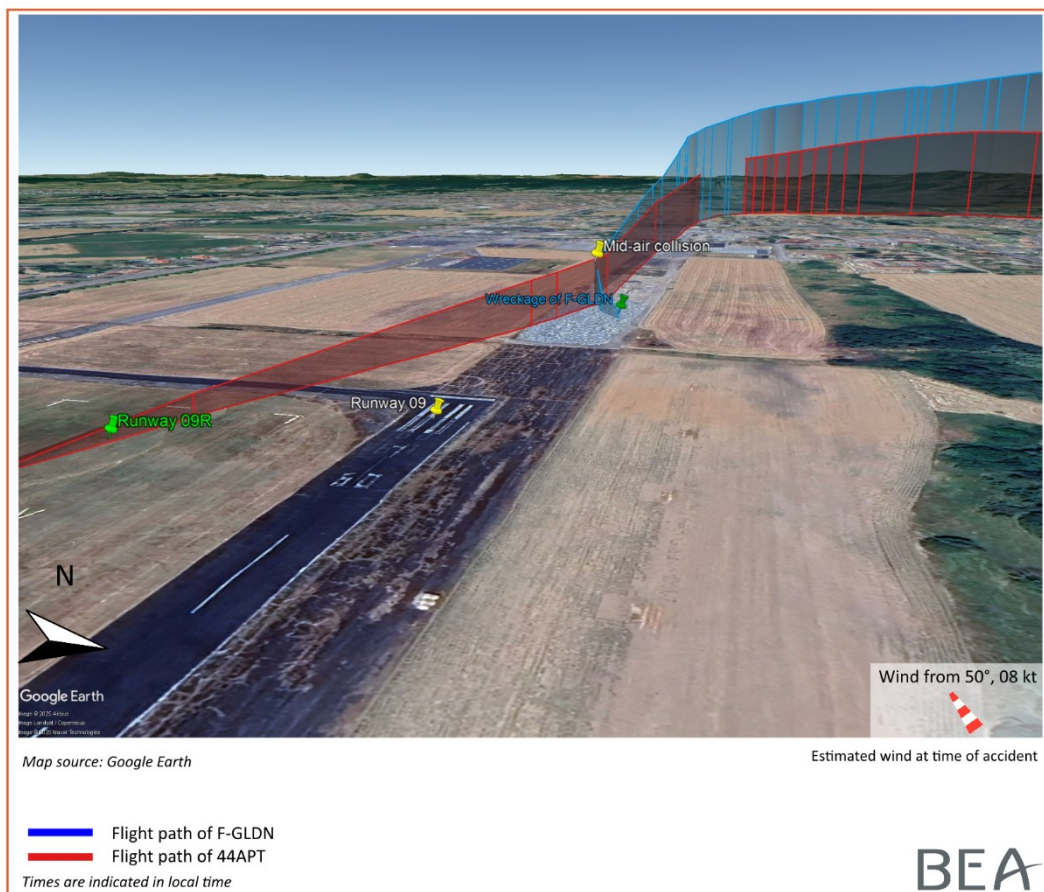
While the pilots of the two aircraft were on final for paved runway 09 (with the pilot of the microlight making a standard approach with a slope of around 3° and the pilot of the DR400 carrying out a practice forced landing with a steeper slope of around 7°), they collided in flight around 20 m above the ground and approximately 200 m from the runway threshold.

Figure 1: flight paths of the two aircraft during the mid-air collision

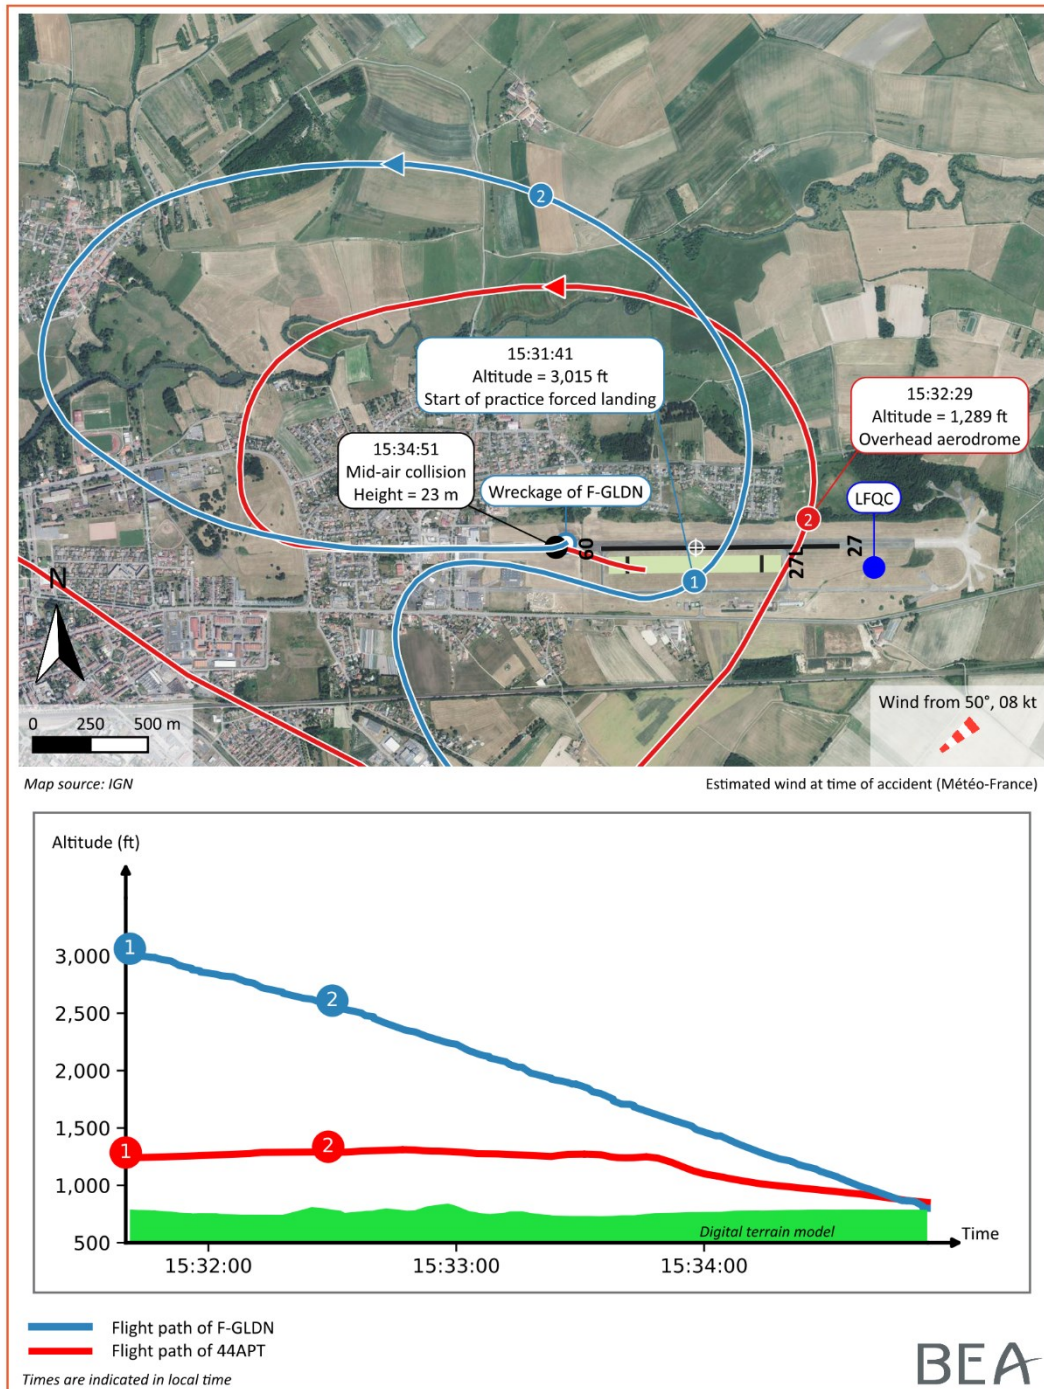
occupied. The instructor then asked the pilot to climb to 3,000 ft to carry out a practice forced landing and transmitted the associated radio message (see Figure 2, point ①). For the occupants of the aeroplane, there was nobody in the circuit likely to interfere with their exercise.

The pilot of the microlight flew towards the south over a few points of interest and then returned to Lunéville. He flew over the aerodrome at an altitude of approximately 1,300 ft (see point ②) then joined the downwind leg for paved runway 09. The pilot indicated that he transmitted his radio messages, and in the absence of any response or other transmission, he thought he was alone in the circuit.

Figure 2: flight paths of the two aircraft

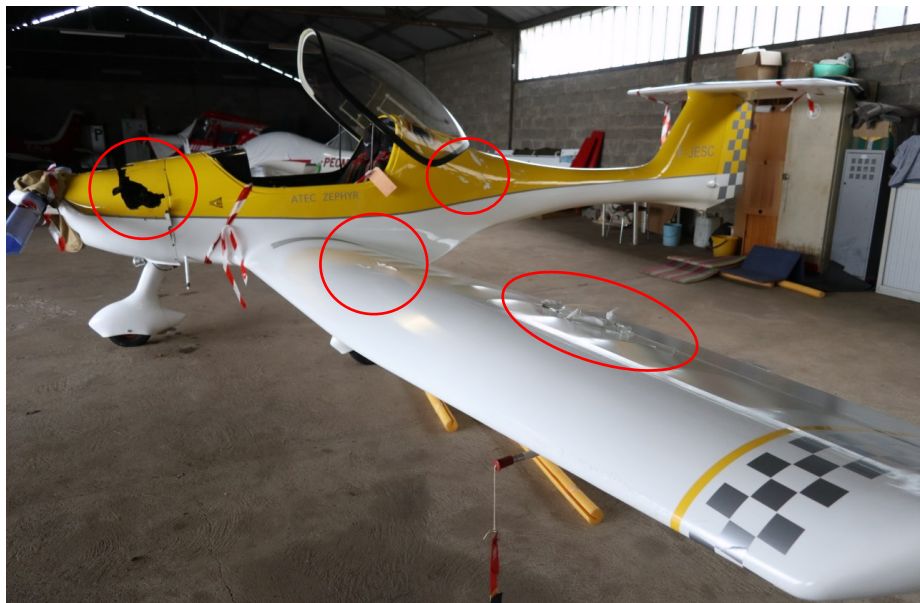
The engine cowling, part of the engine and the left wing showed marks of contact with the propeller of the DR400. The damage observed on the engine (severing of several electrical cables, of the ignition units, of an attaching point on the frame and of the fuel manifold on the left-hand side) explained the loss of power noticed immediately after the collision. Tyre marks and impact marks were also visible on the fuselage and on the whole of the second half of the left wing. The microlight's tailplane, canopy and landing gears were intact. The flight control linkages were examined and were operational.

Figure 3: general view of the microlight (Source: BEA)

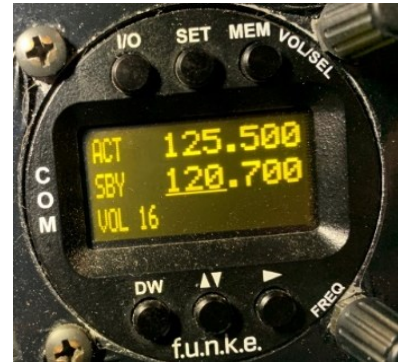
Following visual checks on the electrical system, the microlight was powered up again with its battery still connected. The active radio frequency was set to 125.500 MHz, and the stand-by frequency⁴ was set to 120.700 MHz. Radio transmission and reception were tested on the ground over the area's A/A frequency (123.500 MHz). The radio was operating nominally.

Figure 4: radio of the microlight
(Source: BEA)

The BEA did not identify any nearby aerodrome, including in neighbouring countries, using the frequency 125.5 MHz, which was set as the active frequency on the microlight's radio.

The pilot of the microlight, on the return leg of a local flight from Lunéville aerodrome, most probably mistakenly selected the frequency 125.5 MHz instead of 123.5 MHz. His radio messages were not heard by the other users of the aerodrome, and he thought that he was alone in the aerodrome circuit.

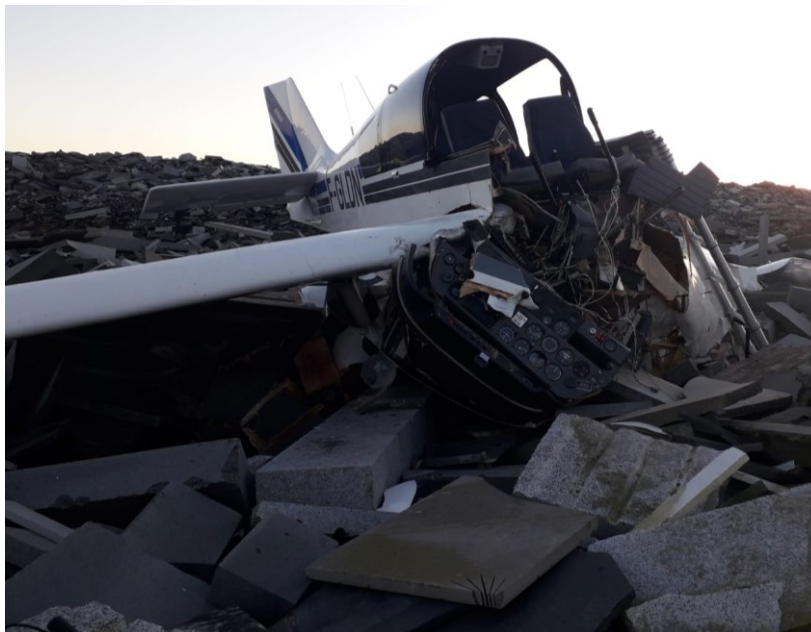
The wreckage was lying on a pile of marble rubble located on the axis of the final for the paved runway, around 170 m before the threshold. The wreckage was complete and not dispersed. The extensive damage to the left wing (which was partially folded under the fuselage) and to the front of the aeroplane (which was lying vertically in the rubble) indicates a very probable nose-down attitude and a steep left bank angle when the aeroplane struck the ground.

Traces of paint were observed on the tread and left-hand sidewall of the front tyre. This damage, as well as part of the damage visible on the blades, was related to the collision with the microlight. The rest of the damage observed seemed to result exclusively from the impact with the ground.

Figure 5: site and wreckage of the DR400 (Source: Lunéville police services)

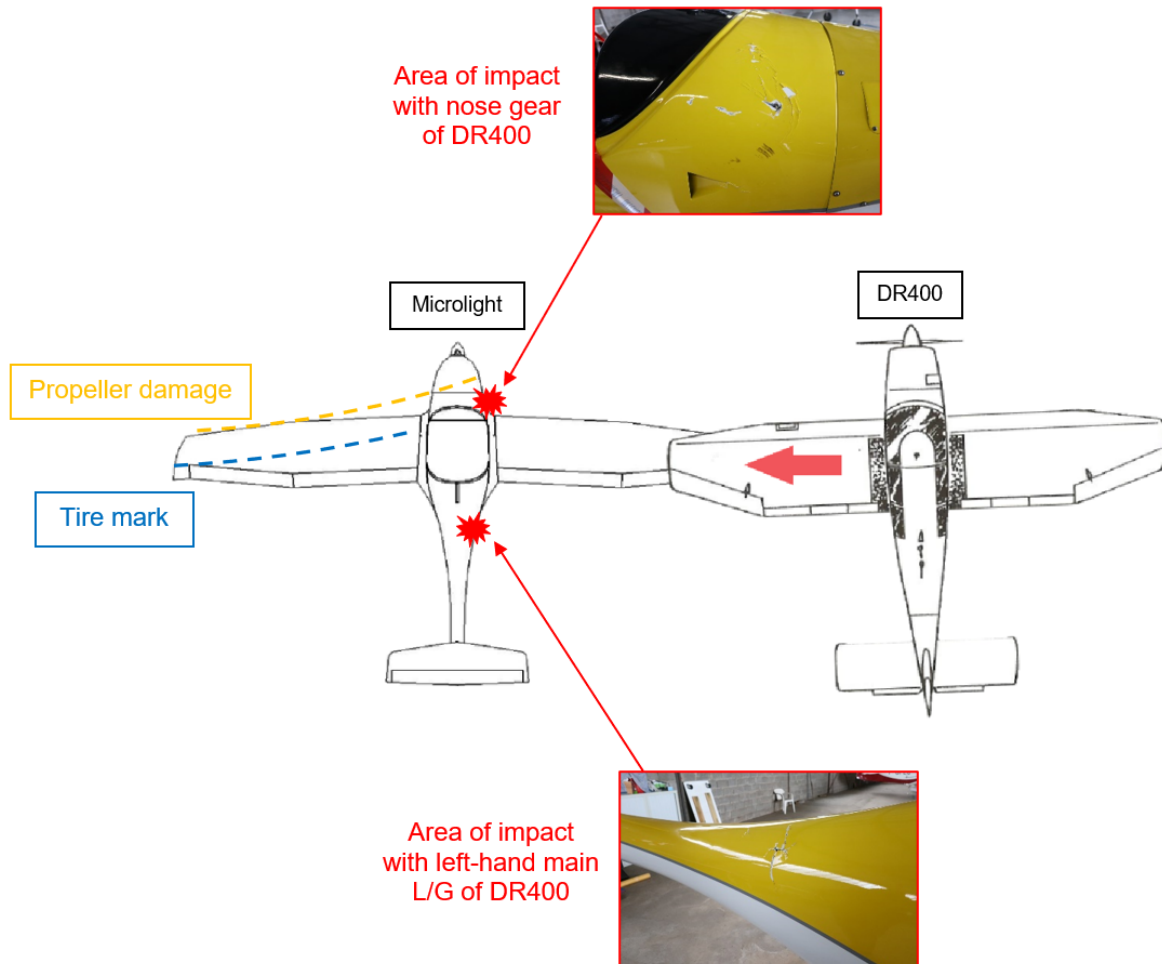
The observations made on the microlight and on the wreckage of the aeroplane were consistent with a side collision between the two aircraft flying in a convergent direction towards the runway, with the DR400 located higher than and to the right of the microlight. The two aircraft did not suffer any major structural damage during the collision, which nevertheless caused the microlight's engine to stop and the aeroplane to lose control until it collided with the ground.

Figure 6: estimated paths of the two aircraft at the time of the collision (Source: BEA)
