Accident to the ROBIN DR400-160
registered **F-GLKL**
on Tuesday 30 July 2024
at Buigny-Saint-Maclou

Time	Around 17:50 ¹
Operator	Aéroclub d'Abbeville - Buigny - Baie de Somme
Type of flight	Introductory flight
Persons on board	Pilot and three passengers
Consequences and damage	Aeroplane destroyed

**Staying on the backside of the power curve during
take-off, collision with ground, post-impact fire,
during an introductory flight**

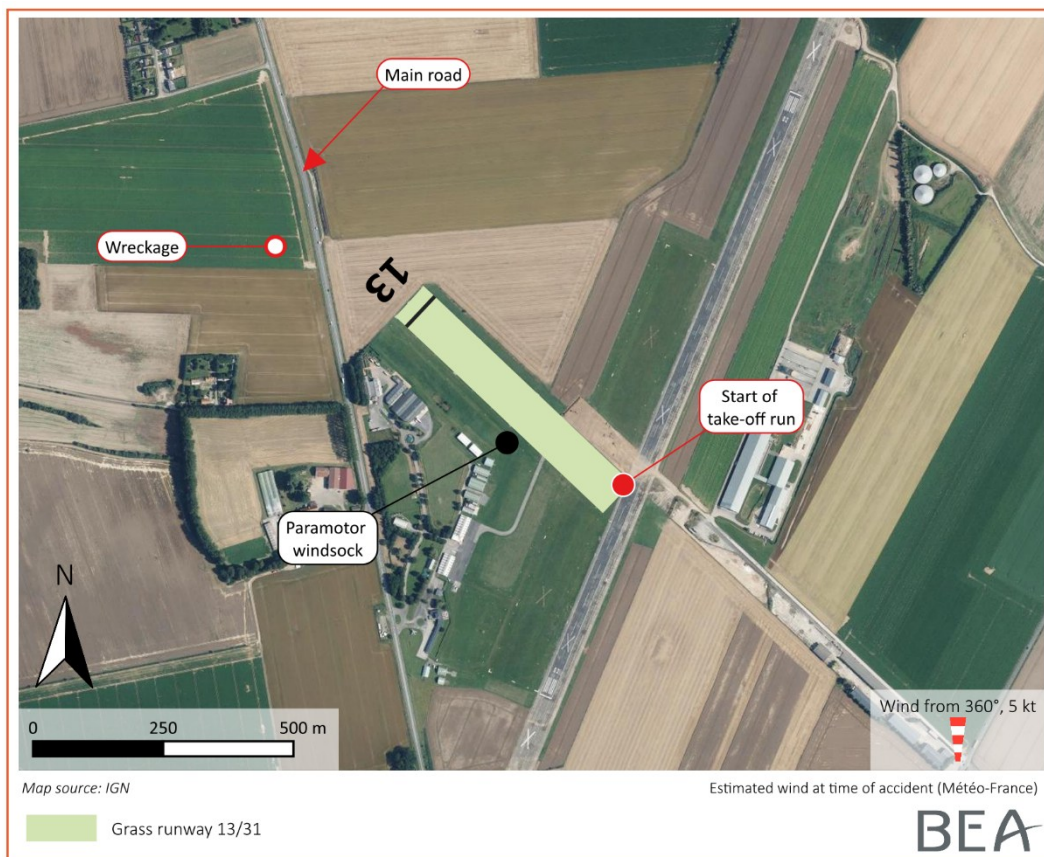
The wreckage was lying around 250 m from the end of the runway in a field of low-growing crops with deep furrows. Debris, notably fairing debris, was scattered over approximately ten metres upstream of the wreckage in the direction of the aeroplane's arrival path.

There was no perimeter fence or high vegetation between the end of the runway and the road.

Figure 1: position of wreckage

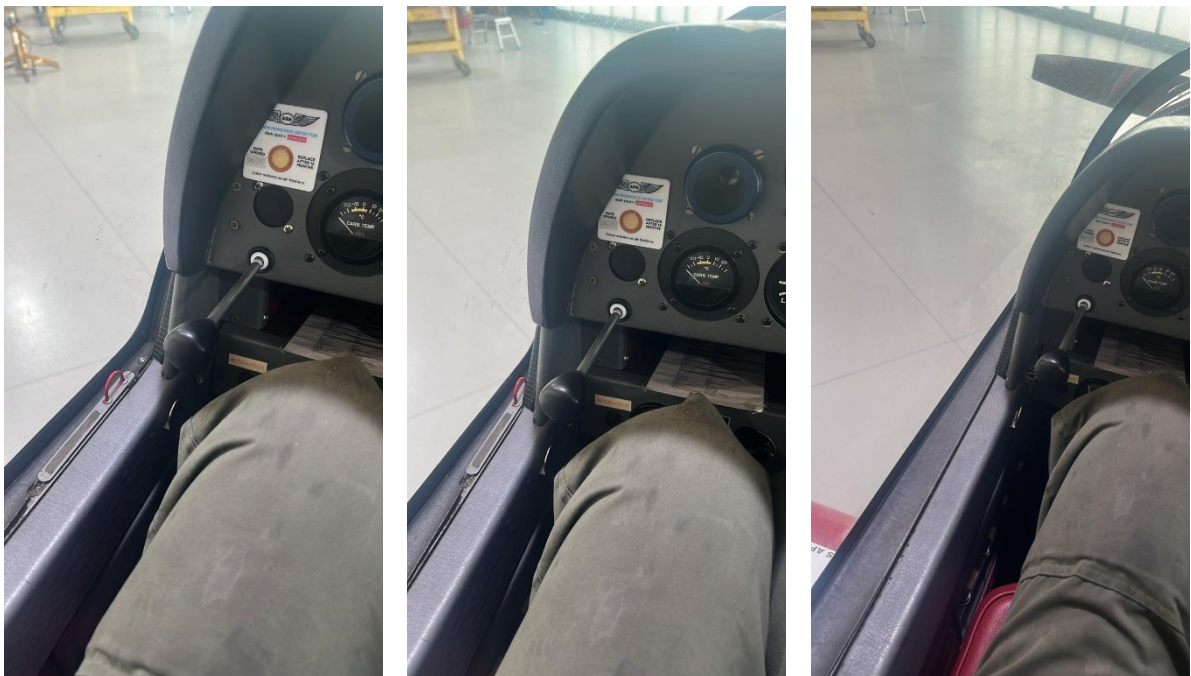
In the event of an emergency situation, the canopy is equipped with a release system that can be activated by means of two levers situated each side of the cockpit, on the armrests, close to the instrument panel. When the two levers are raised and the handle is in the “unlocked” position, the canopy is released from its rails and can be raised. However, if the canopy is slid forward by more than ten centimetres, the release levers are no longer in the pilot’s field of vision and may be difficult to access and use, in particular during an emergency evacuation.

Figure 3: photo of release lever from left seat with canopy closed (left-hand side), open by 8 cm (middle) and open by 30 cm (right-hand side) (source: BEA)

During the evacuation, the canopy slid forward around 30 cm before blocking very probably due to deformations of the airframe. With the canopy in this position, the pilot was unable to reach the release handles and the occupants had to evacuate the aeroplane by the available small opening before it was completely destroyed by the fire.

During the evacuation, the canopy partially slid forward before blocking, very probably due to deformations of the fuselage. In these conditions, the release levers were no longer in the pilot's field of vision, and the right-hand lever was difficult to access from the pilot's seat. The occupants, who were of slim build, were able to escape through the partially open canopy. The occupants of the [DR400-160 registered F-GREP, involved in an accident on Saturday 26 October 2024](#), experienced the same situation. In this type of situation, releasing the canopy without attempting to open it beforehand would probably have facilitated evacuation. Furthermore, a passenger, informed before the flight about the canopy release procedure, could, in an emergency, operate the lever on their own.
