**Accident** to the Cameron - Z105  
registered **F-GMGE**  
on Monday 24 July 2023  
at Villecey-sur-Mad

## Hard landing, passenger ejected, during an air show

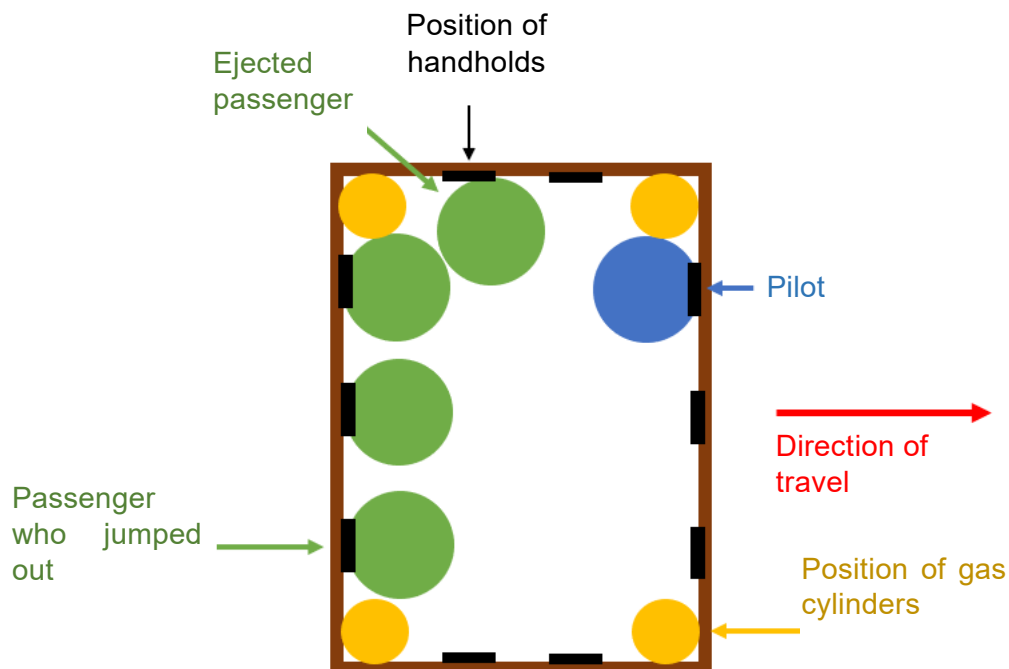
In the basket, the passengers were positioned with their backs to the direction of travel during the landing.

Figure 1: position of people in basket (source: BEA)

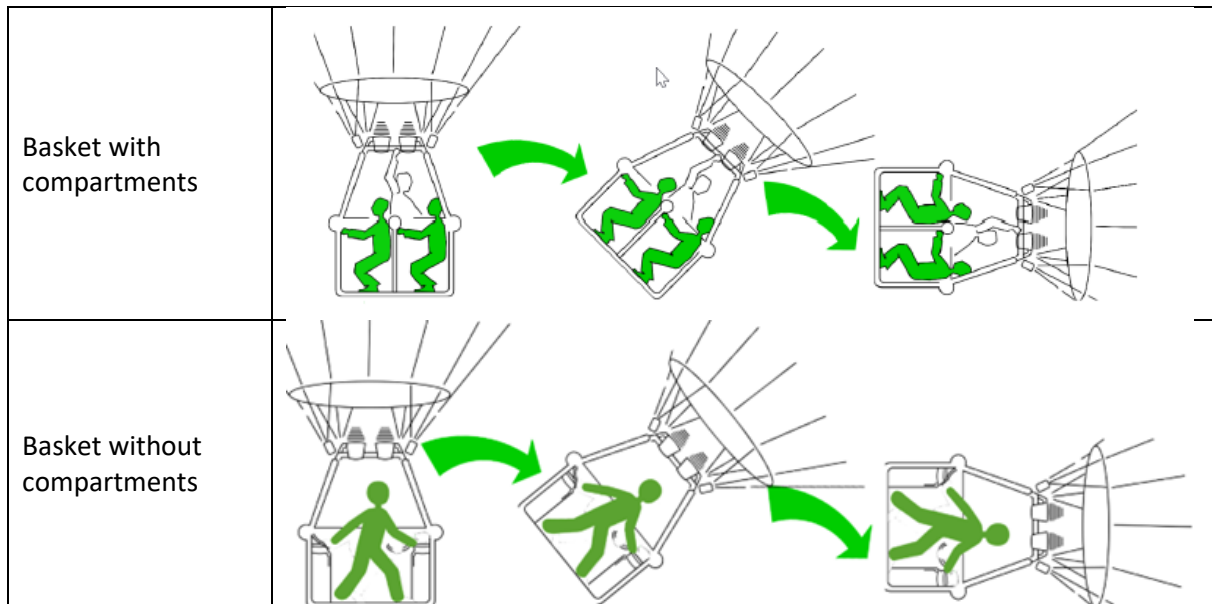
In the [Safety instructions regarding the preparation and operation of hot-air balloons](#) written by the DSAC in collaboration with [Fédération Française d'Aérostation](#) (FFAé)<sup>3</sup>, it is recommended, in baskets without compartments, that passengers have their backs turned to the direction of travel if there is sufficient space as in a basket with compartments, and if not to stand sideways, facing the flight path.

Figure 2: illustrations based on the safety instructions (source: DGAC)

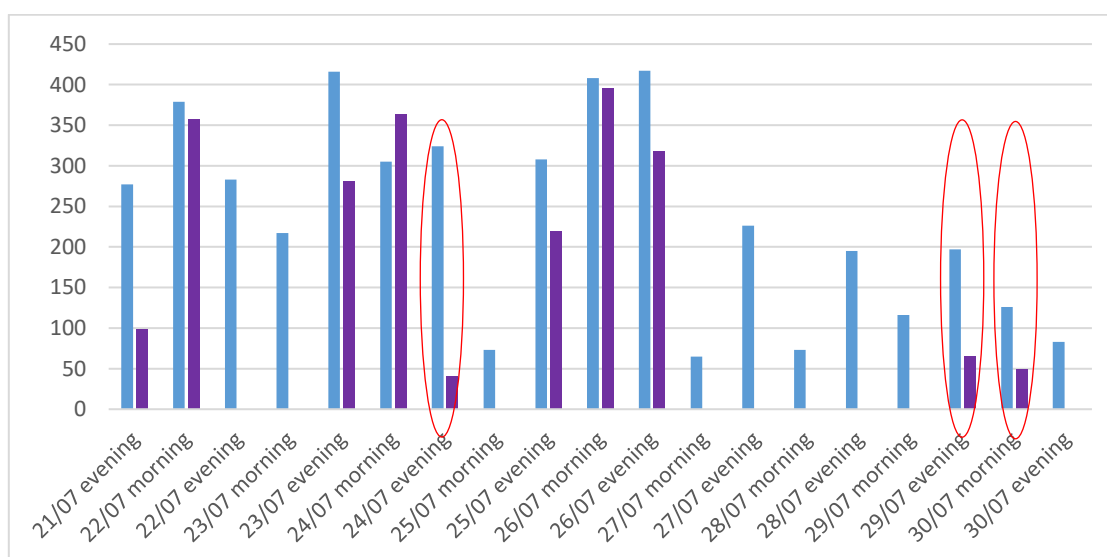
*Figure 3: number of participants at the briefing and number of pilots who refuelled for the 19 displays*

Nine of the nineteen planned displays were cancelled due to the weather conditions (no pilot refuelled, see **Figure 3**).

Other accidents and incidents involving balloons other than F-GMGE occurred during the balloon festival (see paragraph 2.5 ), during the displays in the evening of Saturday 29 July and the morning of Sunday 30 July (see **Figure 3**).

**Figure 3** shows that for the displays during which accidents and incidents occurred, a small proportion of the pilots present actually took part in the flights.
