Accident to the CESSNA - F152
registered **F-GMOU**
on 10 July 2022
off the coast of île de Ré

Engine failure in cruise, ditching

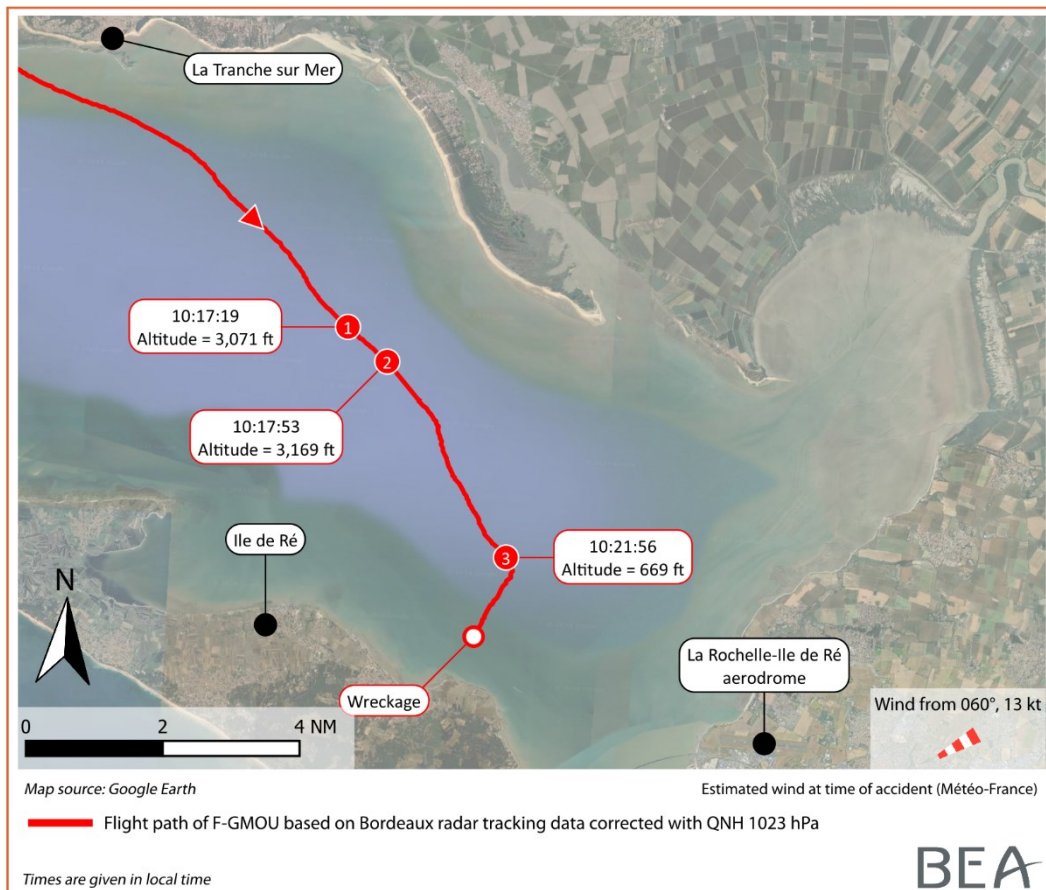
A short time later, at 10:17:19, he heard a second engine misfire and immediately informed the air traffic control service at La Rochelle-île de Ré airport of the engine problems and of his intention to land there (see Figure 1, point ①).

At 10:17:53, the pilot informed the air traffic control at La Rochelle that his engine had shut down (point ②). The pilot tried to start up the engine but without success. He adjusted the pitch attitude to adopt and hold the best glide speed of 60 kt.

Estimating that he was closer to Ile de Ré than Rochelle airport, the pilot headed towards the island to attempt a forced landing in the fields (point ③).

Figure 1: flight path of F-GMOU based on radar data (source: BEA)
