Accident to the ROBIN - DR400 - 140B
registered **F-GMXY**
on Tuesday 15 August 2023
at Lavau-sur-Loire

Time	Around 11:45 ¹
Operator	Aéroclub Loudunais
Type of flight	Cross country
Persons on board	Pilot, two passengers
Consequences and damage	Pilot and passengers fatally injured, aeroplane destroyed
This is a courtesy translation by the BEA of the Final Report on the Safety Investigation. As accurate as the translation may be, the original text in French is the work of reference.

**Loss of external visual references, loss of control,
collision with surface of water**

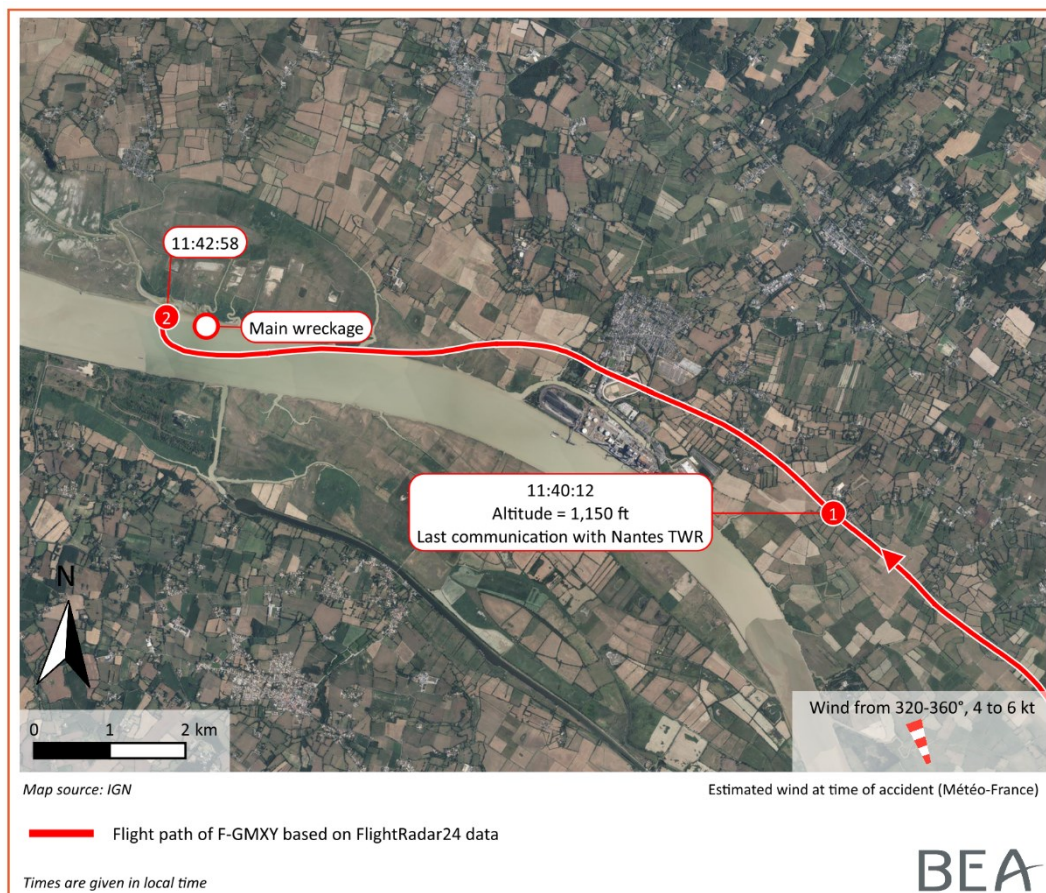
Figure 1: final flight path of F-GMXY

At 11:42, the flight path of the aeroplane described a tight RH descending turn until radar contact was lost at 11:42:58. The on-board computer data stopped a few seconds later (see **Figure 10**).

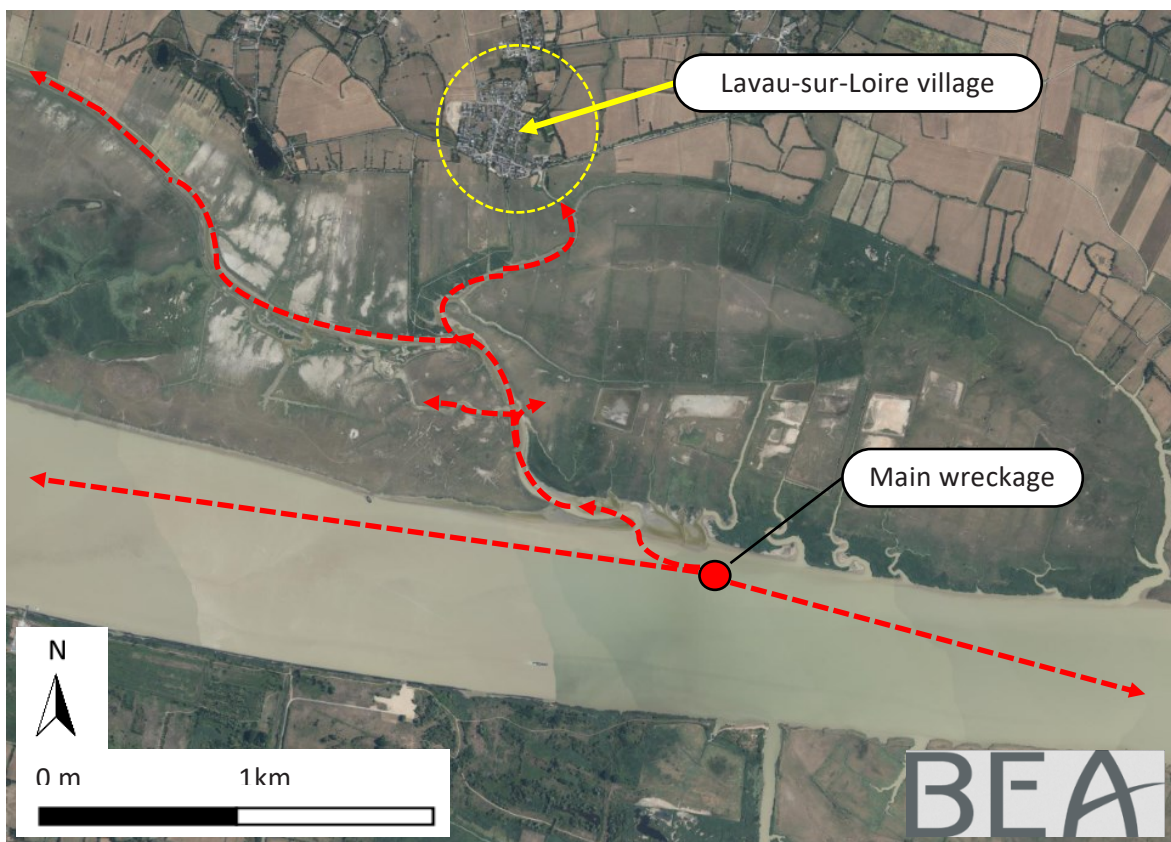
*Figure 2: position of main wreckage and main paths taken by debris after impact with the Loire
(Source: IGN, annotations BEA)*

The main wreckage was lying in the Loire estuary, close to the north bank (around 30 m at low tide), level with Lavau-sur-Loire village.

The position of the main wreckage, mentioned in **Figure 2** and **Figure 3**, corresponded to a precise spot in the Loire where the following items were found, at a depth of between 1.30 m and 4 m depending on the tides:

- the engine (without the propeller);
- the cockpit;
- parts of the cockpit seats;
- tail fin and rudder;
- LH part of elevator;
- the two fuel tanks;
- control cables, electrical cables.

No sign of the aeroplane having come into contact with the dry land around the position of the main wreckage was observed.

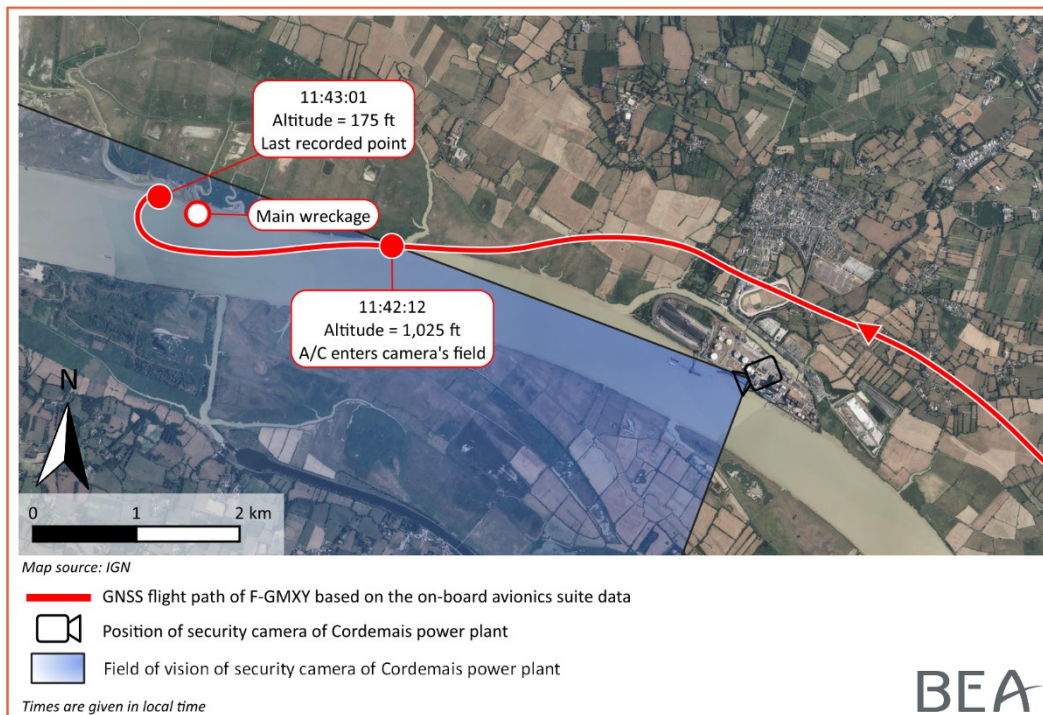
Figure 6: flight path of aeroplane in camera's field of vision

The GNSS flight path taken from the on-board avionics suite showed that the DR400 entered the camera's field at 11:42:12. The last recorded point was at 11:43:01.

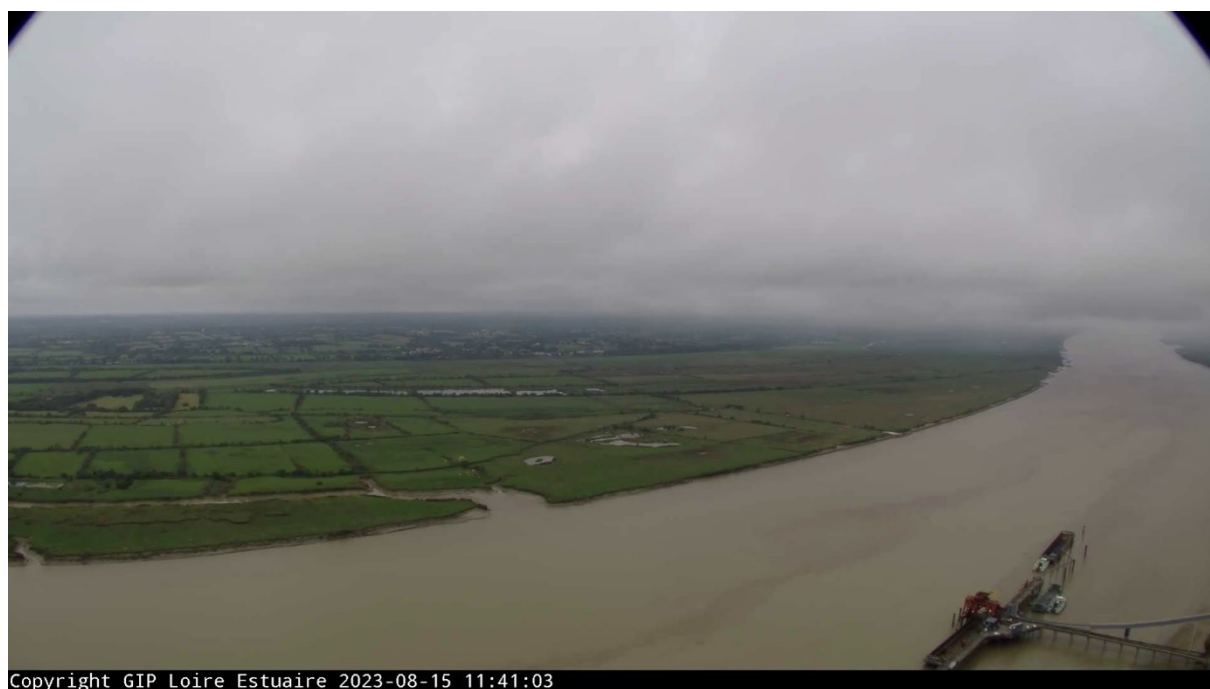
Figure 7: camera image at 11:41 (Source: GIP Loire Estuaire)

On the first image, recorded at 11:41:03, the aeroplane was not in the camera's field of vision. Low stratus clouds concealing the Loire estuary could be seen. They were below the horizon with respect to the camera and were therefore below the altitude of 735 ft.

On viewing the images from Cordemais power station at 11:41 and 11:43 am, Météo-France specified that the ceiling was estimated to be at a height of around 700 ft (i.e. an altitude of around 850 ft) with light precipitation over the accident site. The estimated visibility was between 4 and 6 km in the precipitation.

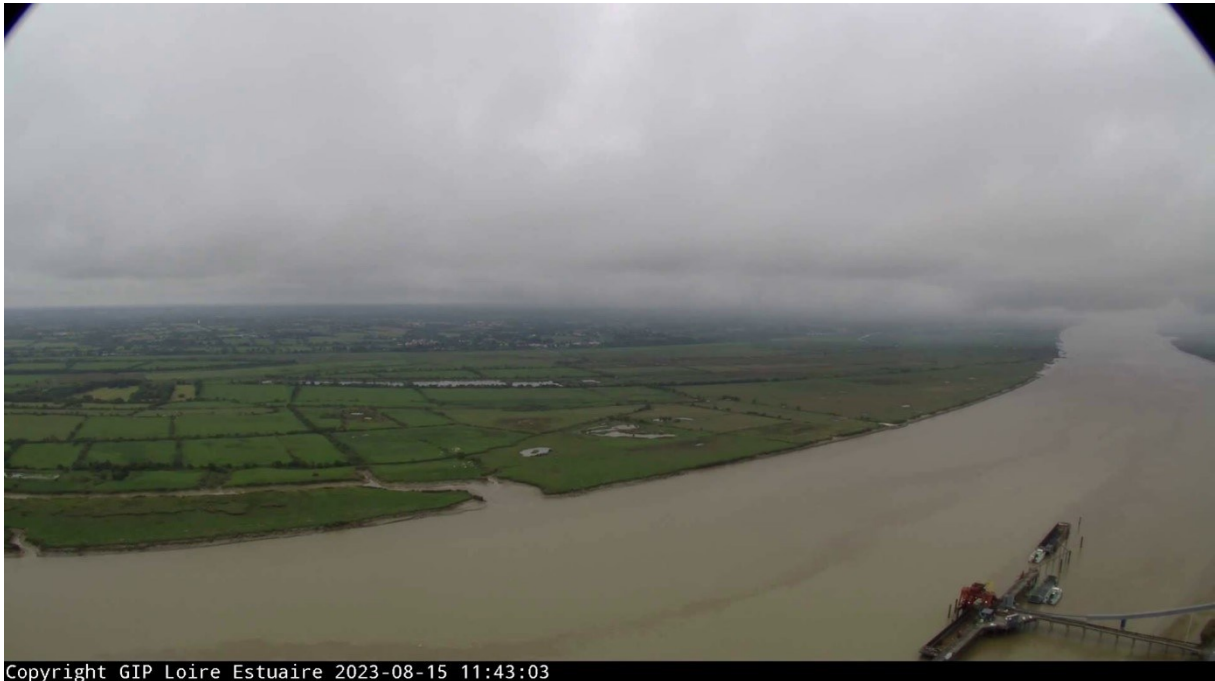
Figure 8: camera image at 11:43 (Source: GIP Loire Estuaire)

On the second image recorded at 11:43:03, it could be seen that the low stratus front had moved forward, characteristic of sea cloud moving inland.

This sea cloud moved up the Loire estuary. At this time, the recording of the DR400's position had stopped two seconds earlier; the aeroplane was very probably overhead the site where the wreckage was found, i.e. six kilometres from the camera.

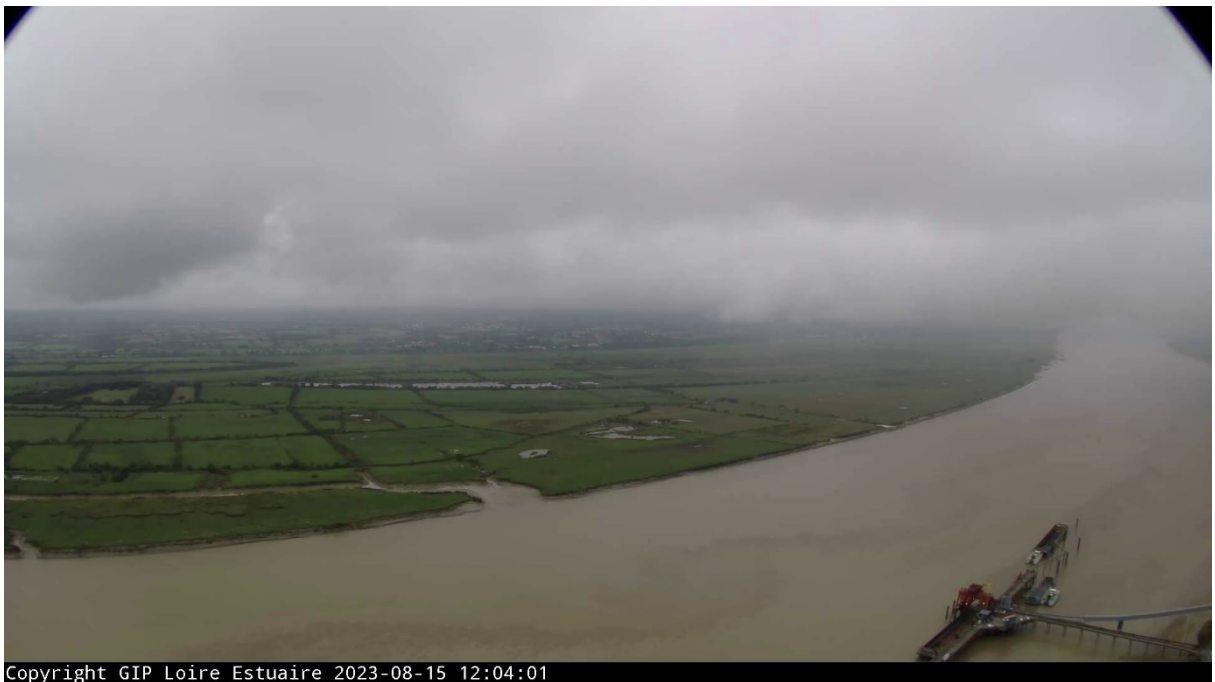
Figure 9: camera image at 12:04 (Source: GIP Loire Estuaire)

An image showed the decrease in visibility and the lowering of the ceiling with the bank of stratus clouds arriving at the chimney 21 min later.

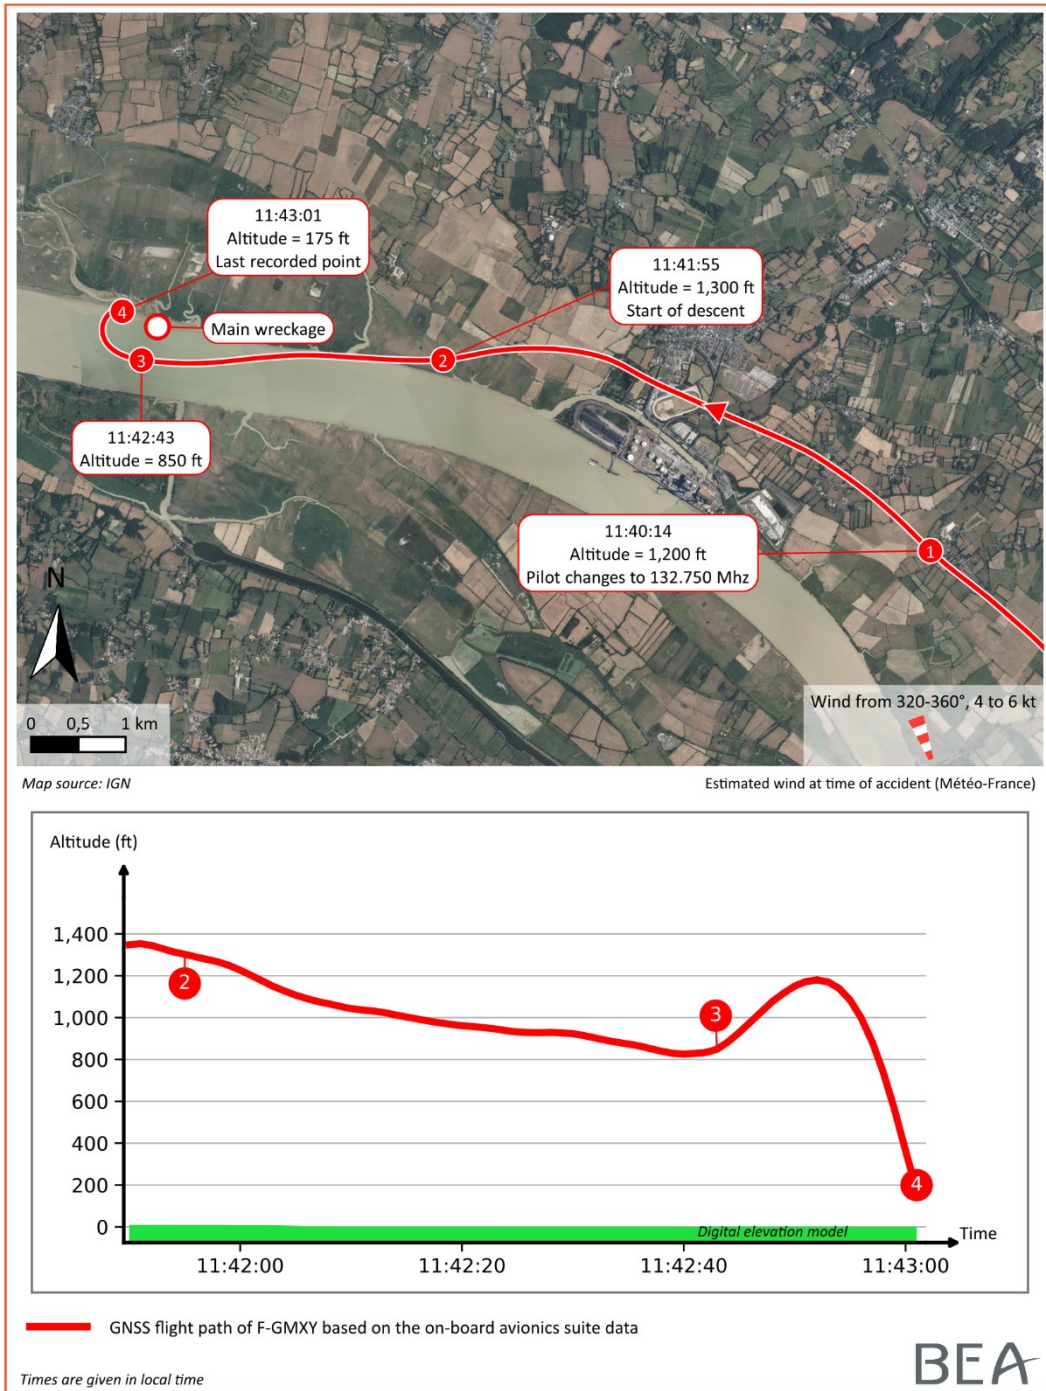
Figure 10: flight path based on the on-board avionics suite

The read-out of the GTN750Xi computer data, also acting as a radio transceiver, showed that after the last exchange with Nantes tower (see **Figure 10**, point **1**) the pilot, who should have selected the FIS frequency (130.275 Mhz), inadvertently selected 132.750 Mhz⁴.

The flight path downloaded from the computer showed that after passing north of Cordemais powerplant, the pilot turned left and then descended (point **2**).

At 11:42:43, at an altitude of around 850 ft, overhead the Loire (point 3), the pilot started a RH turn northwards in climb to an altitude of around 1,200 ft, reaching a vertical speed of 3,000 ft/min. The ground speed and vertical speed then quickly decreased.

The flight path of the aeroplane showed that the latter suddenly lost altitude in the RH turn. At the last recorded position (point 4), the altitude was around 175 ft. The mean rate of sink was more than -7,500 ft/min in the last part of the flight path.

The analysis of the GNSS flight path found that when passing north of Cordemais power station, the pilot turned left and flew over the Loire probably to avoid incoming sea clouds. The aeroplane then started a RH turn in climb with a high vertical speed until reaching an altitude of around 1,200 ft. The aeroplane very probably entered the cloud layer and the pilot then lost external visual references. During the turn and climb, the ground speed and vertical speed decreased and then while continuing the RH turn, the aeroplane very probably took a steep nose-down attitude. The rate of sink then substantially increased.
