Accident to the ROBIN - DR400 - 140B
registered **F-GOOF**
on 14 June 2023
at Pressignac-Vicq (Dordogne)

Time	Around 18:30 ¹
Operator	Cercle Aérien Peugeot
Type of flight	Cross-country
Persons on board	Pilot and one passenger
Consequences and damage	Pilot and passenger severely injured, aeroplane destroyed

**Non-stabilised approach, long landing, runway veer-off,
collision with obstacles**

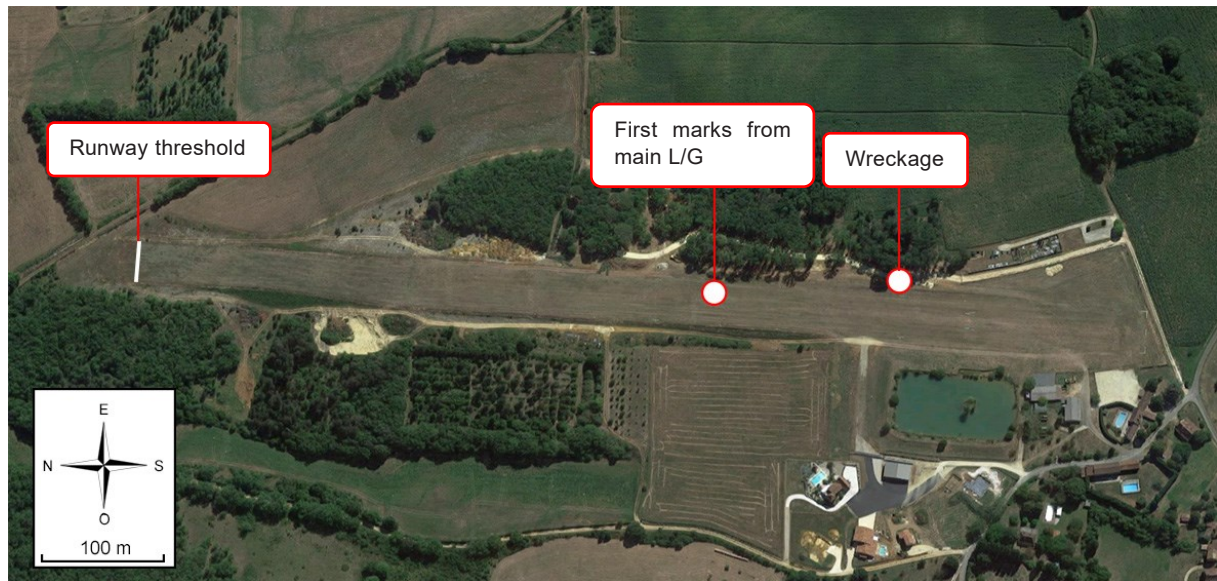
Figure 1: accident site (Source: Google Earth, BEA annotations)

The wreckage was located approximately 600 m from the threshold of runway 19 and 40 m to the left of the runway centreline, at the foot of trees over 10 m tall.

The first marks left by the main landing gear on the runway were approximately 110 m before the wreckage. The first mark corresponds to the right main landing gear and was located approximately 3 m before the mark left by the left landing gear. Approximately 30 m after the first mark, a runway light located on the left side of the runway was damaged. A mark left by the

nose landing gear was observed after this damaged light. The marks then stopped at the bank bordering the runway, before the perimeter fence.

During the landing, the aeroplane touched down on the runway about 500 m after threshold 19, to the left of the centreline, it deviated to the left and then exited the runway. The aeroplane collided with the fence located on the left side of the runway and then with trees.

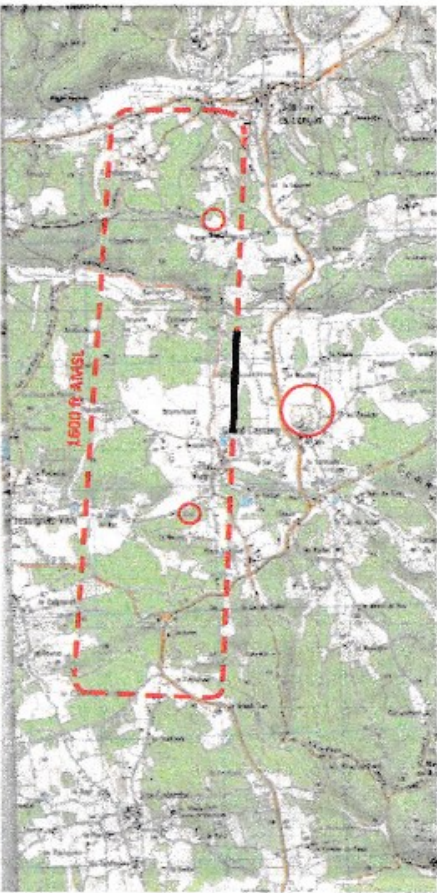
Figure 2: aerodrome chart (source: Aéroclub du Rebeyrotte)

The pilot stated that the runway circuit described on the chart bypassed the farm he saw on the final path, with the base leg being to the north of this farm. Retrospectively, he considered that he did not study the chart sufficiently. He specified that he had landed at Pressignac-Vicq Rebeyrotte aerodrome several years before and was therefore confident. However, given the hilly environment, the references there were different from those of the aerodromes where he was used to flying, which may have misled him. He added that he did notice a fairly light northerly wind, but forgot to take into account the tailwind component on final approach⁶.

⁴ Farm circled in red to the north of the runway on the aerodrome chart (see **Figure 2**).

Partial knowledge of the aerodrome chart led the pilot to turn too early onto the base leg and thus contributed to the non-stabilised approach.
