Accident to the ROBIN DR400-160
registered **F-GREP**
on Saturday 26 October 2024
at Pérourges - Meximieux

**Attempted take-off, vibrations on rotation, bounces,
runway overrun**

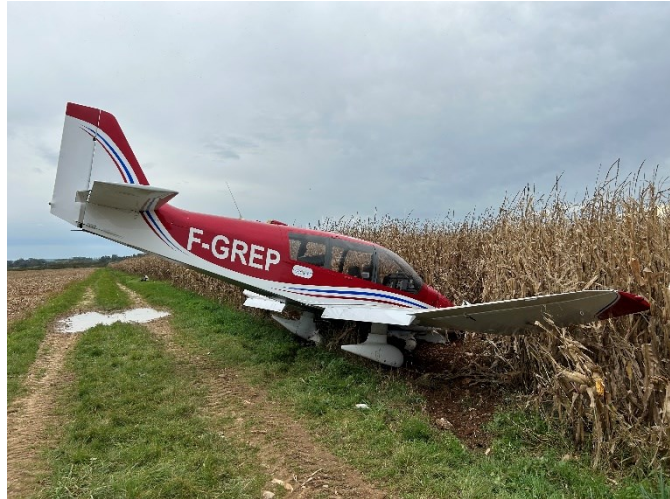
The pilot, accompanied by three passengers (including one seated in the front right seat, who was also a pilot), carried out engine tests, then taxied to the holding point of runway 16². He lined up at the runway threshold and applied take-off power. At 105 km/h, he pulled on the stick, the aeroplane adopted a nose-up attitude and started to vibrate strongly. As the end of the runway approached, the pilot tried to continue with take-off. The aeroplane deviated to the left, made a runway veer-off and overrun, crossed a fence, run in a harvested field, struck a large stone and deviated to the right. The nose landing gear collapsed and the aeroplane ended its course at the edge of a maize field.

Figure 1: photograph of F-GREP (Source: BEA)

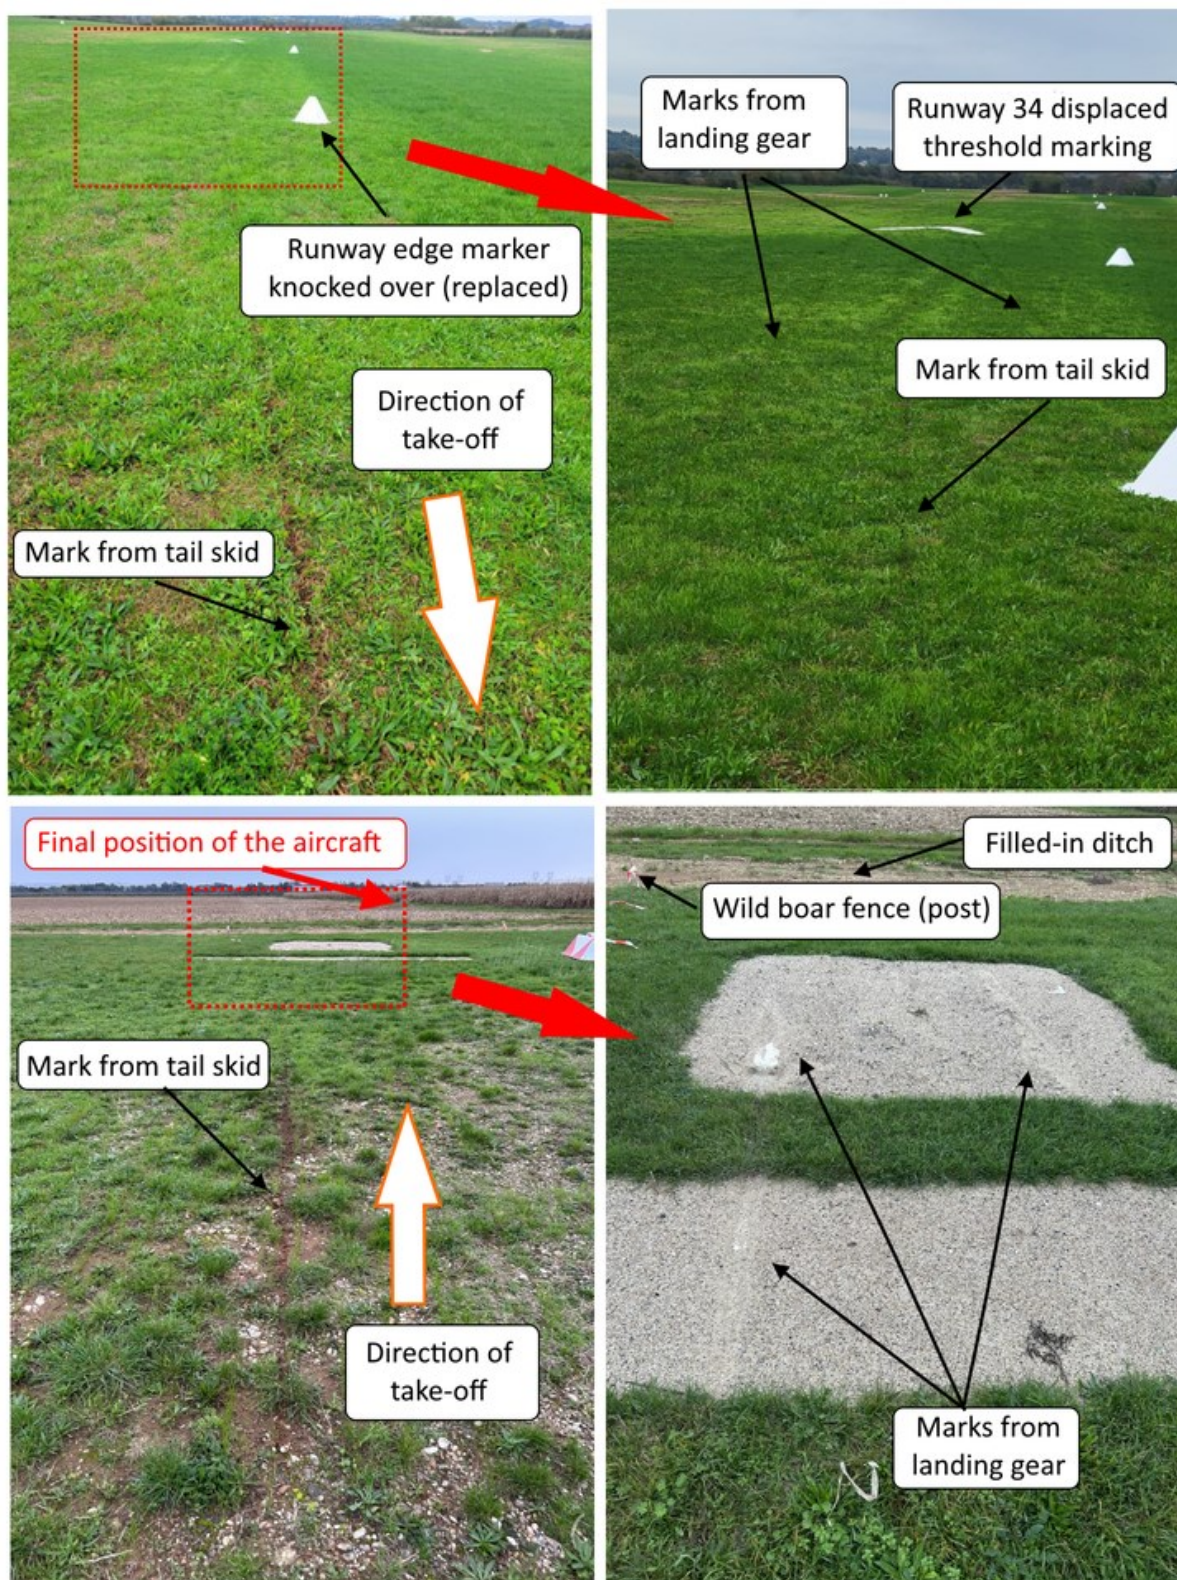
Examination of the marks on the runway showed that the main landing gears were in contact with the runway when the aeroplane crossed the displaced threshold markings of the opposite runway (i.e. 120 m before the end of runway 16) and indicated that the aeroplane had started to deviate to the left. A friction mark from the aeroplane tail skid was also observed. One of the frangible runway edge markers was also torn off.

Just before the end of runway 16, marks from the main landing gears and the tail skid were observed again, indicating that the aeroplane most probably bounced with a high nose-up attitude between the two sets of marks. The aerodrome is surrounded by a wild boar fence consisting of posts with two wires stretched 20 cm and 70 cm high. The upper wire was torn off and found wound on the left main landing gear, while the lower wire was intact. When it passed the fence, the aeroplane was less than 1 m high. The run marks were observed again in the harvested field located in the extended centreline of the runway.

Figure 2: marks recorded (Source: BEA)

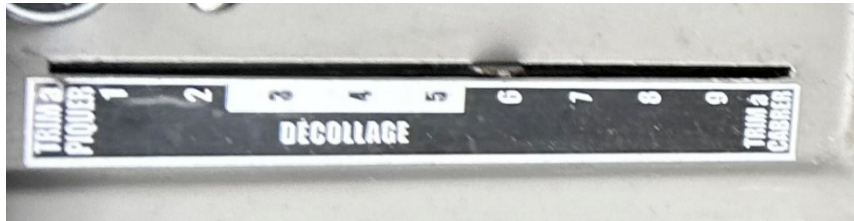
Photographs of the aeroplane taken just after the accident showed that the carburettor heat system was not activated, the power control was in the "full throttle" position, the mixture control was in the "full rich" position and the trim was in the "nose up" position (index on 6), outside the recommended range for take-off.

Figure 3: elevator trim position (Source: BEA)

After a take-off run that seemed normal to him, the pilot made an input on the stick to initiate rotation. The aeroplane had an aft centre of gravity and the elevator trim in the nose-up position beyond the aft limit for take-off.

- an incomplete check of the aeroplane's configuration before lining up, which led to taking off with the elevator trim in the nose-up position beyond the limit.
