Accident to the Issoire Aviation APM20 “Lionceau”
registered **F-GRPN**
on Wednesday 17 May 2023
at La Chapelle-la-Reine

Time	Around 18:30 ¹
Operator	Aéroclub Brocard
Type of flight	Cross country
Persons on board	Pilot
Consequences and damage	Pilot fatally injured, aeroplane destroyed
This is a courtesy translation by the BEA of the Final Report on the Safety Investigation. As accurate as the translation may be, the original text in French is the work of reference.

Collision with ground

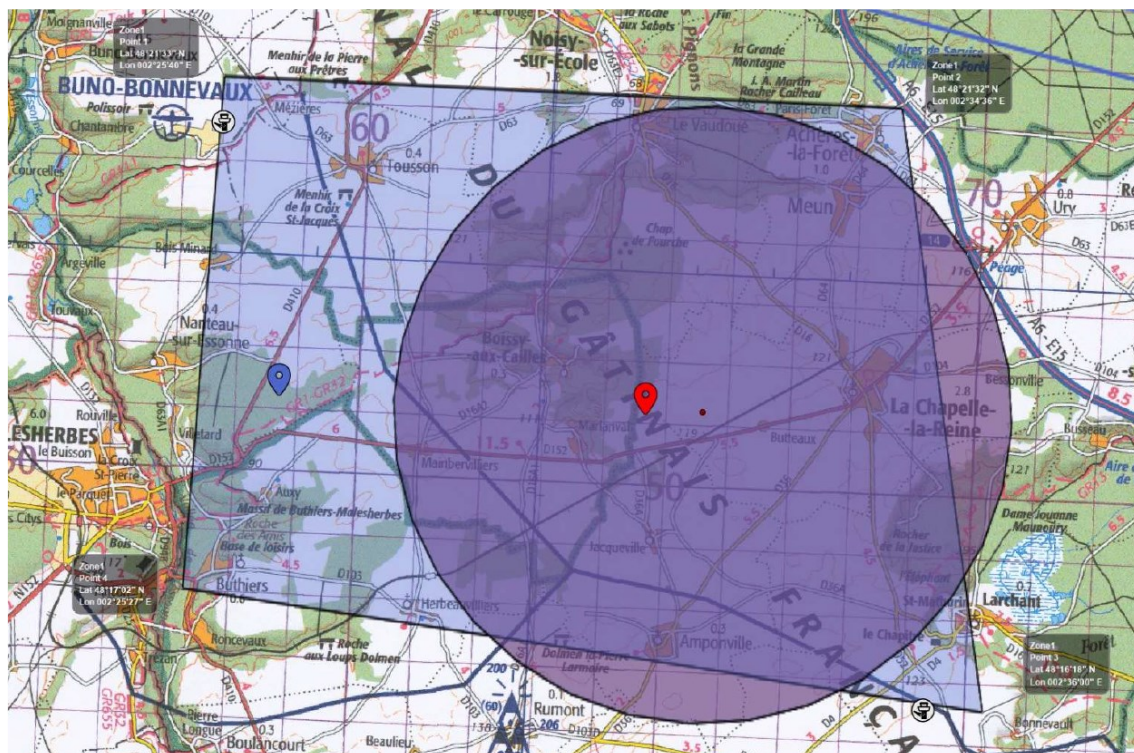
On the basis of the statement, deemed credible, ground search resources were deployed by the Gendarmerie in a search zone delimited by the blue quadrilateral shown on **Figure 2**.

Based on the information provided by the husband, the search services asked the competent authorities to locate the pilot's telephone by radiolocation. At around 23:00, the search operations were concentrated in the area where the telephone had been located (purple circle on **Figure 2**).

Figure 2: search areas (source: ARCC-Lyon) and location of wreckage (red marker)

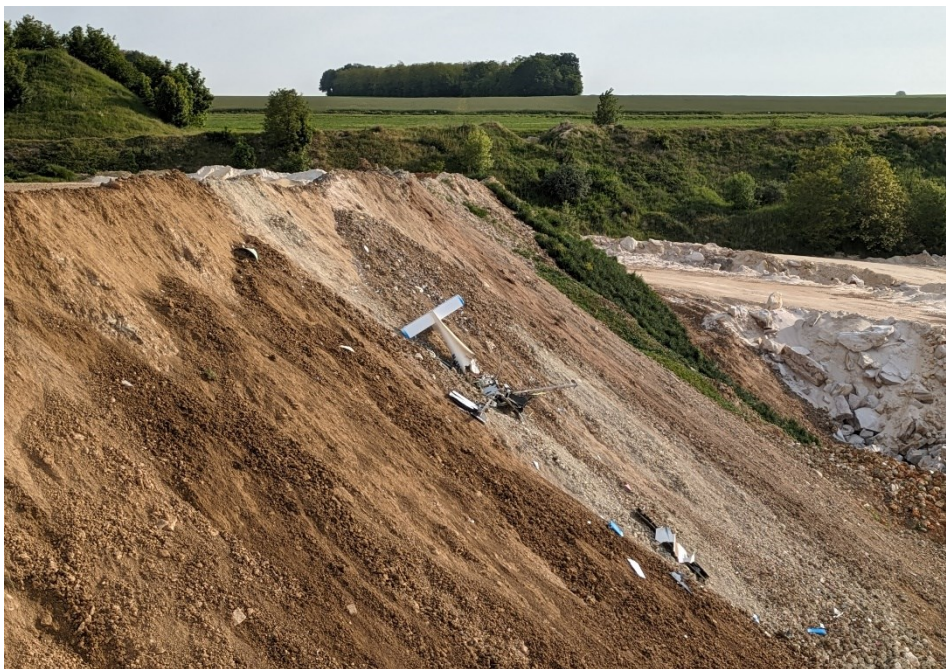
Figure 3: wreckage of aeroplane (source: Gendarmerie)

The extent of the damage to the aeroplane and its penetration into the slope shows that it collided with the ground with high energy. The wings were level and the attitude was nose-down at the time of the impact.

Ruptures were observed on the aileron control and elevator control linkages. All these ruptures were the result of the collision with the ground. The yaw control channel was continuous.

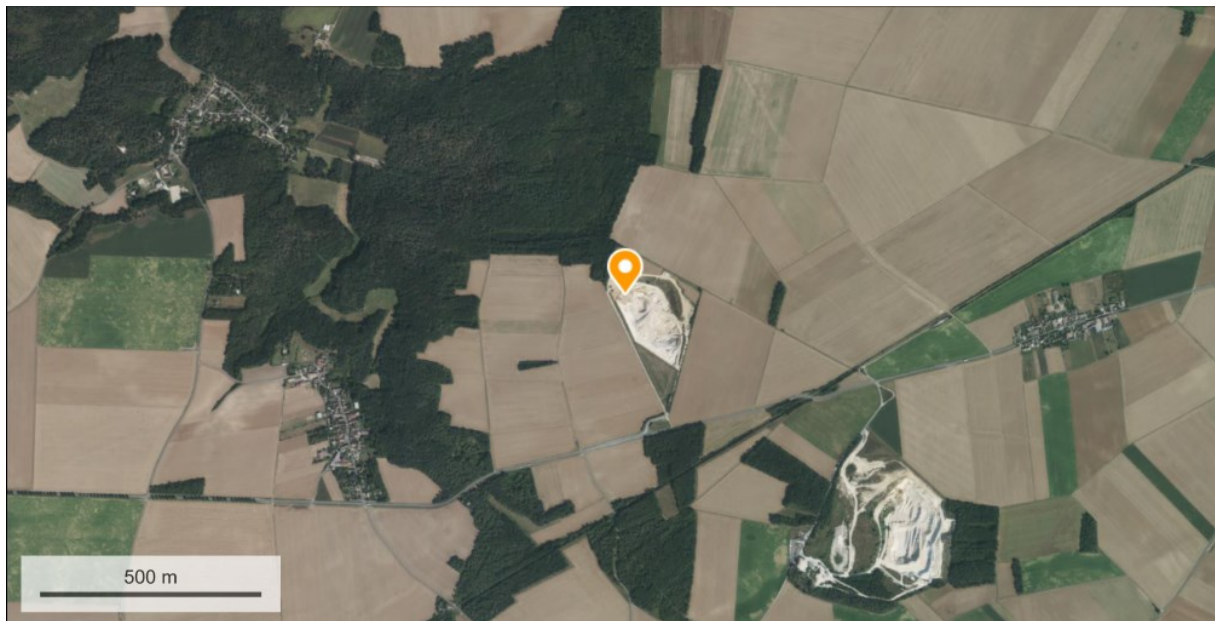
The quarry where the aeroplane wreckage was found was situated in an area where there were numerous fields available for a forced landing (see **Figure 4**).

*Figure 4: aerial view of quarry where wreckage was found
(Source: Géoportail, aerial view in 2021)*
