Accident to the ROBIN DR400/120
registered **F-GSBN**
on Friday 14 June 2024
on Chartres - Champhol¹ aerodrome

**Runway veer-off on increasing power during a touch-and-go,
collision with windsock, rupture of LH wing,
collision with ground**

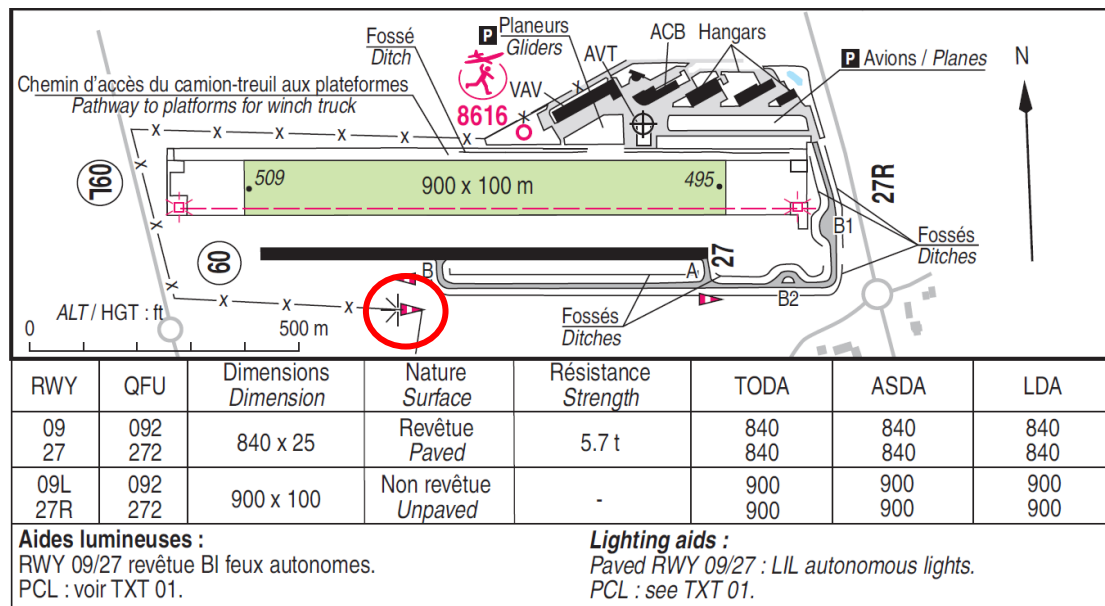
Figure 1: information concerning runways at Chartres aerodrome with location of accident shown by a red circle (source: SIA)

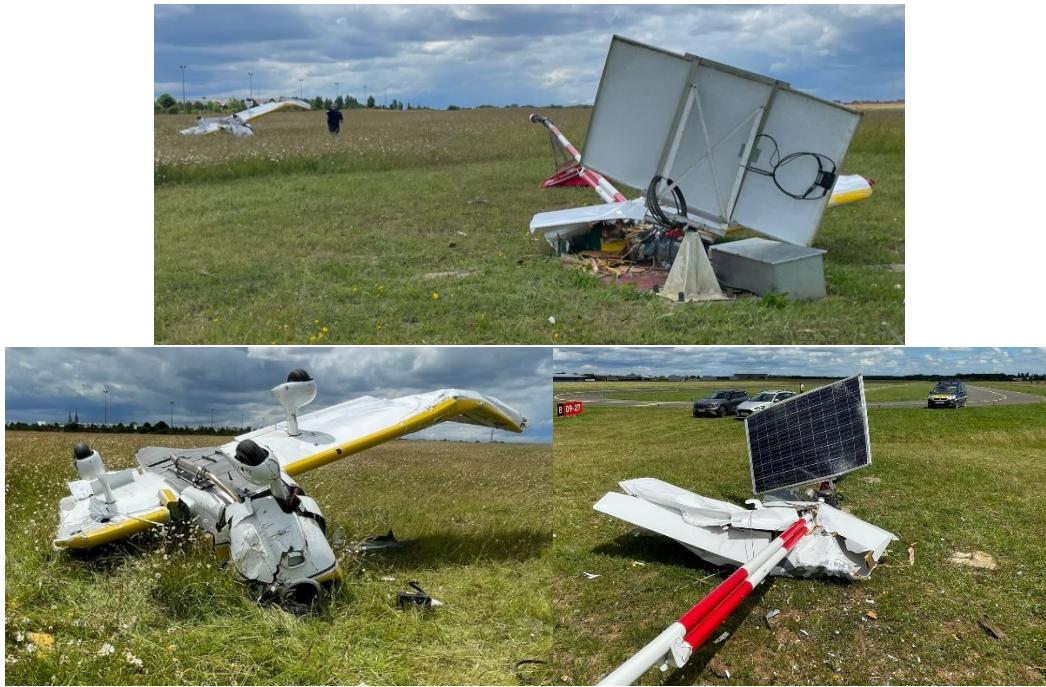
The main part of the wreckage was situated a few dozen metres from the windsock. The aeroplane was very damaged and lying on its back. Part of the LH wing had been torn off and was embedded in the windsock.

Figure 2: accident site (source: GTA)
