Accident between the Boeing 777-300 registered **F-GSQT** operated by Air France and the Airbus A330-900 registered **N411DX** operated by Delta Air Lines on Wednesday 30 August 2023 at Paris-Charles de Gaulle

Collision between an aeroplane taxiing and a stationary aeroplane

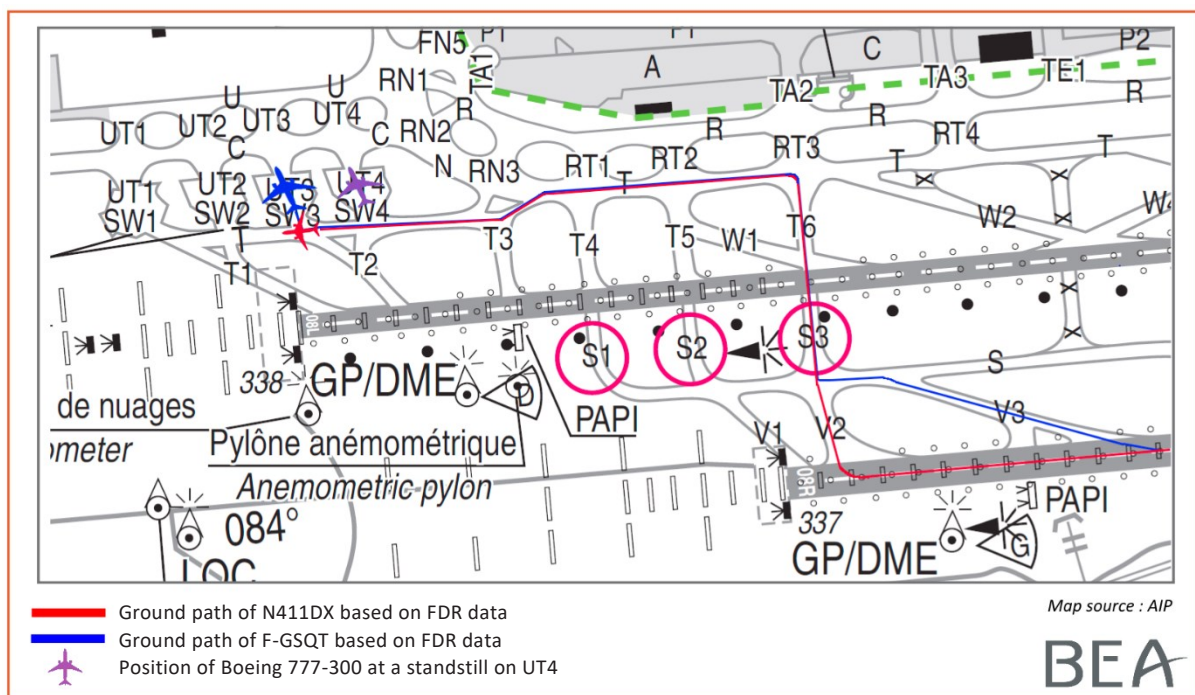
The Delta Air Lines Airbus A330-900 from Seattle (USA), landed on runway 26L at around 13:25. The aeroplane vacated the runway via ramp V2, crossed runway 26R via taxiway S3 and then taxied on taxiway T6. At the junction with taxiway T, the controller asked the crew to turn left onto T and then right onto UT2 in order to hold on the de-icing pads, as their terminal parking stand was also busy. The Airbus A330-900 taxied on taxiway T at a ground speed of around 12 kt, passed behind the Boeing 777-200 holding at UT4, slowed down to around 8 kt and passed behind the Boeing 777-300 holding at UT3.

At 13:31:30, the tip of the right wing of the Airbus A330-900 stuck the tail of the Boeing 777-300. The Airbus A330-900 came to a halt a few metres further on.

Figure 1: ground paths of 777-300 registered F-GSQT and A330-900 registered N411DX
(Source: AIP, annotations BEA)

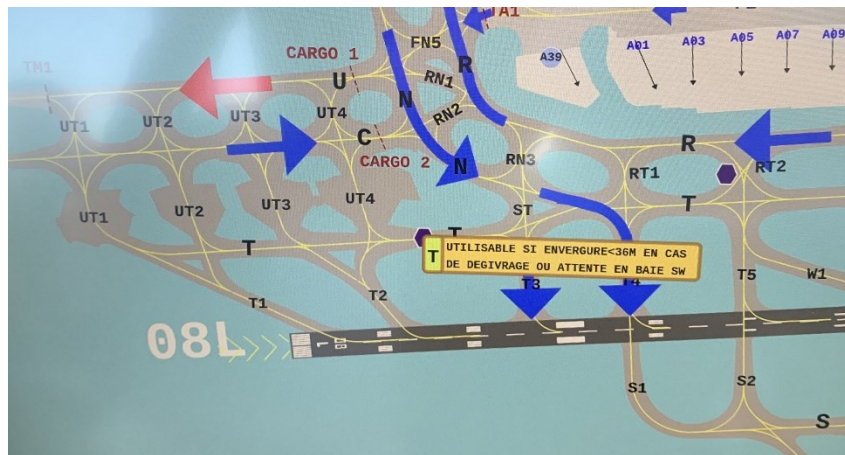
is used to display the limitations for ground movements: T can be used if wingspan < 36 m if there is de-icing or an aircraft holding on pad SW.

Figure 2: limitation for taxiing on T (Source: SNA-RP/CDG)
