**Accident** to the CESSNA 208 "Caravan"  
registered **F-GUTS**  
on Thursday 25 April 2024  
at Gap-Tallard aerodrome

## **Failure of propeller governor in aerodrome circuit, off-airfield forced landing**

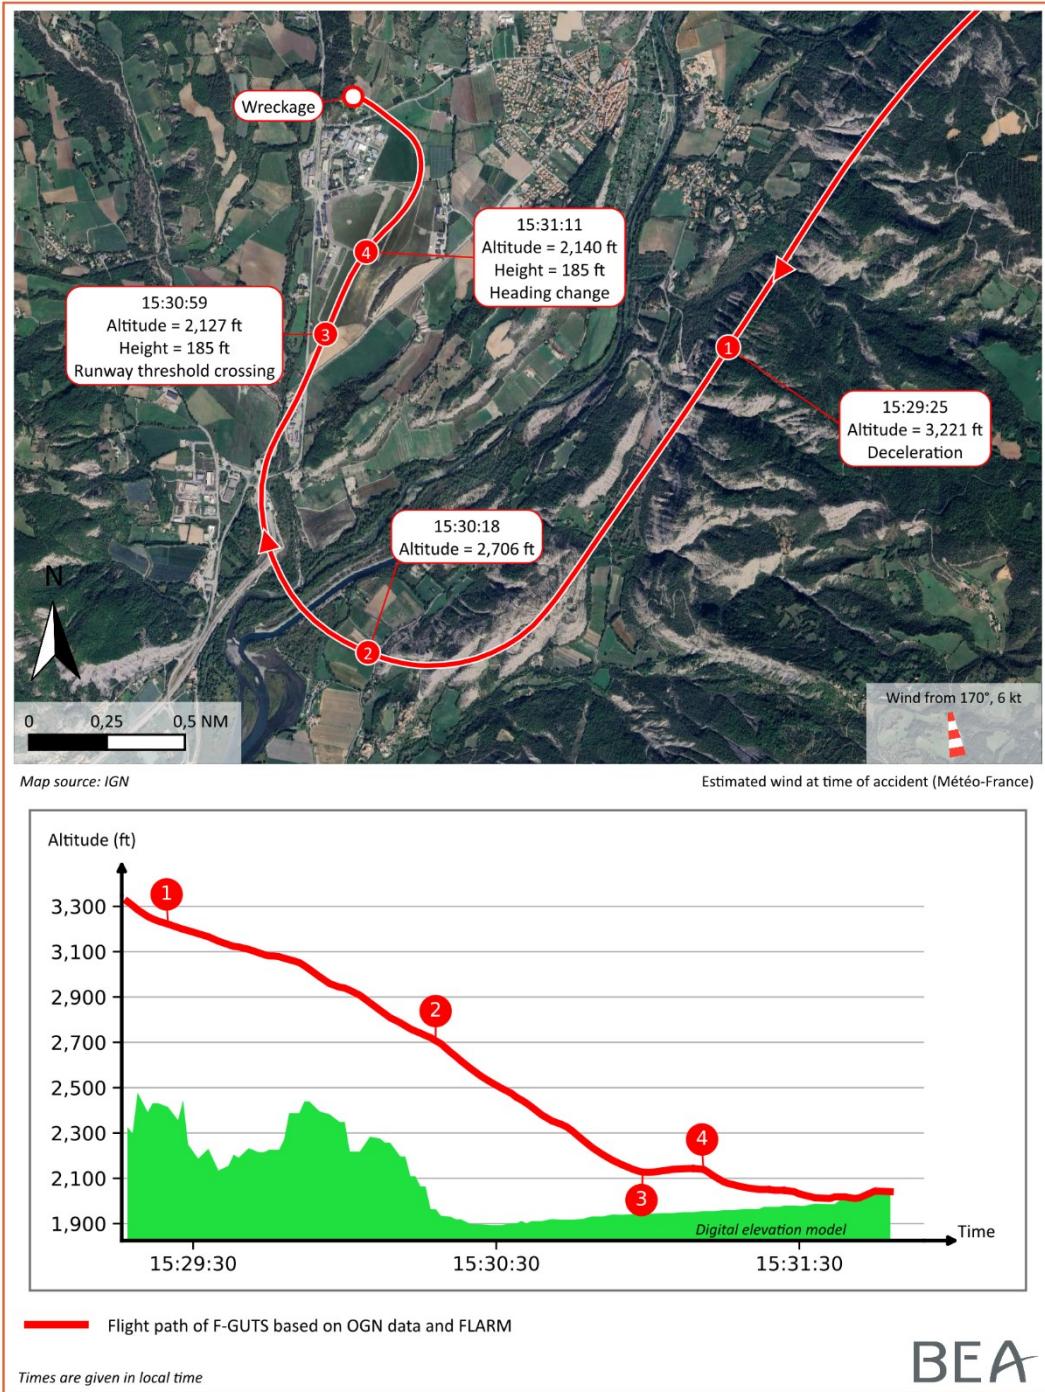
Figure 1: flight path of F-GUTS

The pilot anticipated the turn onto the base leg in order to shorten his circuit pattern. In the middle of the base leg, the aeroplane was at an altitude of 2,760 ft, with a ground speed of around 100 kt (point ②). The aeroplane flew over the runway threshold at an approximate height of 185 ft, the ground speed was around 100 kt (point ③). As he was flying over the runway, the pilot slightly turned to the right (point ④) before turning left. He then carried out a forced landing in a clearing to the north of the runway.

- the arrival in the runway circuit at an altitude approximately 750 ft higher than recommended;
- inadequate flight path management following the failure of the propeller governor.

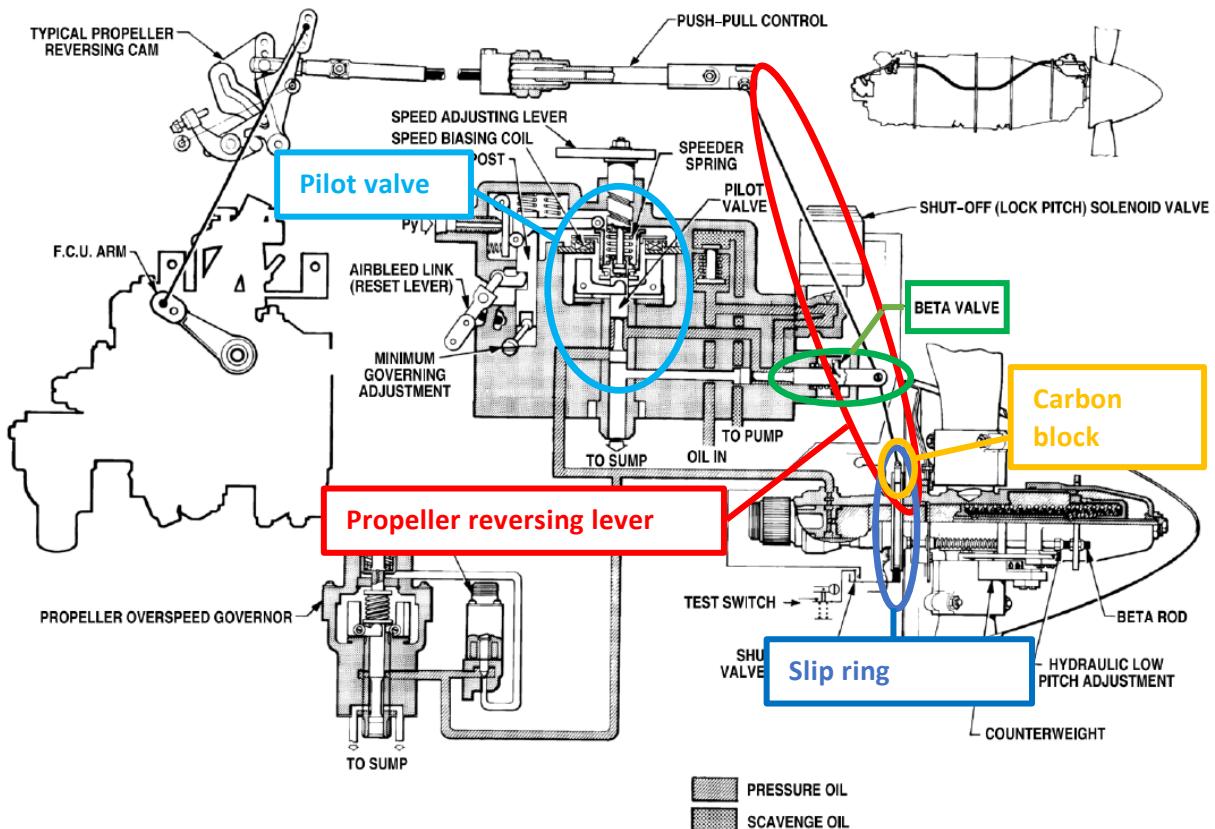
Figure 3: schematic diagram of propeller governor (source: Pratt & Whitney Canada)

The **pilot valve** (in blue in **Figure 3**) is the primary means of governing the propeller. Thus, in normal flight conditions, the pilot valve regulates the oil pressure delivered to the servo piston in order to maintain the propeller speed selected by the pilot.

The purpose of the **beta valve** (in green in Figure 3) is to provide the governor with a thrust reversal capability. This valve is installed upstream of the pilot valve and is mechanically actuated by the propeller reversing lever. When the poppet<sup>5</sup> of the valve is pushed in, the valve has no influence on the governor's hydraulic system. When the poppet moves forward, this initially prevents high-pressure oil from reaching the propeller servo piston. The pressure applied to the piston then remains constant. If the valve continues to move forward, the pressurized oil actuating the servo piston will be directed back to the reservoir, and hydraulic pressure will no longer be applied to the servo piston. In this case, the servo piston will be subject only to the force of the return spring and will move the propeller to the feathered position.

At the propeller, the propeller reversing lever is also connected via a carbon block (in **orange** in **Figure 3**) to a slip ring (in **dark blue** in Figure 3) which follows the movements of the servo piston.

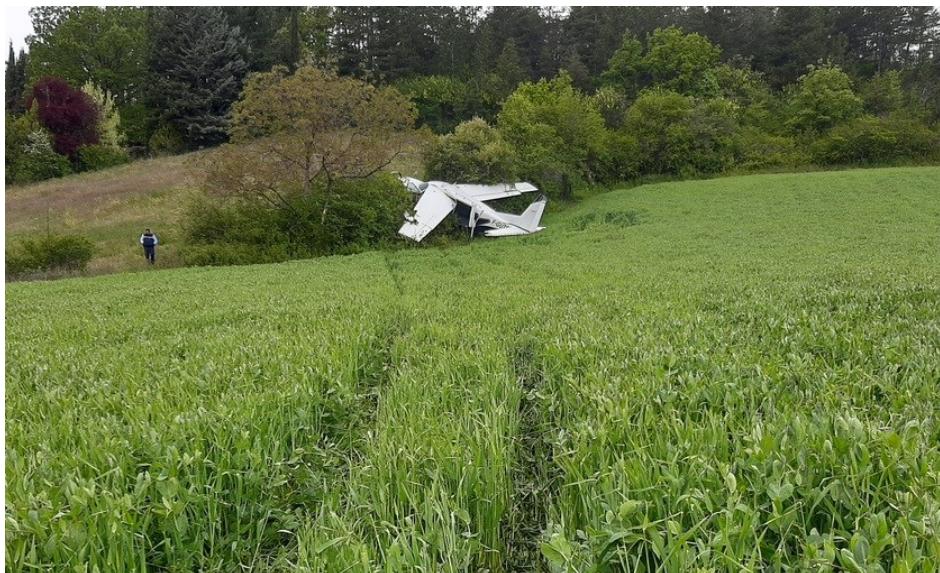
Figure 4: accident site (source: BGTA)

The aeroplane collided with a bank at the edge of a field located 600 m north of the threshold of runway 20. Based on the examination of the wreckage, all the damage observed was caused by the collision with the ground.

The propeller was found in the feathered position on the wreckage.

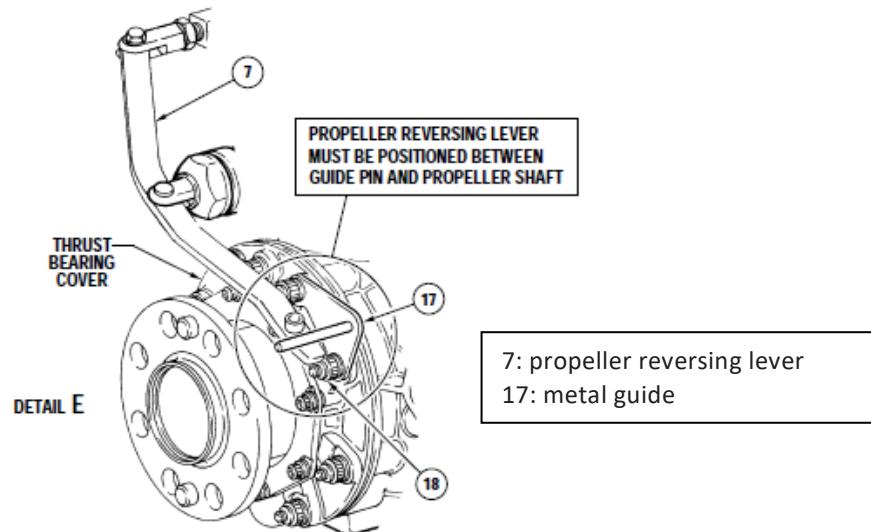
Figure 5: excerpt from PT6A-114A engine maintenance manual (source: Pratt & Whitney Canada)

The engine maintenance manual describes the lever installation procedure in detail and mentions the risk of incorrectly positioning the lever, illustrating it with **Figure 5**.

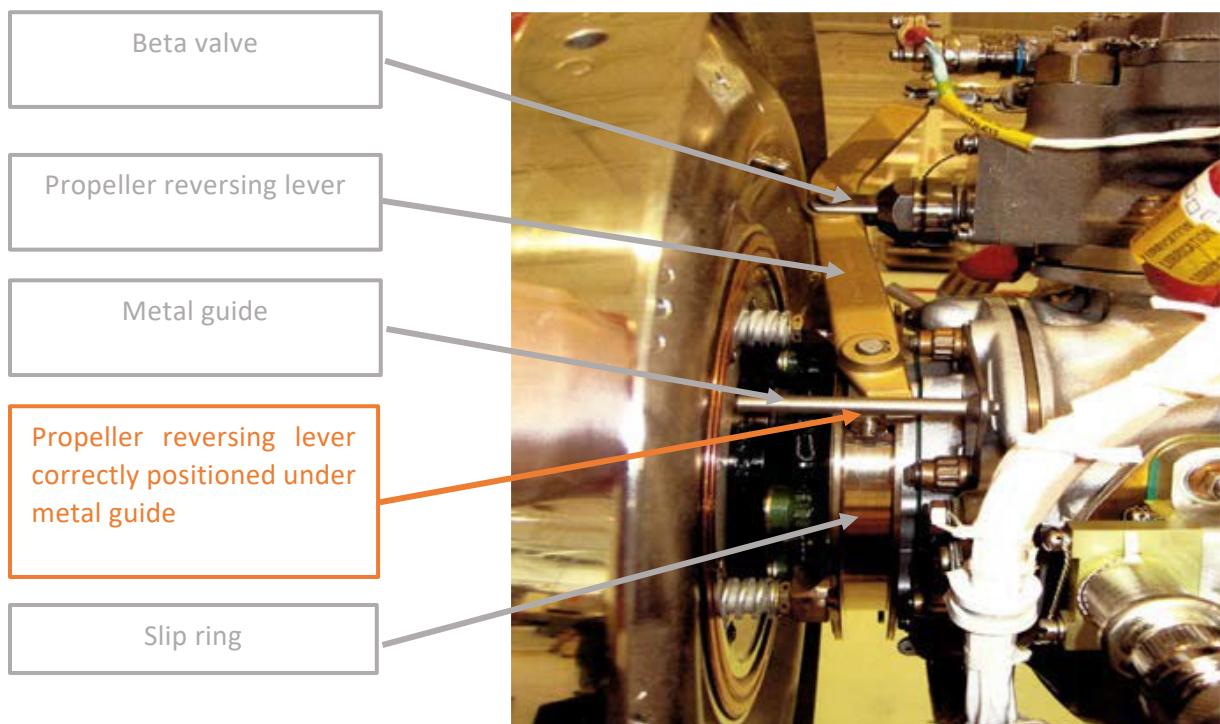
Figure 6: photo of the correct installation of the propeller reversing lever on a PT6 engine  
(source: [NTSB](#))

The examination of the powerplant revealed the incorrect installation of the propeller reversing lever. In its normal position, this lever is positioned under a metal guide (see **Figure 5** and **Figure 6**) so that the carbon block cannot come out of the slip ring groove. On F-GUTS, it was positioned on top of the metal guide (see **Figure 7**).

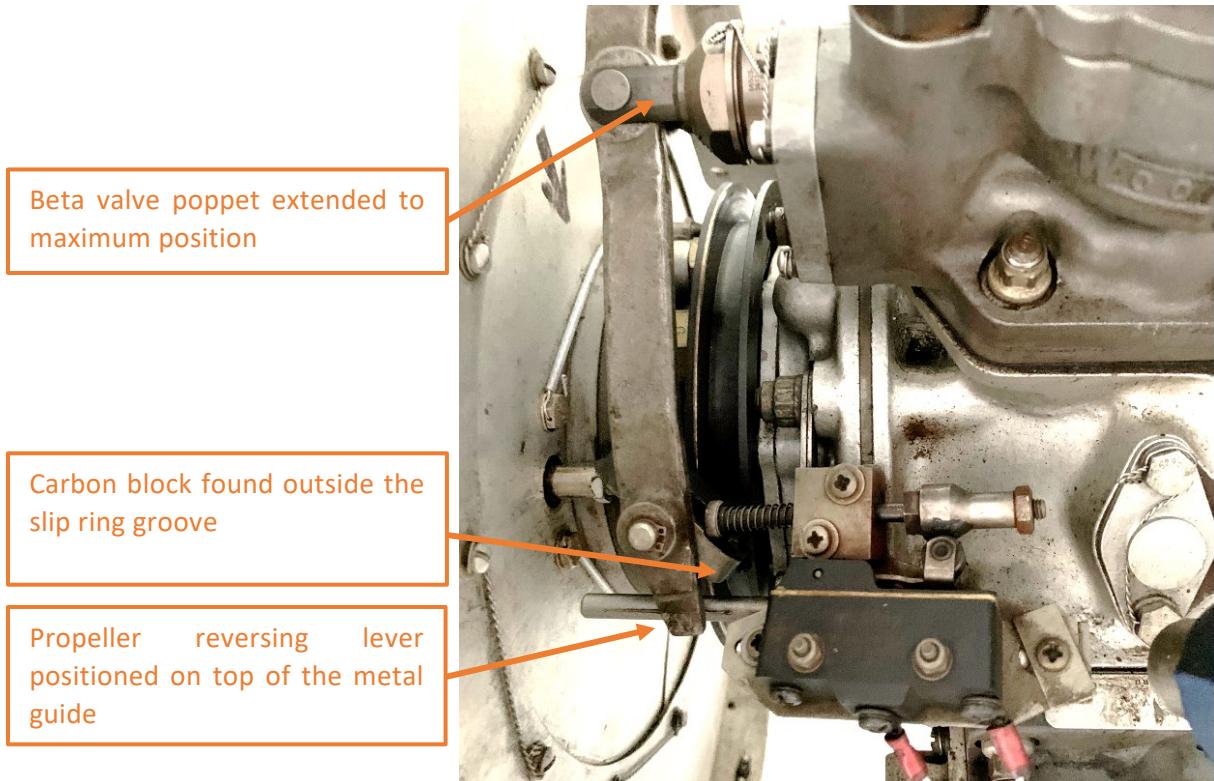
Figure 7: photo of installation of propeller reversing lever taken on the wreckage of F-GUTS  
(source: BEA)

Due to the incorrect installation, the carbon block was no longer properly held in the slip ring groove, and it came out of it (see **Figure 7**). This allowed the propeller reversing lever to move and action the Beta valve until the propeller was feathered.

The malfunction of the propeller governor was the result of the propeller reversing lever being incorrectly installed during the last maintenance operation performed on the aeroplane, a little less than two months before the accident flight.

- the very probable absence of a double-check by the maintenance workshop, for the correct position of the propeller reversing lever after the maintenance operation. The re-installation of a propeller was not considered a critical task by the maintenance workshop;
- the design of the metal guide of the propeller governor, making it possible to incorrectly install the propeller reversing lever.

The maintenance workshop has defined propeller re-installation as a critical task. As a consequence, after each propeller re-installation, an independent inspection is performed to check that the maintenance task has been properly completed. This practice reduces the risk of the incorrect installation of the propeller reversing lever.

Furthermore, in response to an NTSB recommendation following several cases of the incorrect installation of the propeller reversing lever, the engine manufacturer has designed and obtained the certification for a new metal guide design that prevents the incorrect installation of the reversing lever on engines equipping the Cessna Caravan (PT6A – 114/114A/140 engines). This new design will be featured on engines produced from the first quarter of 2026. It will also be possible to retrofit older engines via a Service Bulletin.
