**Accident** to the DIAMOND - DA40  
registered **F-GUVU**  
on 3 April 2023  
at Annecy-Meythet (Haute-Savoie)

**Student-pilot hit by rotating propeller in parking area,  
in instruction**

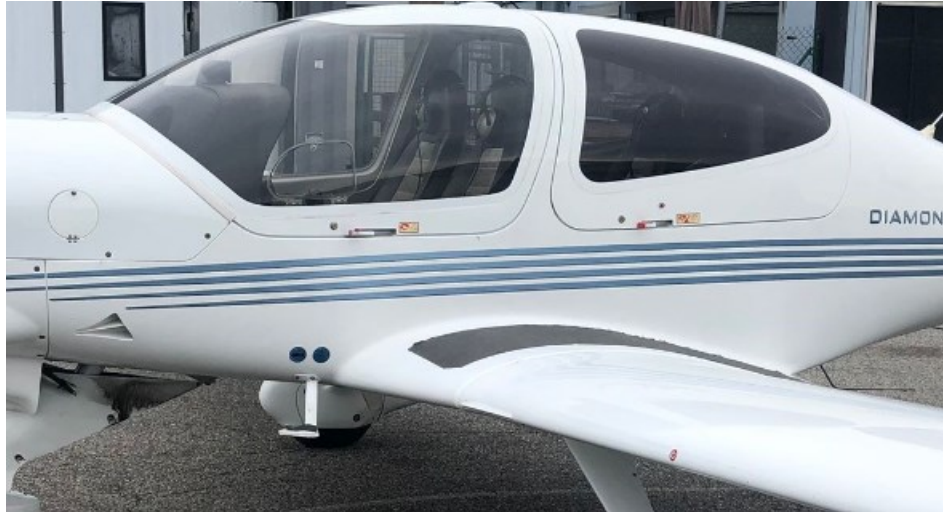
F-GUVU is a four-seater DA40 aeroplane with tricycle landing gear. It is equipped with a forward-tilting canopy and a gullwing door at the rear left. A step in front of each wing provides access to the two seats at the front. A reinforced wing-walkway at the wing root provides access to the front and rear seats (see **Figure 1**).

*Figure 1: step and wing-walkway to access the aeroplane*

He explained that after the flight preparation briefing, he had the pouch containing the aeroplane's documents and put it on the left wing to start the pre-flight inspection with the instructor. He added that he boarded using the step in front of the wing, as he was used to doing. After starting the engine and discussing the taxi clearance read-back with the instructor, they were interrupted in their tasks for starting taxiing and informed of the presence of a bag that had fallen down behind the aeroplane. He stated that, in consultation with the instructor, the latter asked him to exit the aeroplane to have a look while he maintained the canopy half-opened with the throttle lever in the idle position. According to him, he got out "normally" from the front as he was used to doing, but lost his balance forwards. He explained that he had the intention of walking along the wing while bending down to see underneath in order to locate the bag.

- during engine start-up, a bag fell from the left wing to the ground, behind the wing, probably due to the relative wind generated by the propeller;
- the student-pilot got out of the aeroplane using the step located in front of the leading edge;
- once on the ground, with his back almost turned to the instructor who was still on board, he bent down slightly and headed forward until he was hit by the propeller.
