**Serious incident** to the ROBIN DR400-120  
registered **F-GUXI**  
on Saturday 20 January 2024  
at Saint-Cyr-l'École

<b>Time</b>	Around 16:50 <sup>1</sup>
<b>Operator</b>	Aéroclub de Versailles
<b>Type of flight</b>	Local
<b>Persons on board</b>	Pilot
<b>Consequences and damage</b>	Aircraft slightly damaged

## Lorry struck on final approach, go-around

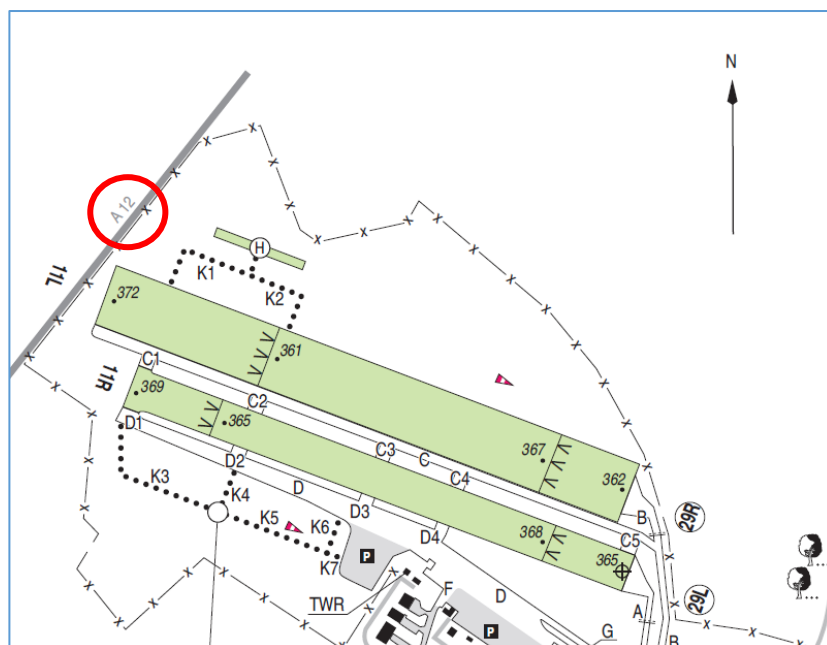
Saint-Cyr-l'École aerodrome is equipped with two unpaved runways. Runway 11L/29R measures 890 m x 100 m, and runway 11R/29L measures 865 m x 60 m. The A12 motorway runs along the immediate west side of the aerodrome. Due to the presence of various obstacles, the two runways have displaced thresholds which reduce the landing distance available to 615 m for runway 11L and 715 m for runway 11R. On a standard approach slope of 3°, these displaced thresholds guarantee flight over the A12 motorway at a height of around 16 m.

Figure 1: excerpt from VAC chart illustrating displaced thresholds and environment (Source: AIS)

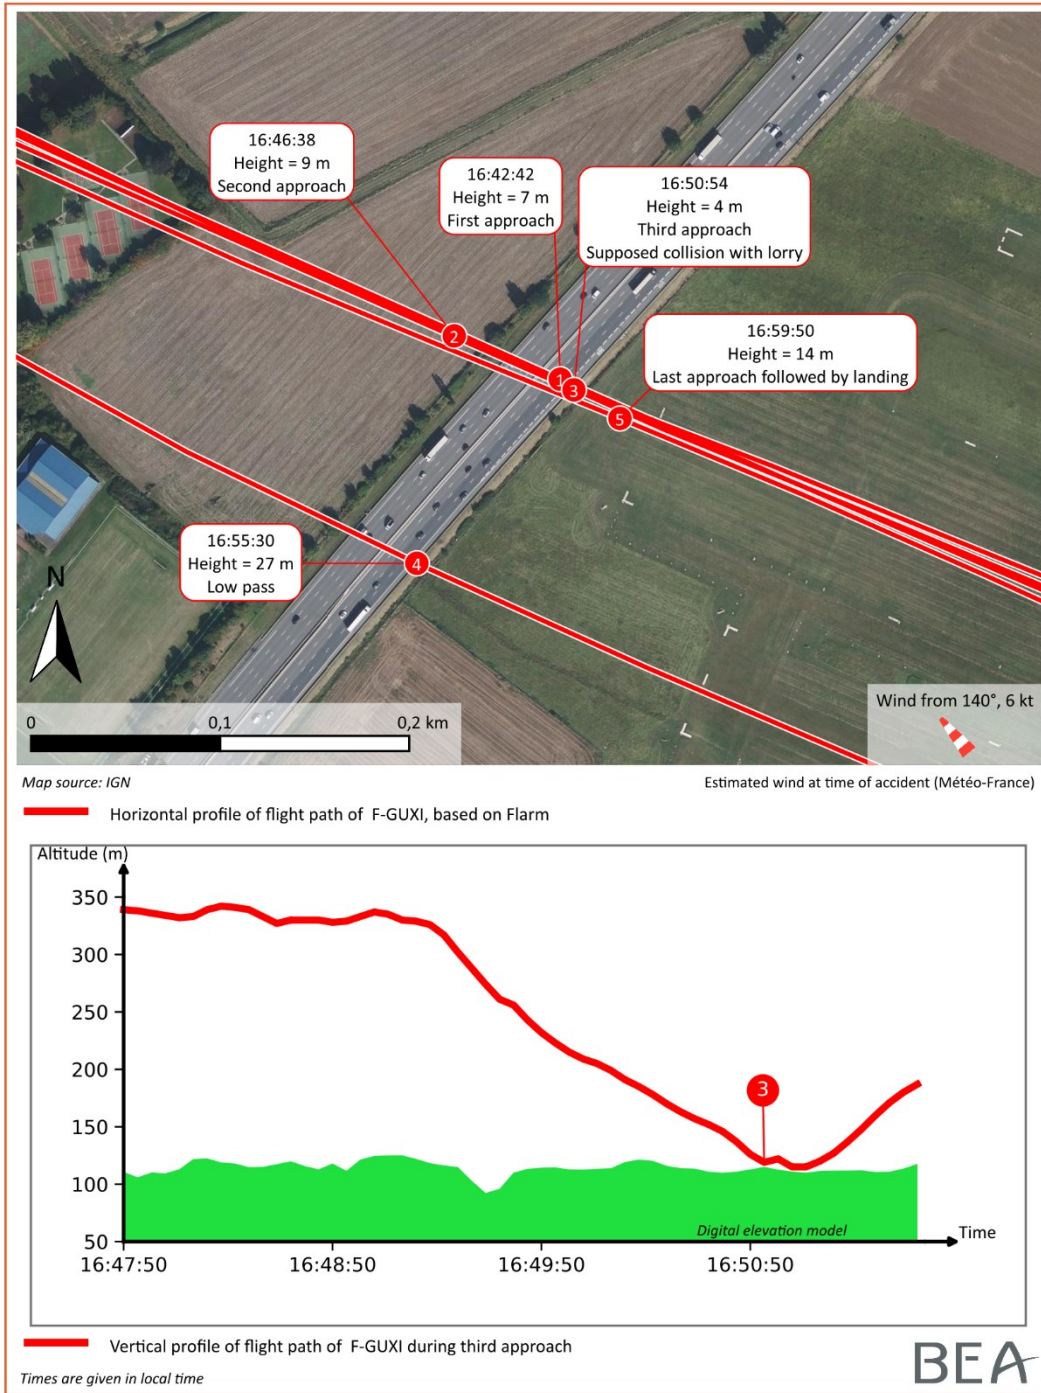
Figure 2: flight path (source: BEA)

During the first two approaches, the aeroplane flew over the motorway at a height of seven and then nine metres.

During the third approach (see **Figure 2**, point **3**), the lowest point recorded by the Flarm corresponded to a position overhead the motorway of a height of four metres. This height is consistent with the average height of an articulated lorry.

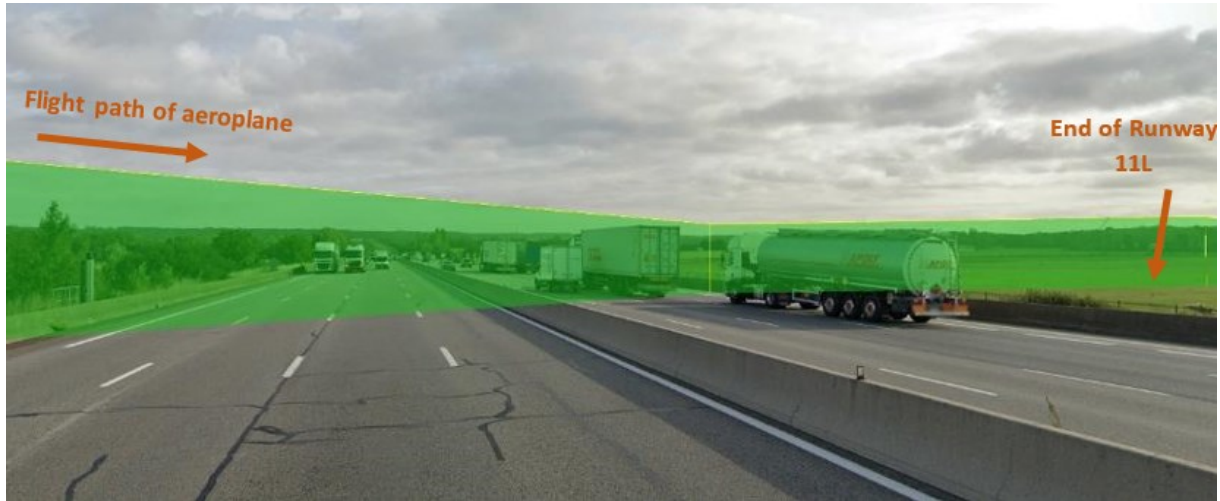
The 3D view<sup>6</sup> below also shows the flight path of the aeroplane during the third approach:

*Figure 3: 3D view of flight path of third approach  
(Source: Google Street View, annotations BEA)*

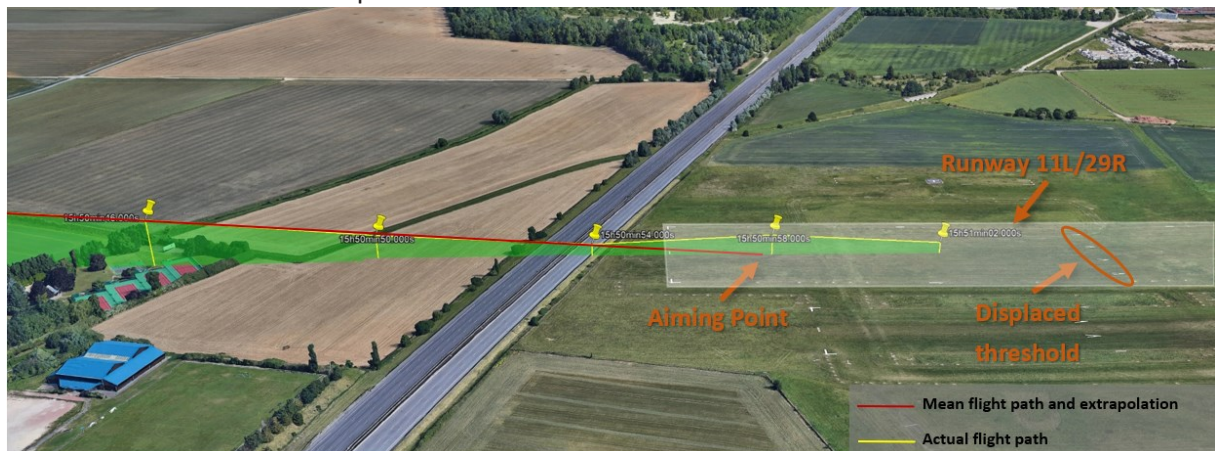
The extrapolation of the flight path on the final approach shows that the aiming point was located around 200 m before the displaced threshold.

*Figure 4: extrapolation of aiming point on 3D view  
(Source: Google Earth, annotations BEA)*

The pilot indicated that he was not used to carrying out missed approaches. He considered that his management of the go-around in the first two approaches was not sufficiently fluid. He thought that he had focused his attention on the go-around procedure to the detriment of the flight path and the aiming point during the third approach (see **Figure 4**).

The flying club's chief pilot indicated that holding the approach slope and correctly visualizing the aiming point were going to be among the items proposed to instructors for the recurrent training flights.
