Accident to the ROBIN DR400-180
registered **F-GUXO**
on Sunday 7 January 2024
at Vichy

Time	Around 15:10 ¹
Operator	Aéroclub de Vichy
Type of flight	Local
Persons on board	Pilot and one passenger
Consequences and damage	Pilot and passenger fatally injured, aeroplane destroyed
This is a courtesy translation by the BEA of the Final Report on the Safety Investigation. As accurate as the translation may be, the original text in French is the work of reference.

Collision with ground, at end of downwind leg

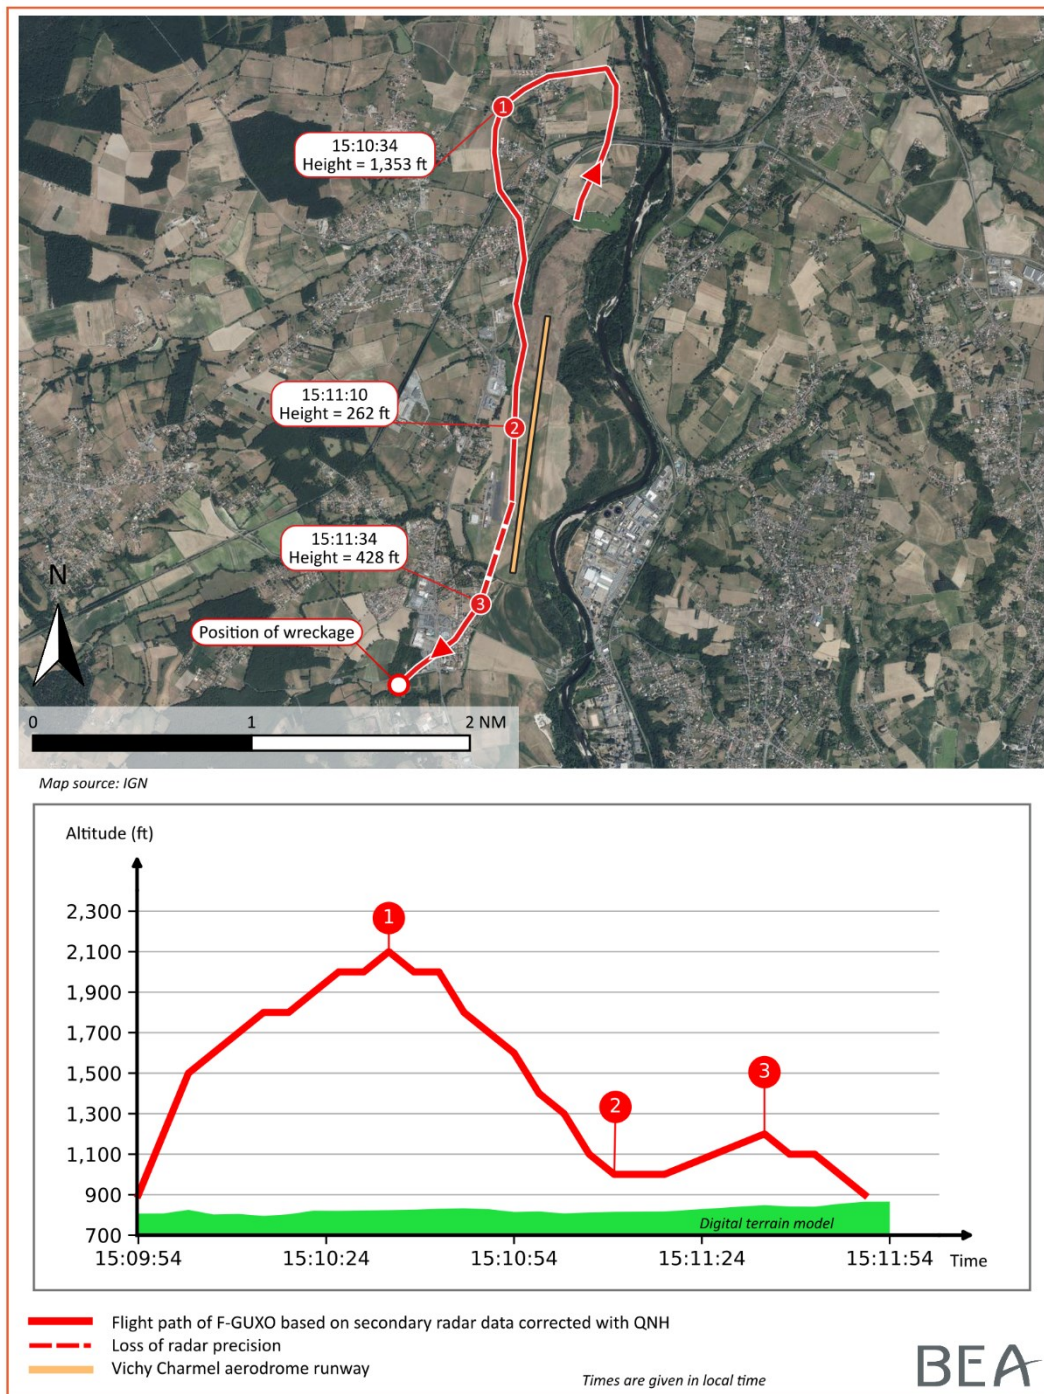
Figure 1: flight path of aeroplane

The pilot, accompanied by a passenger who was also a pilot, took off from runway 01 at Vichy - Charmeil aerodrome. He climbed to a height of 1,350 ft², then carried out a U-turn (see **Figure 1**, point **1**) and descended to a height of 300 ft to fly over the runway on the reciprocal QFU (see point **2**). He headed towards the end of the downwind leg for runway 01 while climbing to 400 ft (see point **3**). From this point, the radar plot shows the aeroplane making a smooth descent. A witness, who saw the aeroplane descending before losing it from view, found the aeroplane wreckage in a field.

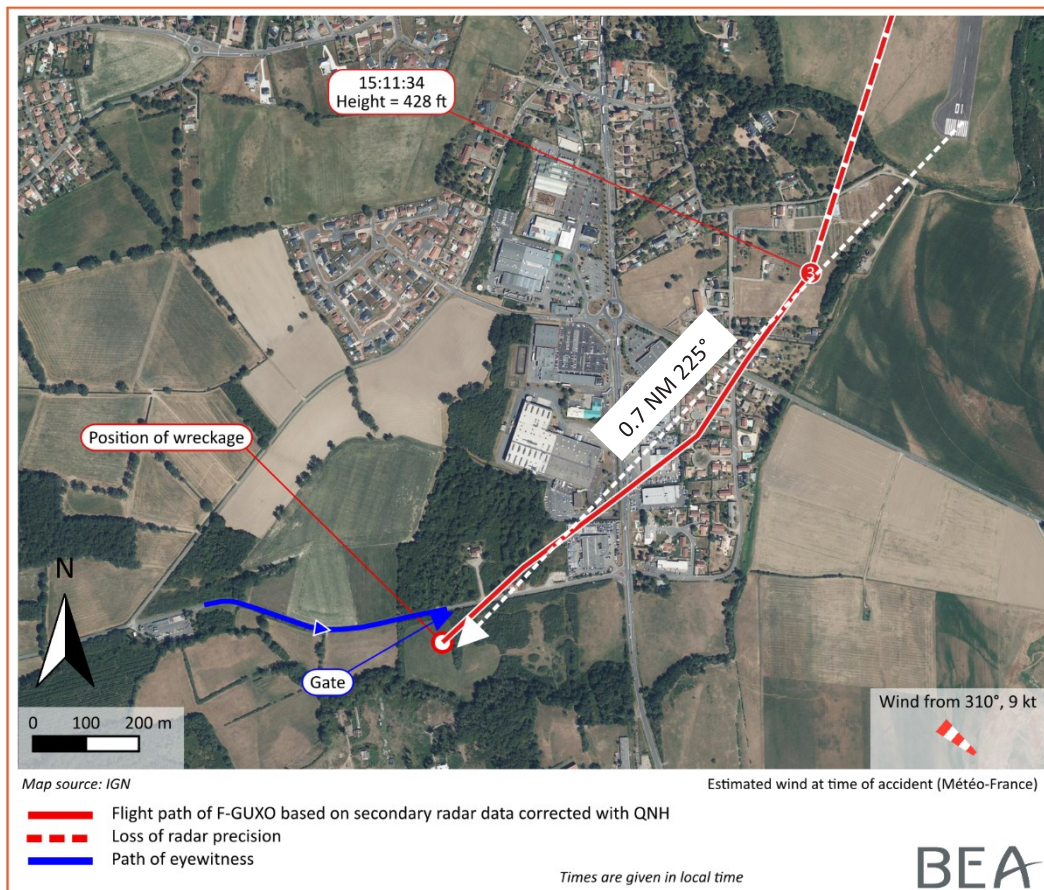
Figure 2: situational view of wreckage and environment

The accident site was situated south-west of and around 0.7 NM from the threshold of runway 01 of Vichy - Charmeil aerodrome. The aeroplane was found in a field. The approach flight path on a south-westerly heading passed abeam a group of trees bordering the field.

The damage to the front section of the aeroplane and the distribution of the debris indicate a high-energy impact and a nose-down attitude at the time of the collision with the ground.

The parts found in and around the group of trees show that the loss of the RH wing, the propeller, the starter ring gear and the propeller flange was due to contact with the vegetation when the aeroplane passed through the trees.
