Accident to the CESSNA 208B “Grand Caravan”
registered **F-GXMP**
on 30 April 2022
at Pamiers (Ariège)

Time	Around 18:20 ¹
Operator	Centre École de Parachutisme Sportif de l’Ariège
Type of flight	Parachute drop
Persons on board	Pilot and one passenger
Consequences and damage	Aeroplane substantially damaged

Fuel exhaustion, forced landing before runway, tipping into a ditch

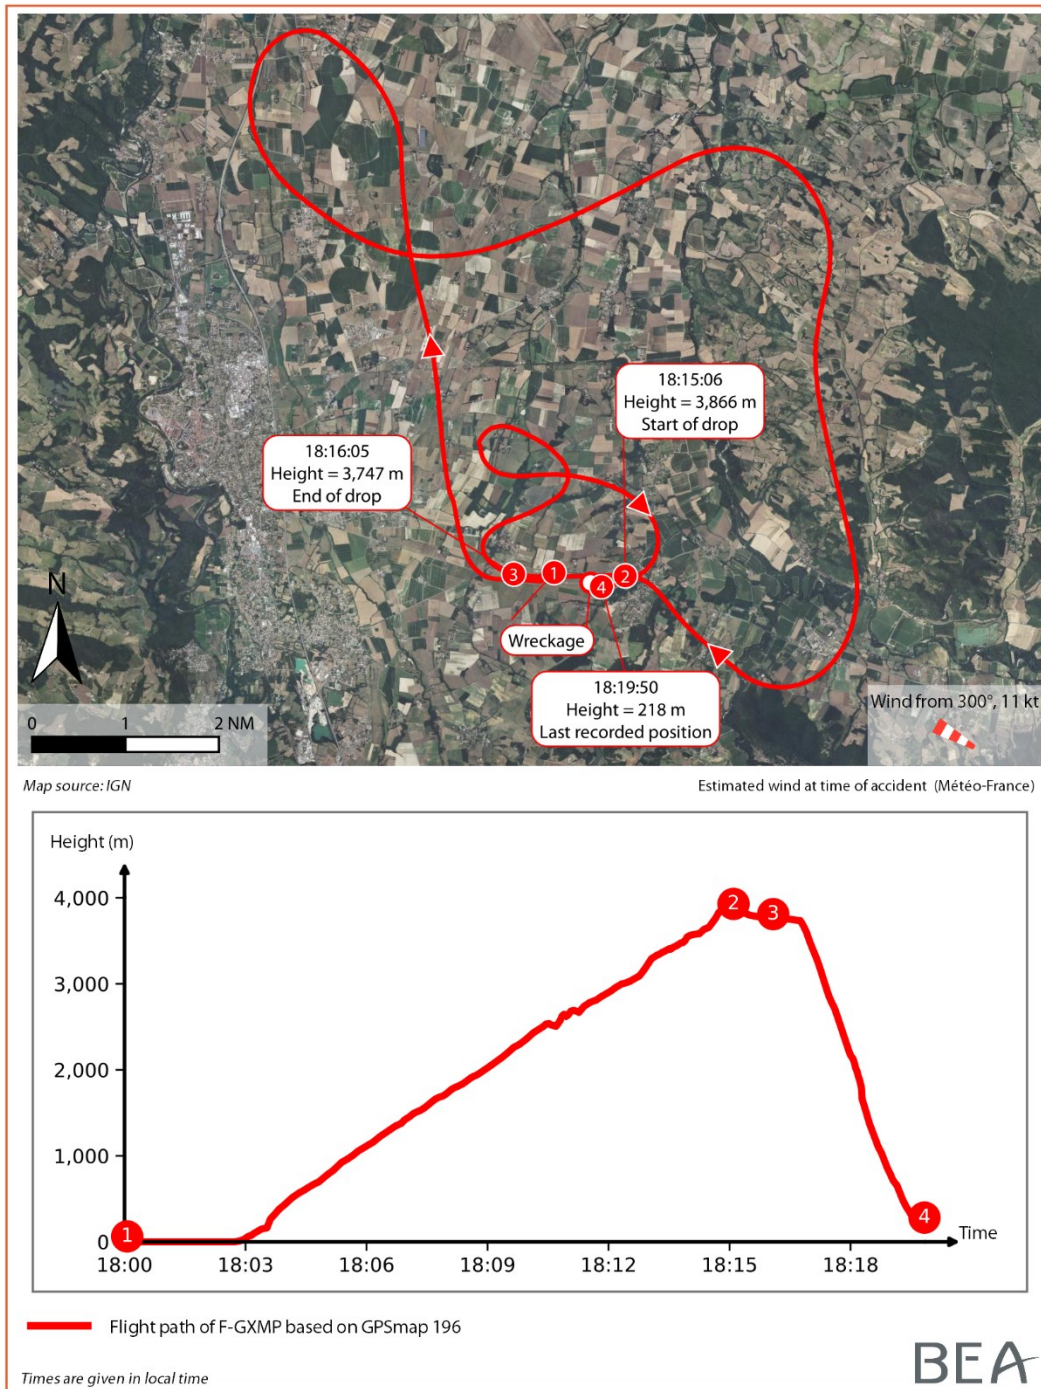
He took off for the fourth rotation, made the drop, landed and shut down the engine. The pilot stated that during start-up for the last rotation for a parachute drop at a height of 4,000 m, the low fuel level indicator lights for each tank illuminated in amber (see *Figure 1*, point ①). The pilot thought he had 85 l in the right tank and 29 l in the left tank. He continued with the start-up with a view to making the flight.

Figure 1: complete path of F-GXMP (Source: BEA)

During the climb, the pilot realised that the fuel gauges were displaying a level close to the minimum. He planned to carry out the drop at a height of 3,000 m, but in the end continued the climb to the drop height. Upon reaching the height of 3,800 m, the low fuel level indicator light for the feeder tank illuminated in red. He asked the 18 parachutists to jump as quickly as possible. The drop lasted around one minute (see *Figure 1* between points 2 and 3).

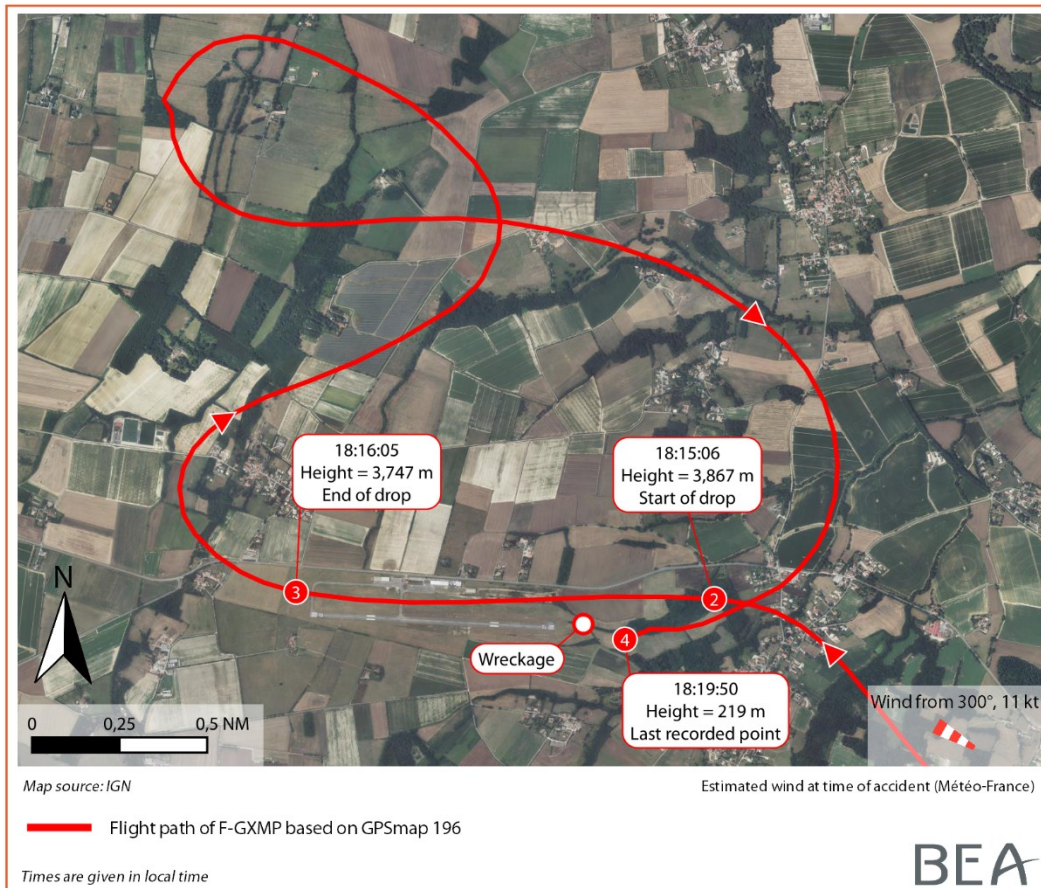
Figure 2: drop and final path of F-GXMP (Source: BEA)

The pilot started the descent with the engine at reduced speed. He distanced himself from the aerodrome, turning northwards to avoid interfering with the parachutists who were landing near the runway. He attempted to increase the power, without success. He understood that he had no fuel remaining, then the engine shut down. At a height of around 500 m, in the base leg, he configured the aeroplane for landing (third flap detent position). The pilot indicated that he decided not to feather the propeller.

On final, he realised that the aeroplane was low on the glide path and fully retracted the flaps in order to reduce the drag. The aeroplane instantly sank whilst the pilot increased the attitude to compensate for this loss of lift. The aeroplane touched down in a grass field located before the threshold of runway 27 and bounced. It ran for several dozen metres before crossing a grove and coming to a stop in a ditch.

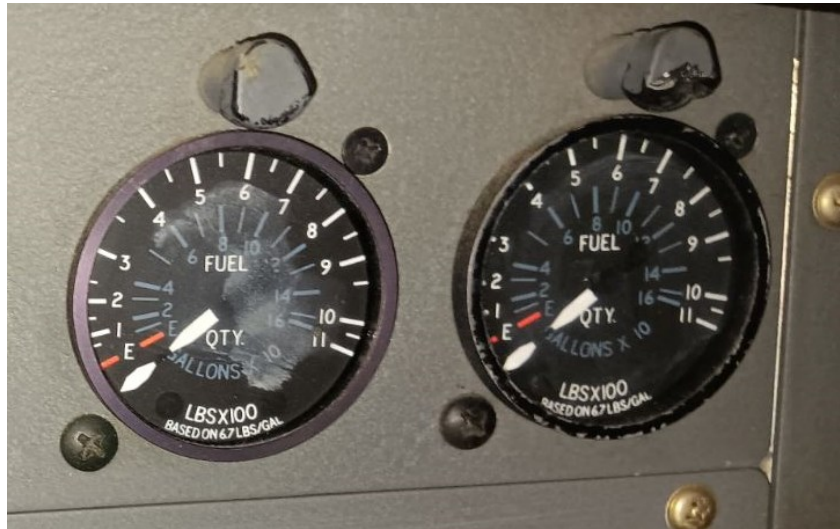
Each tank is equipped with a pointer gauge, graduated in hundreds of pounds (lb) or in tens of gallons (see *Figure 3*). According to the aeroplane flight manual, 100 lb corresponds to approximately 56.5 litres of fuel. A half-graduation therefore corresponds to approximately 28 l, and 1.5 graduations corresponds to approximately 85 l².

Figure 3: tank gauges (Source: pilot)
