**Serious incident** to the ROBIN DR400-160  
registered **F-GYAC**  
on 6 March 2024  
at Nantes-Atlantique airport

**Manual rotation of the propeller, unexpected engine start-up, ground run without a pilot**

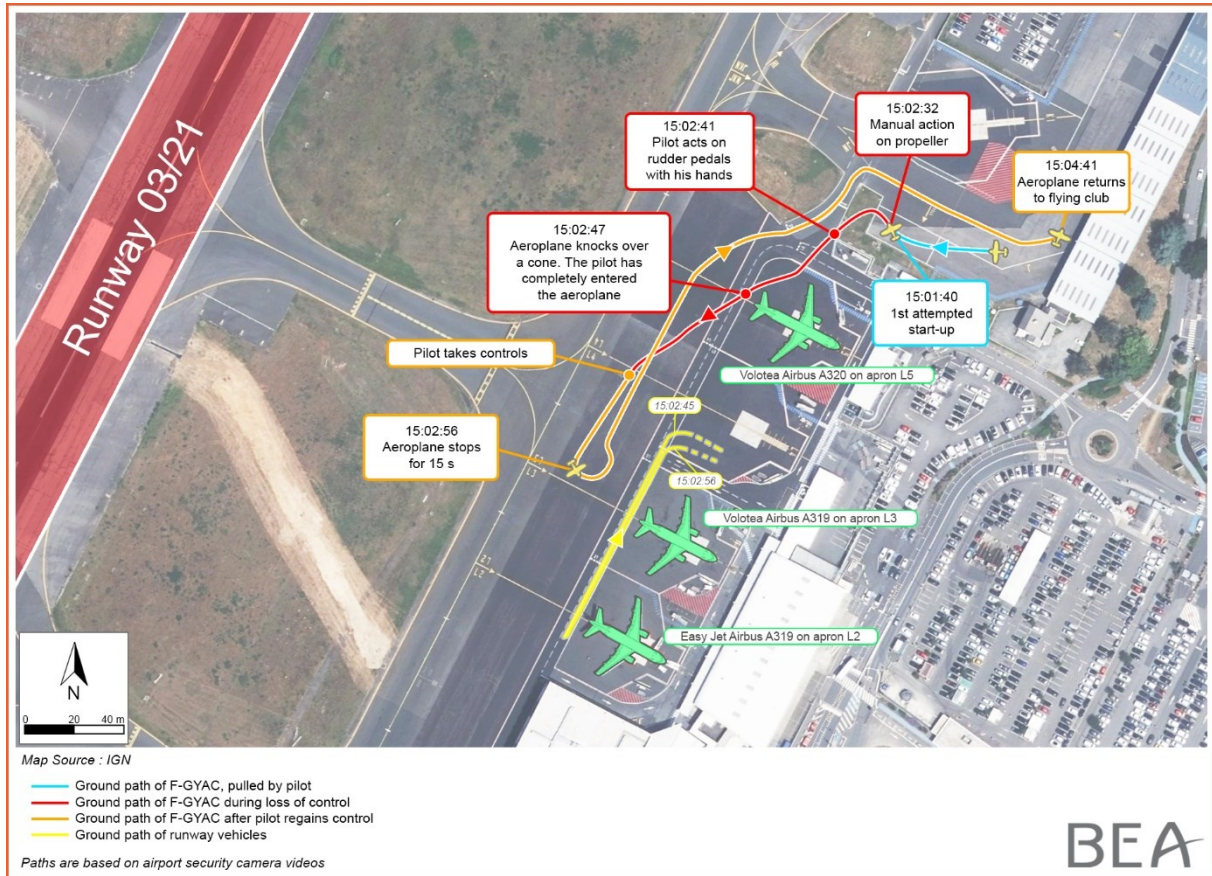
The pilot rotated the propeller and, as it passed the compression point, the engine suddenly started. The pilot quickly moved out of the way and saw that the aeroplane was beginning to move forward. He tried to hold the aeroplane by pushing on the left wing with his hand, which caused the aeroplane to spin to the left. The pilot managed to climb onto the left wing and tried to get on board the cabin. The aeroplane then gained speed and ran on the grass strip towards an A320 parked in the commercial aviation parking area. The pilot tried to reach the cabin again, but the movement of the aeroplane on running through the grass strip prevented him from doing so. However, he managed to enter the cockpit partially and, by bending over, pressed the right pedal with his hand to make the aeroplane turn to the right. He finally managed to get on board and regained control of the aeroplane, which he then brought back to the club.

Figure 1: ground run of F-GYAC (Source: BEA)

Successive use of the starter, without actually starting up, caused the battery voltage to drop sharply. Normal starting using the starter thus became increasingly uncertain. The pilot decided to exit the aeroplane, without an appropriate checklist or any special procedures in this unusual situation.

Before getting out of the aeroplane to examine the propeller, the pilot did not fully apply the parking brake. Moreover, he did not remove the keys from the magneto selector. The throttle control was not in the idle position. The mixture control was in the “full rich” position.

When the pilot rotated the propeller by hand and passed the compression point, the engine suddenly started and the aeroplane began to move forward.

The pilot first tried to stop the aeroplane, without success, then he managed, with difficulty, to climb onto the wing and use his hand to operate the rudder pedal to change the DR400's trajectory and avoid collision with an A320 in the parking area. Finally, he managed to enter the aeroplane and regain control of it.

The non-application of the “engine shut-down” checklist contributed to the unexpected starting of the engine and the running of the aeroplane without a pilot at the controls.

Pilots are trained in the procedure for shutting down the engine at the end of a flight, once they have reached the parking area. They use the aeroplane's checklist to check the actions to be taken. However, in certain unexpected situations during which an event requires pilots to get out of the aeroplane to carry out an external visual check, the pilots generally do not think to go through the "engine shut-down" checklist, which would help ensure they are safe while walking around the aeroplane.
