**Accident** to the ULTRAMAGIC - M105  
registered **F-GYFR**  
on 13 August 2022  
at Bondy

<b>Time</b>	Around 14:15 <sup>1</sup>
<b>Operator</b>	Air Pegasus Montgolfières
<b>Type of flight</b>	Tethered flight, commercial
<b>Persons on board</b>	Pilot and two passengers
<b>Consequences and damage</b>	One passenger injured
This is a courtesy translation by the BEA of the Final Report on the Safety Investigation. As accurate as the translation may be, the original text in French is the work of reference.

**Untimely take-off of the tethered balloon, rapid descent  
and collision with the ground in adverse  
weather conditions**

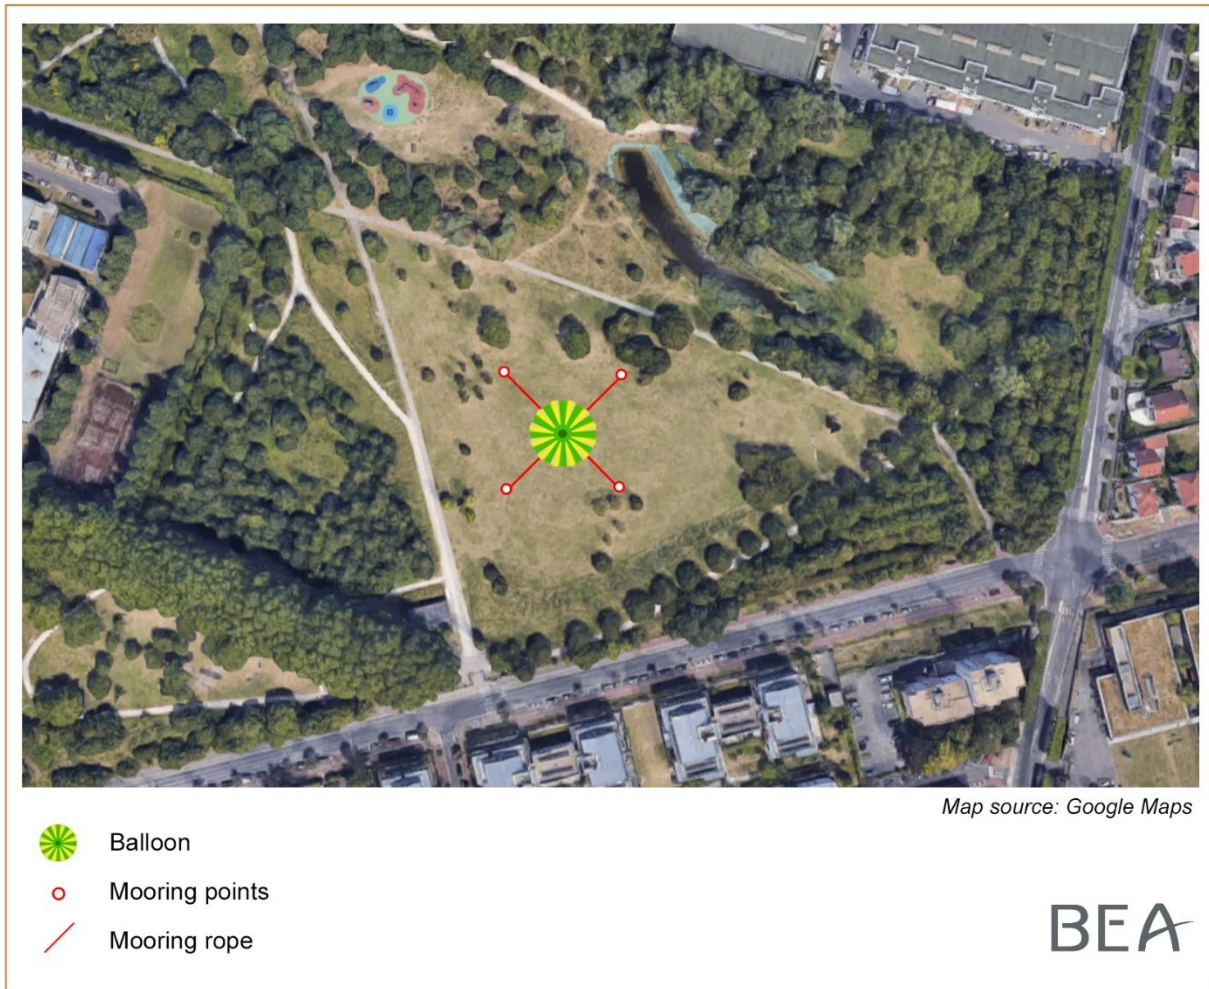
Figure 1: balloon operating site (BEA annotations)

The accident site, a triangle-shaped park with sides measuring between 110 and 150 m, was flat, grassy and bordered by trees. It was located in an urban area, Bondy itself being on the north-east outskirts of Paris.

He indicated that he had set up a windsock and then the balloon at around 14:00 with a crew member. The diagram below shows the plan for mooring the balloon. The pilot chose to set up four mooring points to secure the balloon (see *Figure 1*) even though the envelope was well under 160,000 ft<sup>3</sup> (see *Figure 2* below).

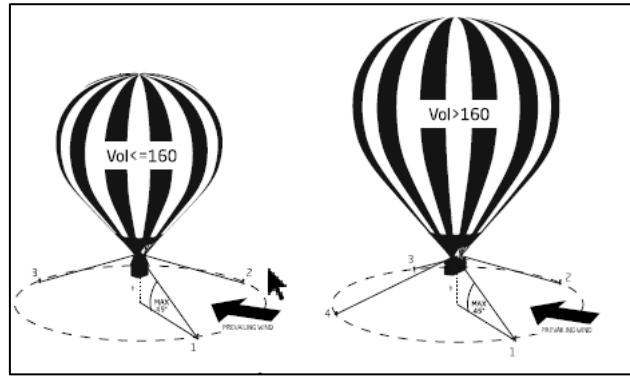
Figure 2: mooring diagram (source: Flight manual)

To be on the safe side, he chose to set up four mooring points instead of the three normally required for this operation.
