Accident to the ROBIN DR400-180 “Regent”
registered **F-GYKM**
on Friday 9 August 2024
at Aire-sur-l’Adour

**Total reduction in engine power during touch-and-go,
forced landing in a field, in instruction**

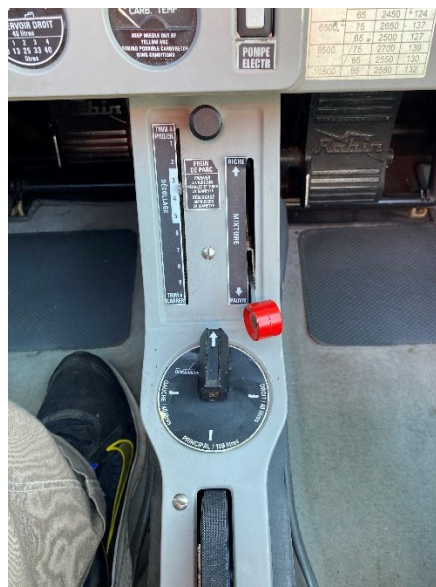
Figure 1: position of the fuel selector valve (Source: BEA)

- the electric pump, fuel selector valve, magnetos, alternator and battery switch were in the OFF position;
- the throttle lever was in the idle position and the mixture lever was in the cut-off position.

A selector valve is located on the instrument panel tunnel (see **Figure 1**). This valve can be used to select one of the three tanks or to close the fuel system.

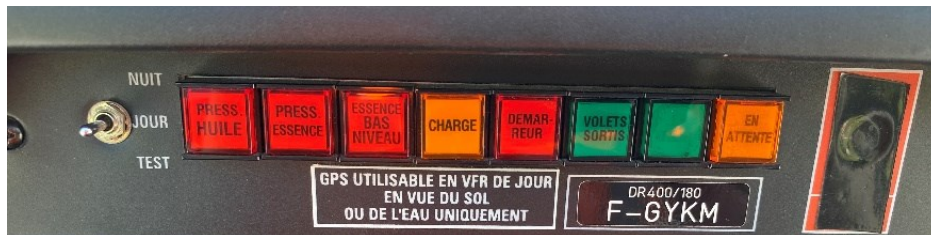
Figure 3: warning strip (Source: BEA)

The fuel pressure warning light illuminates on the warning strip when the pressure measured by the sensor (located between the mechanical pump and the carburettor) is below the defined limit. This can happen in particular when the fuel selector valve is in the OFF position or an intermediate position.

The low fuel level warning light illuminates on the warning strip when the amount of fuel measured by the fuel gauge in the selected tank is below the defined limit² or when the fuel selector valve is in the OFF position or an intermediate position.
