**Accident** to the BOEING - 737- 800  
registered **F-GZHA**  
on 1 October 2022  
on Nantes - Atlantique airport

This is a courtesy translation by the BEA of the Final Report on the Safety Investigation. As accurate as the translation may be, the original text in French is the work of reference.

**Late flare, hard bounced landing, in instruction**

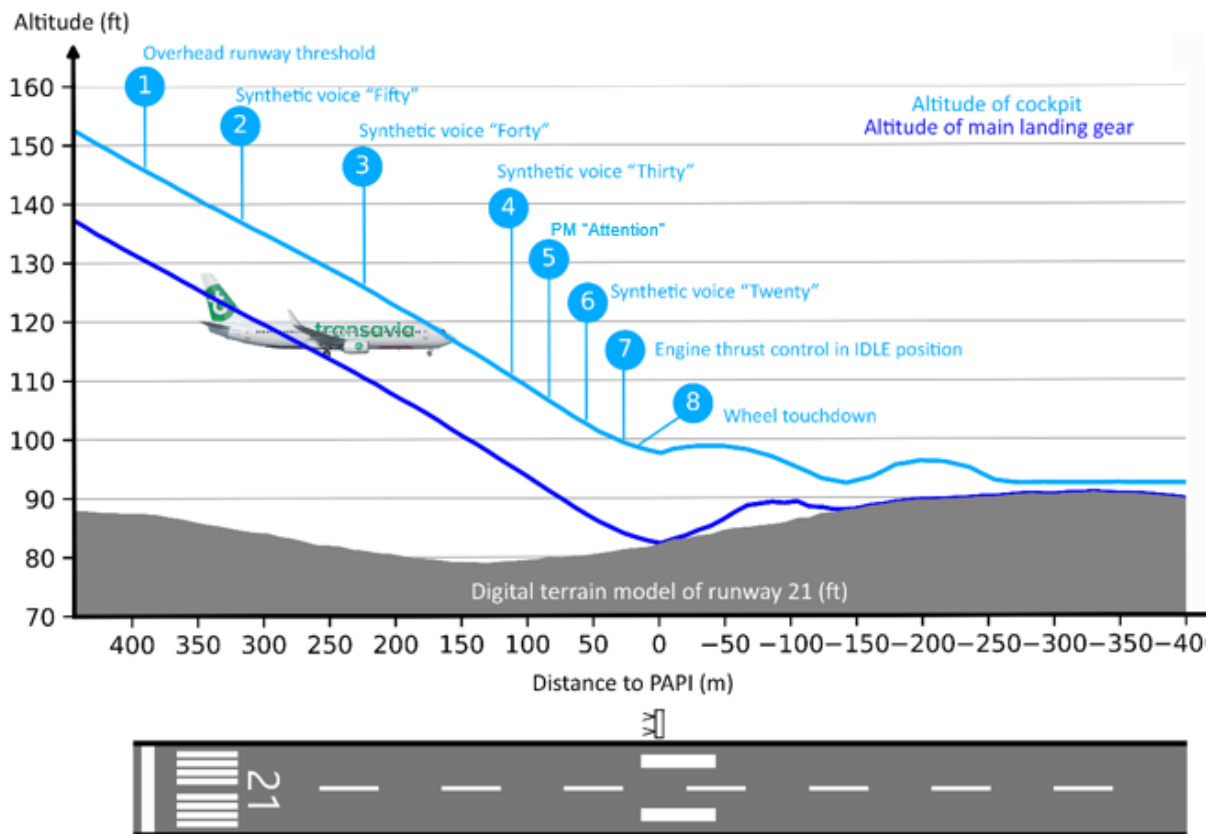
On crossing the threshold of runway 21, at 11:06:10, the aeroplane was at a height of 50 ft with a speed of 158 kt, 2 kt above the Vapp, and decreasing (see Figure 3, point ①). The drift was about 4°, constant until touchdown, and the aeroplane was slight banked to the left. The rate of descent was approximately 800 ft/min. The aeroplane was slightly under the approach slope. Below the height of 50 ft, just before the flare, there was a decreasing headwind.

Figure 3: vertical profile of the landing (source: BEA)

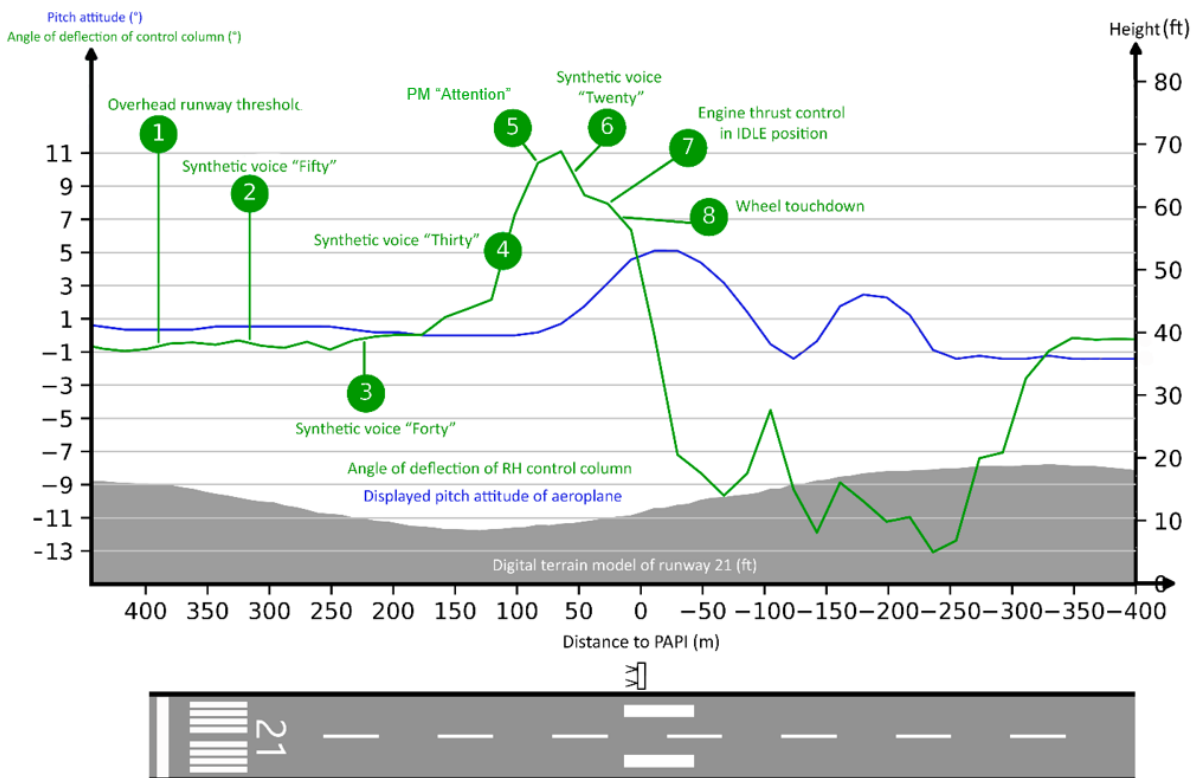
Figure 4: angle of deflection of the column and attitude of the aeroplane (source: BEA)

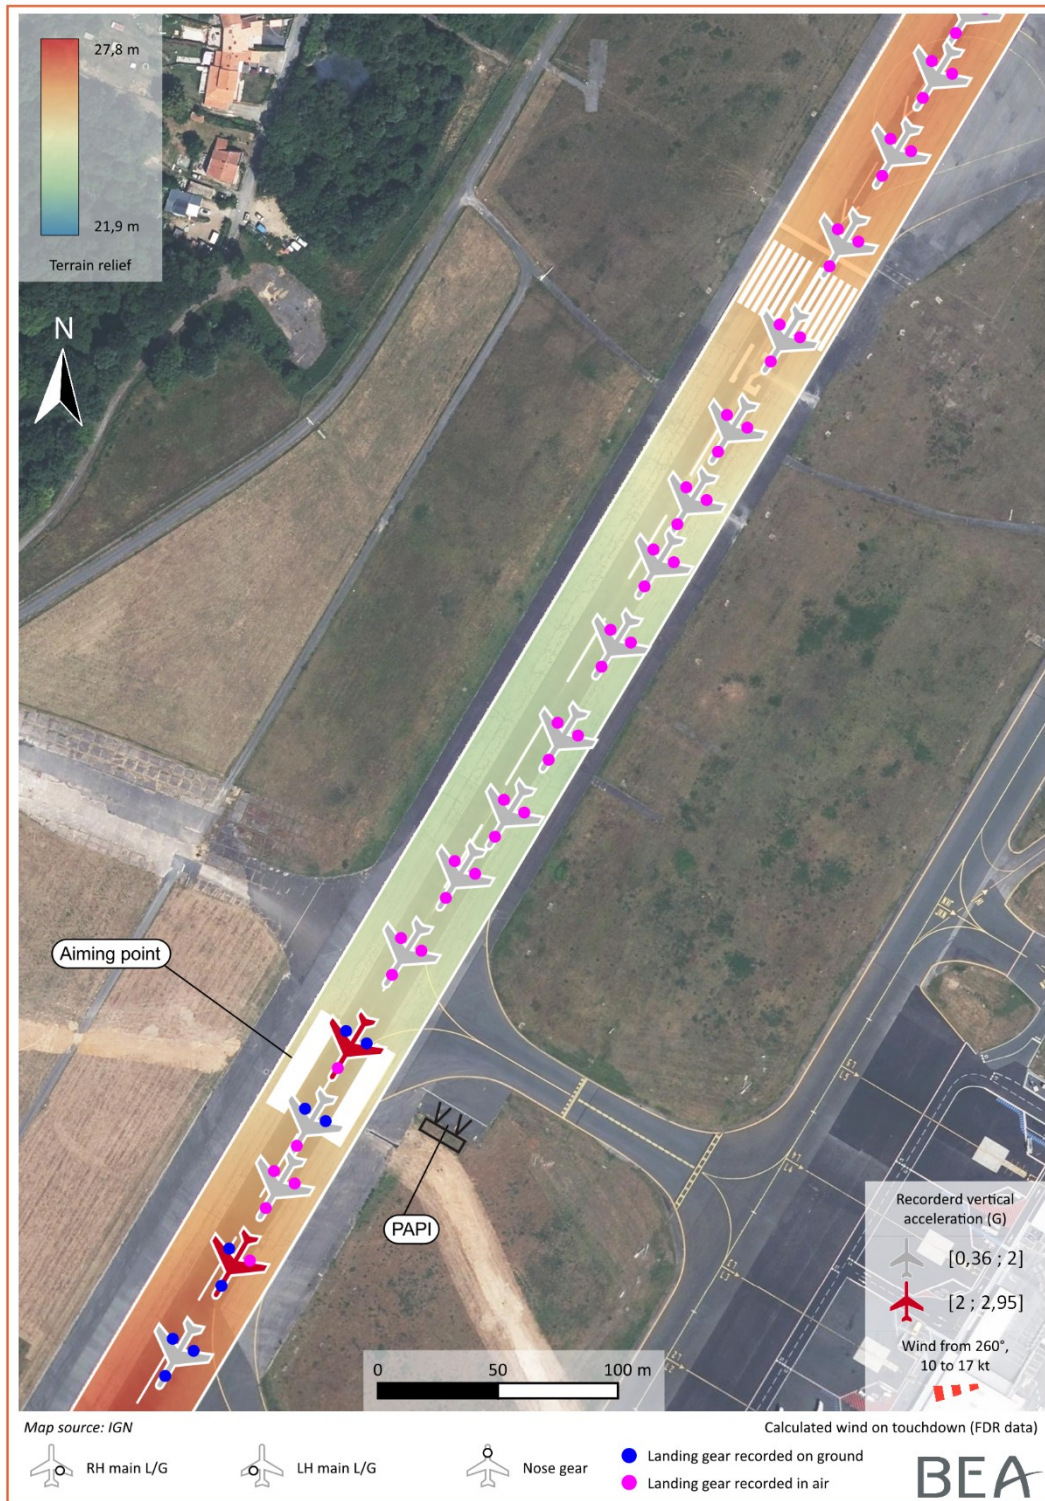
The aeroplane started flying over the upward-sloping part of the runway, about 110 m from the beginning of the touchdown zone markings. The speed was 2 kt below  $V_{app}$ , still decreasing, and thrust was still stabilised at 57% of N1. Shortly after the “thirty” callout (Figure 4, point 4), the instructor warned the co-pilot to watch out, calling out “Attention” (point 5). The pitch attitude, which was stable and close to 0°, started to increase. Less than one second later, after the “twenty” callout (point 6), approximately 30 m from the touchdown zone markings, the co-pilot moved the thrust levers to the IDLE position. The aeroplane’s pitch attitude was then 3° and increasing.

Figure 5: final path, flare and touchdown

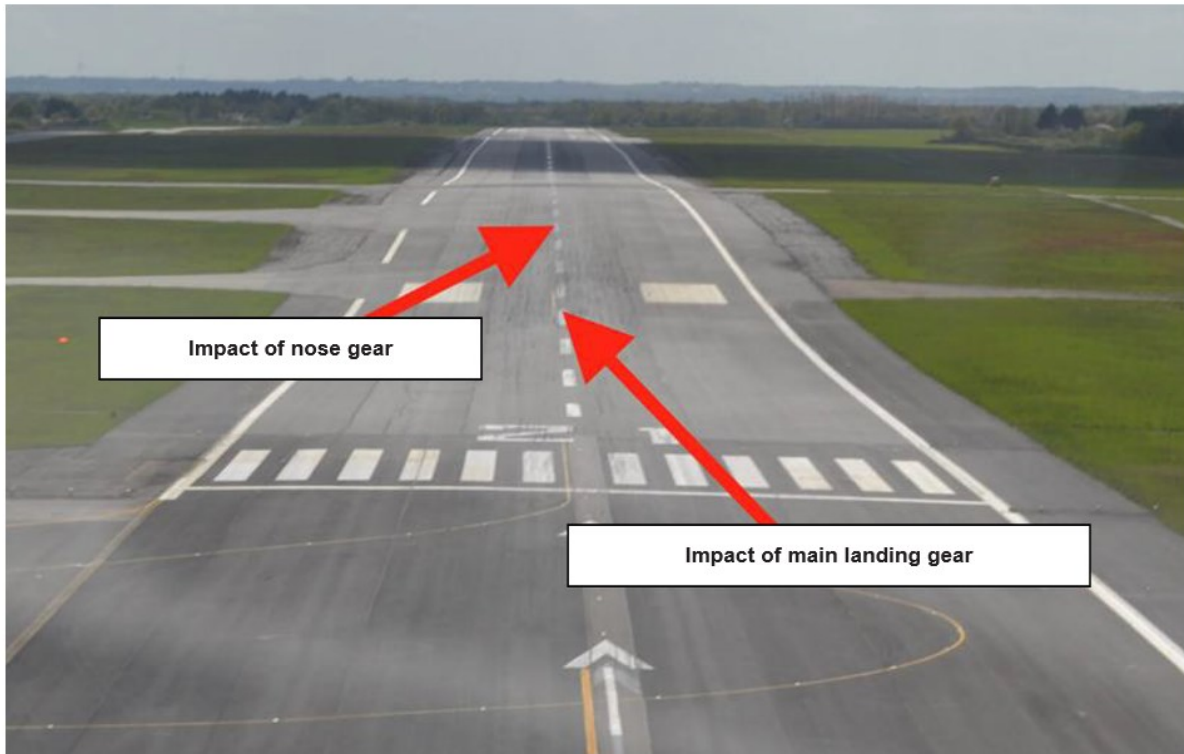
The right and nose landing gears contacted the runway (normal load factor recorded at 2.17 g), still on its upward-sloping part (gradient of around 1.32%). The two tyres on the nose landing gear burst and separated from the rims. On second contact with the runway, the aeroplane's attitude was 1.4° nose down. The left main landing gear contacted the runway shortly after the other two landing gears. The normal load factor increased to 2.2 g. As soon as the aeroplane was on the ground again, the instructor applied another nose-down input, this time to full deflection. As for the co-pilot, he deployed the thrust reversers. The aeroplane continued running on the runway, remaining on the centreline.

Figure 6: impact marks from the landing gears (source: Transavia)

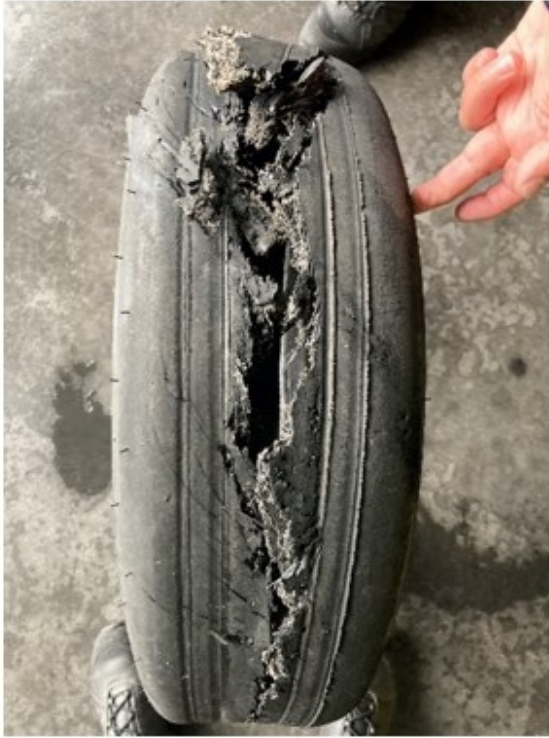
The two tyres of the nose landing gear burst and were ejected on first contact with the ground (see Figure 7).

Figure 7: burst tyre (source: BEA)

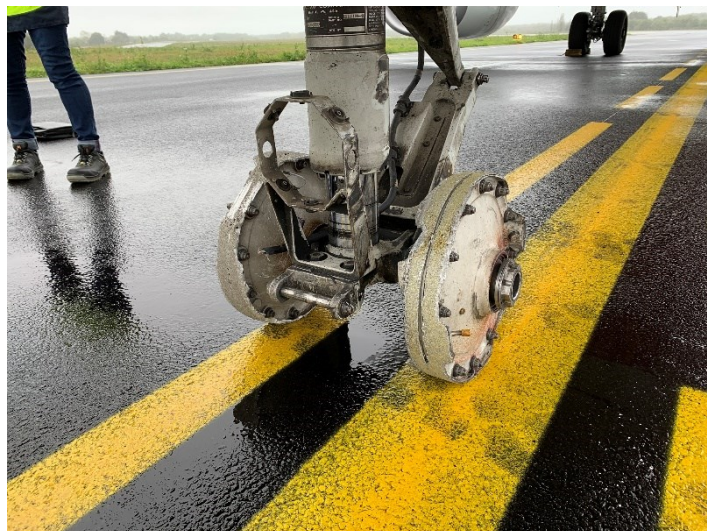
The nose landing gear rims failed between the bead seating area and the rim flanges (see Figures 8 and 9). These were also ejected between the point of contact with the ground and the moment when the aeroplane came to a stop.

Figure 9: ruptured wheels of nose landing gear (source: BEA)

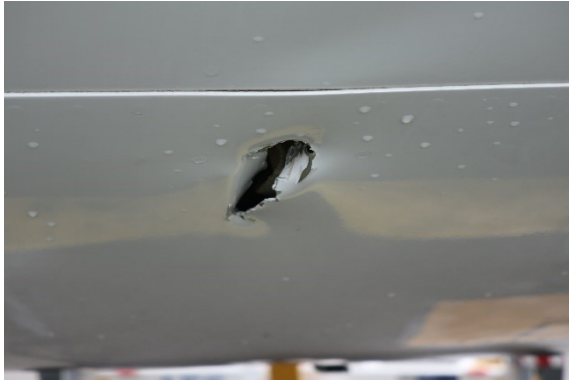
The nose landing gear was damaged in several places and its casing was distorted. The aeroplane's frame located in line with the nose landing gear was distorted. The airframe and engines showed several signs of impact, very probably caused by parts of the wheels and tyres when they detached (See Figures 10 and 11).

Figure 10: example of damage observed on the airframe (source: BEA)

Some damage required repairs. This was the case for the nose landing gear, its casing and some of the aeroplane's bulkheads located nearby. Several impacts caused by debris projected following the failure of the nose wheels also gave rise to repairs.

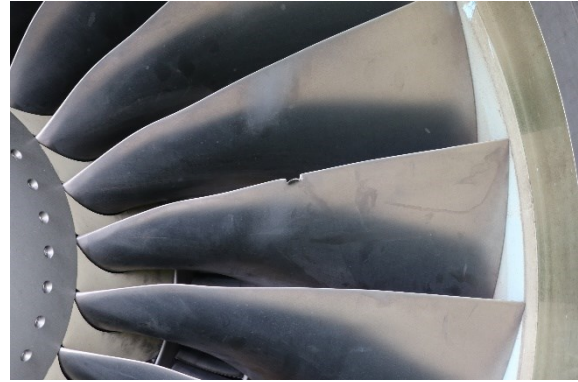
Figure 11: example of damage observed on engines (source: BEA)

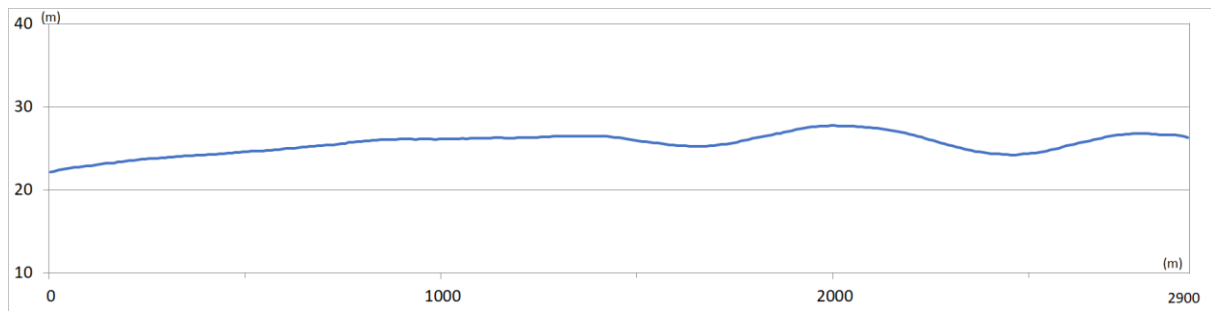
*Figure 13: elevation profile of the runway from threshold 03 to threshold 21  
(source: runway measurements carried out by the airport operator in 2022)*

This succession of slopes takes a shape that pilots identify as a “hump” in the area of the touchdown zone markings, which start 380 m from the threshold of runway 21.

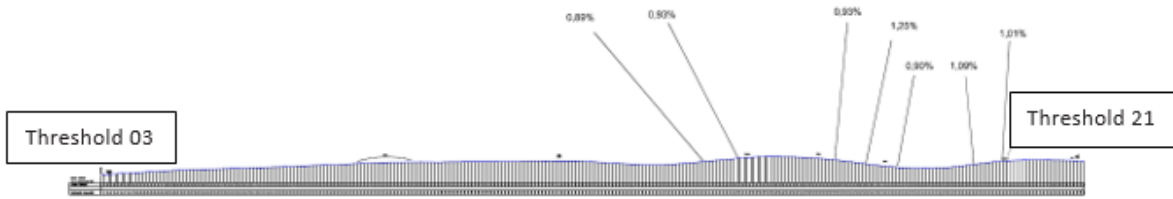
1. The maximum longitudinal slope of the runway is 1.25% on a section of runway located in the last quarter of runway 03 or, in other words, in the first quarter of runway 21 (see Figure 15). This is higher than the slope specified in the certification requirement, which provides for a maximum slope of 0.8%.
2. The blending radii between successive slopes are smaller than those required. These radii may therefore increase the vertical normal load factors on landing or take-off for aircraft with high landing and take-off speeds. It should be noted that at the time the safety study was drawn up, no safety event or difficulty during landing or take-off had been reported in connection with the runway profile.

Figure 15: profile of runway 03/21 at Nantes-Atlantique  
(source: operator's safety study 2015)

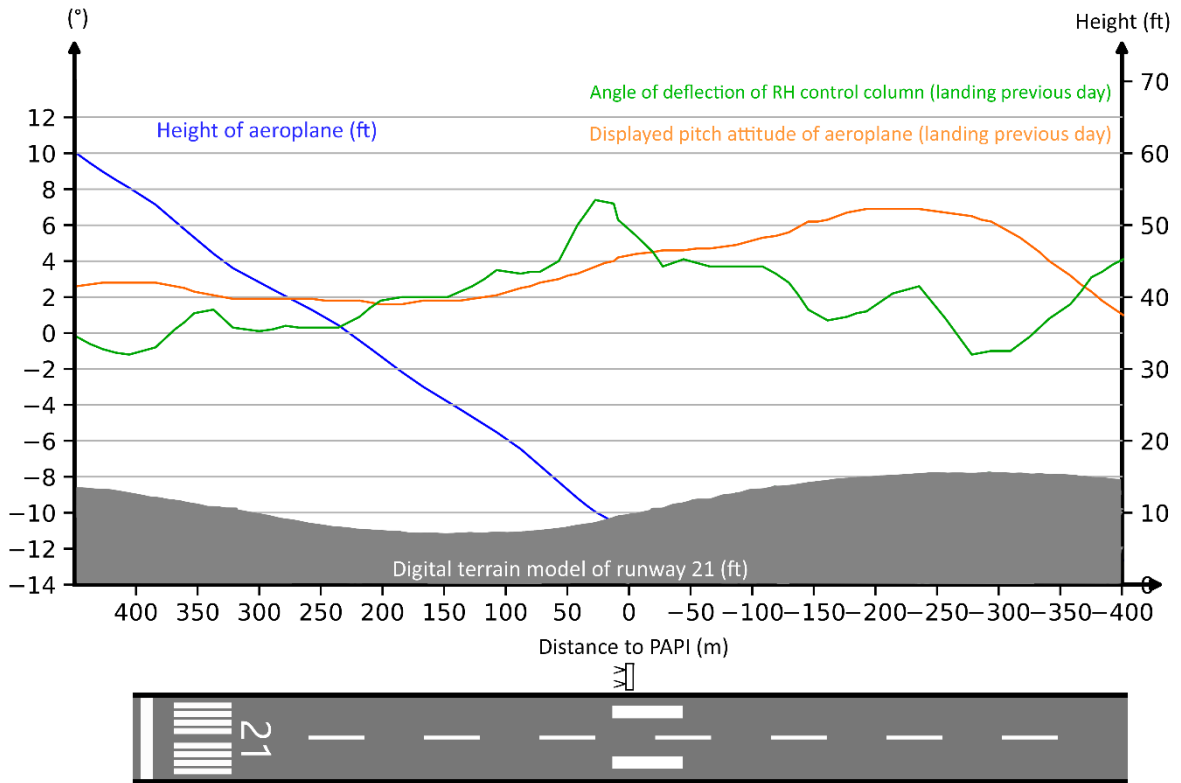
Figure 19: angle of deflection of column during landing on previous day (source: BEA)

During the landing at Nantes on the previous day, the co-pilot was PF. He started the flare about 220 m from wheel touchdown at a height of 37 ft, with a slight nose-up input (2° of control column deflection) which did not affect the aeroplane’s pitch attitude. When the aeroplane reached the runway depression, he then made a more gradual input by pulling on the control column by a deflection of just over 3°. The aeroplane’s pitch attitude then started to increase gradually.

At a height of approximately 20 ft, he continued his input on the elevator control in a more pronounced manner up to a position of 7.5°, whilst the aeroplane’s pitch attitude continued to increase linearly until it reached around 4.5°. At the same time, the co-pilot instantly reduced the aeroplane’s thrust by moving the levers to the IDLE position. When the wheels touched down, the normal load factor was 1.7 g.

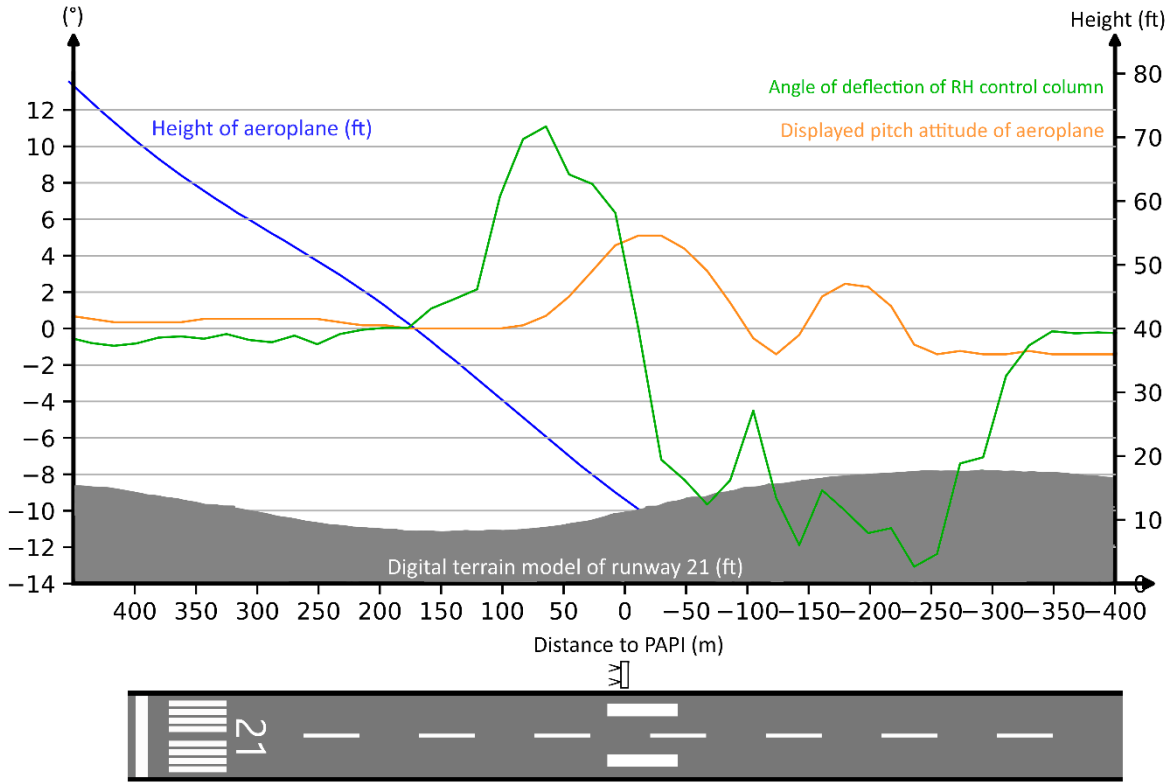
Figure 20: angle of deflection of column during accident landing (source: BEA)

The flare on the previous day had some similarities with the flare of the occurrence, in particular as regards the pitch attitude taken, the marked nose-up input and the late reduction in thrust just before touchdown (not illustrated in the previous figures).
