Accident to the KUBICEK Balloons BB45Z registered F-HAOK on 31 August 2021 at Saint-Germain-Laval (Loire)

Hard landing, bounce, basket upset, injury to a passenger, during a sightseeing flight

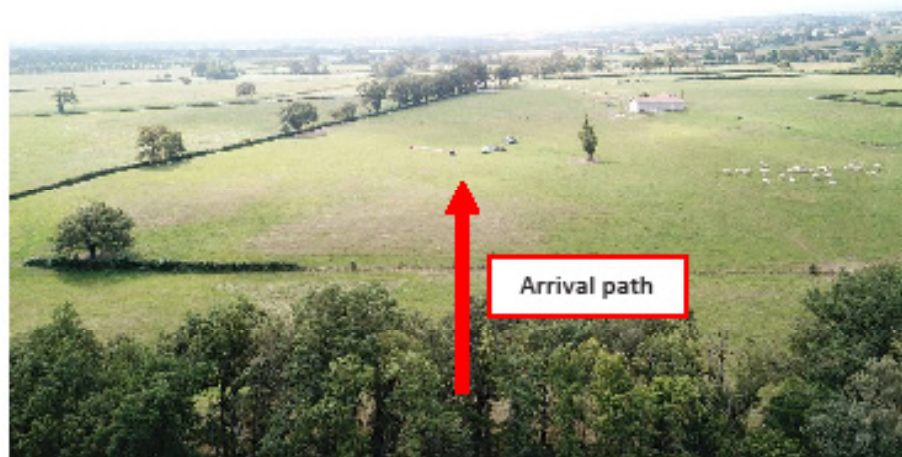
He chose a large field bordered by a line of trees (between five and ten metres tall) for the landing, which he approached from the north. He informed the passengers of the risk of a hard landing and asked them to adopt the safety position that he had demonstrated at the start of the flight. During the landing, after flying over the trees, the basket hit the ground hard and bounced. The basket fell onto its side on making the second contact with the ground and was dragged for about 30 m before coming to a halt approximately 80 m after the line of trees. One passenger fractured her leg.

Figure 1: photo of the accident site

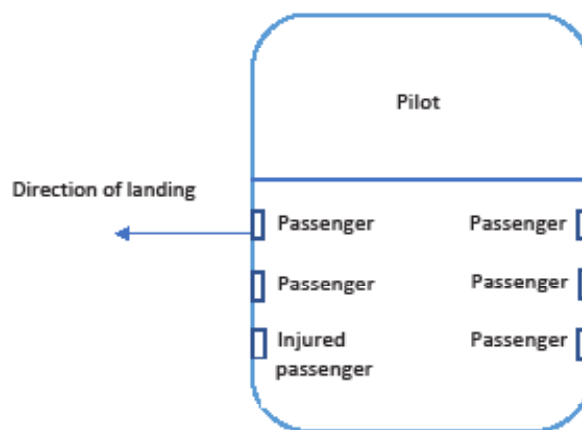
During the accident flight, the six passengers and the pilot were positioned as shown in Figure 2 below. The passengers were facing the basket walls. Three of them, including the injured passenger, were therefore positioned facing the direction of landing, and the other three were positioned with their backs to the direction of landing. This configuration was that recommended in the flight manual.

Figure 2: diagram showing the basket configuration during the accident flight

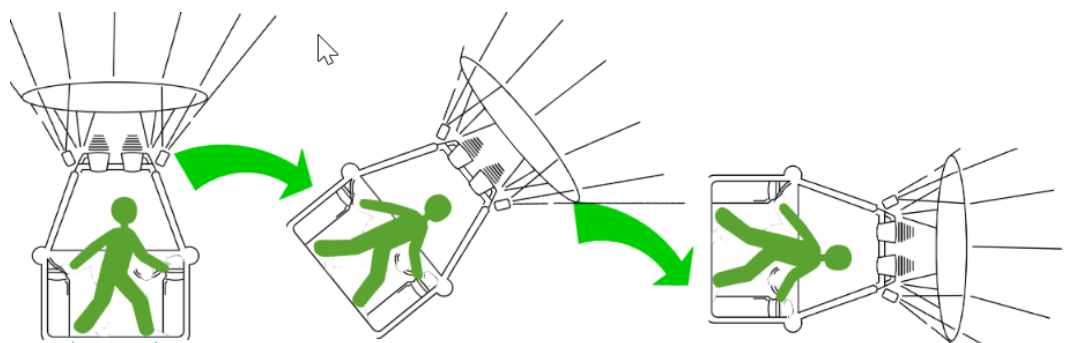
In 2018, the French civil aviation authority (DGAC) published [safety instructions regarding the implementation and the operation of hot air balloons](#). These instructions include a figure that shows the guidelines for landing with a non-partitioned basket. They stipulate turning your back to the direction of landing if there is enough room, otherwise to adopt a sideways position, facing the path. The DGAC intends to contact the French Aerostation Federation (FFAé) to ask for its opinion on the best safety practice and to modify the guide, as necessary.

Figure 3: illustration of the position to adopt in a non-partitioned basket, as specified in the safety instructions published by the DGAC

- the impossibility for some of the passengers to adopt the safety position recommended by the DGAC, back to landing, due to the basket configuration (non-partitioned);
- the age of the passenger, which the pilot had not known before the take-off, and which made her more vulnerable. She had also not told the pilot about her osteoporosis.

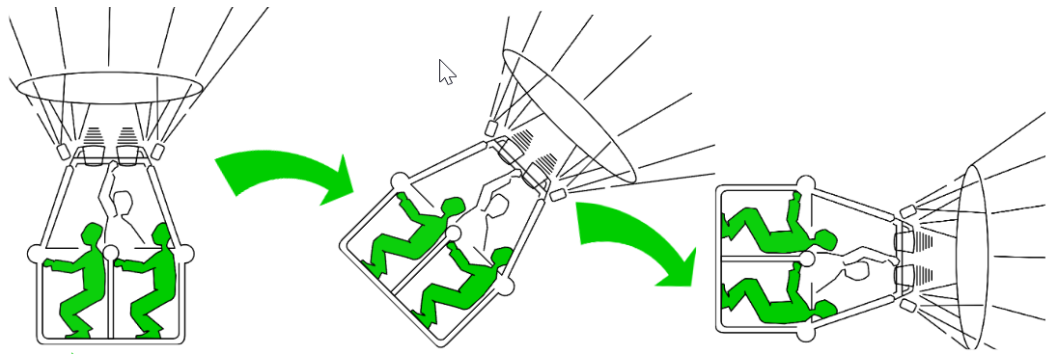
In the case of a partitioned basket, the instructions recommend turning your back to the direction of landing (see Figure 4).

Figure 4: illustration of the position to adopt in a partitioned basket, as specified in the safety instructions published by the DGAC
