**Accident** to the ROBINSON R44 Raven II  
registered **F-HATU**  
on Saturday 9 September 2023  
on Issoire - Le Broc aerodrome

**Loss of yaw control during landing, rollover**

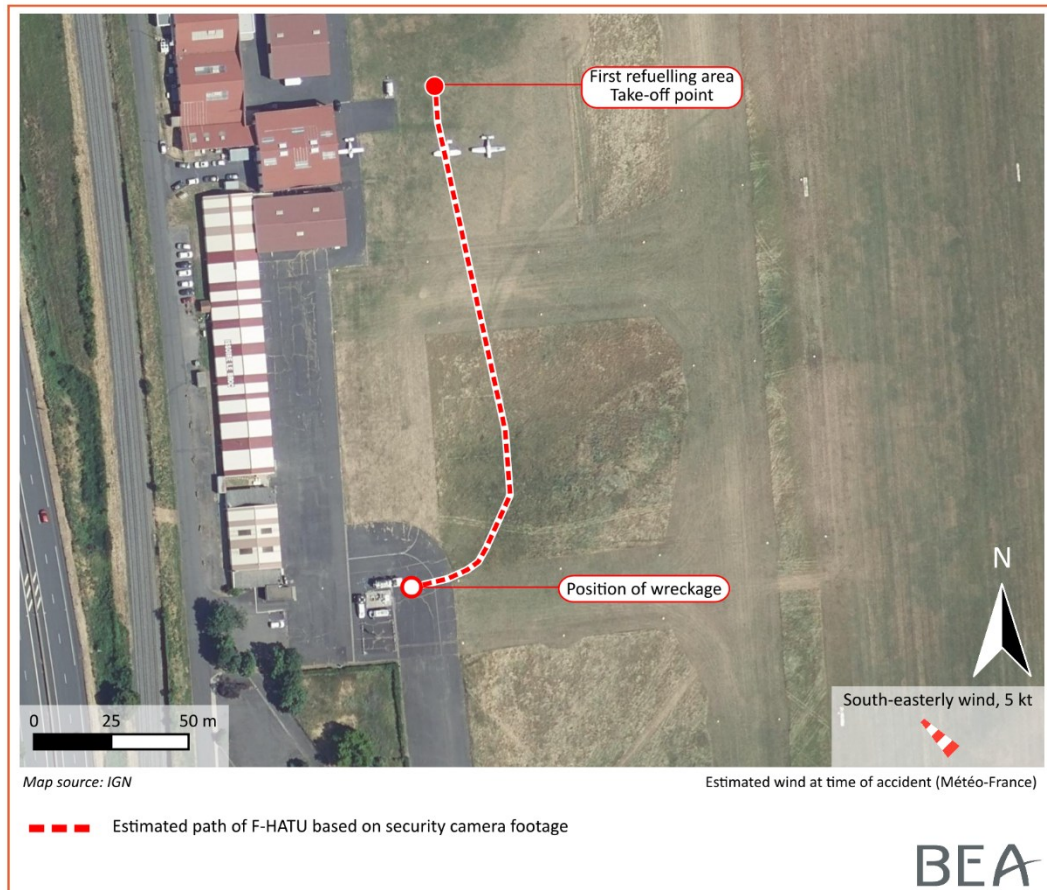
The accident occurred close to a refuelling station, on paved ground (see **Figure 1**).

Figure 1: accident site on Issoire - Le Broc aerodrome

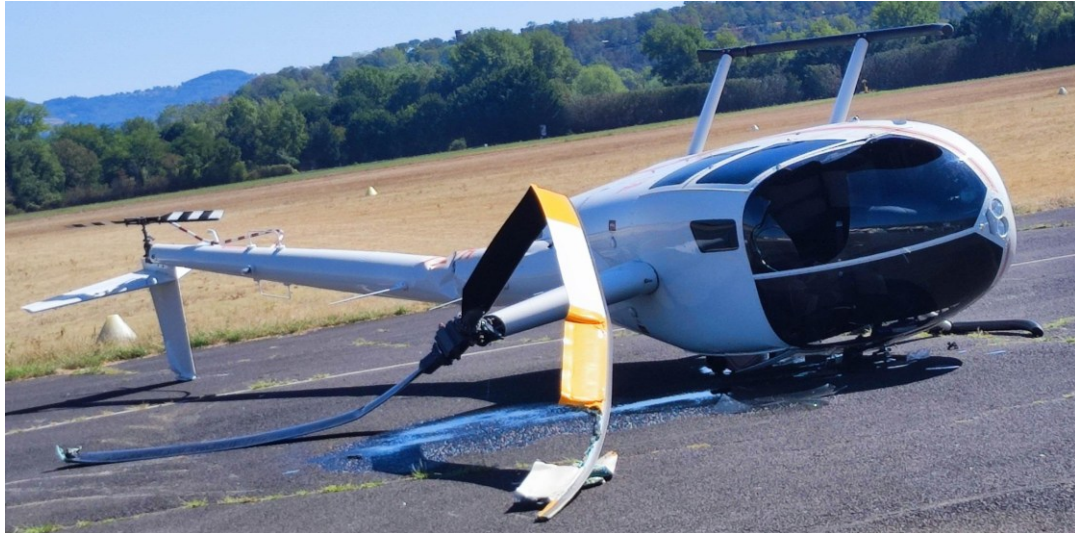
Marks could be observed on the ground, corresponding to the rubbing of the skids and the contact of the main rotor blades when the helicopter rolled over. The wreckage was lying on its right-hand side (see **Figure 2**).

Figure 2: wreckage on accident site (source: BEA)

The examination of the wreckage did not reveal any mechanical failure which could explain the accident. It was observed, in particular, that:

- the deformations of the drive shaft connecting the main gearbox to the tail gearbox indicated the presence of engine drive torque at the time of the accident;
- all the components of the tail rotor drive were functioning normally;
- the connection between the main rotor and the tail rotor drive shaft was nominal;
- the tail rotor blades did not show any significant damage. Each blade freely moved around its pitch change axis with no friction points;
- the mechanical controls of the propulsion system were functional. After energizing the power system, the clutch and the associated light on the instrument panel were functional.
