Accident to the KUBICEK - BB26 - E
registered **F-HBBQ**
on 23 September 2021
at Chambley aerodrome

Time	07:38 ¹
Operator	Private
Type of flight	Instruction
Persons on board	Student pilot
Consequences and damage	Instructor seriously injured

Tethered flight take-off, in solo instruction, fall of instructor hanging from the guide rope

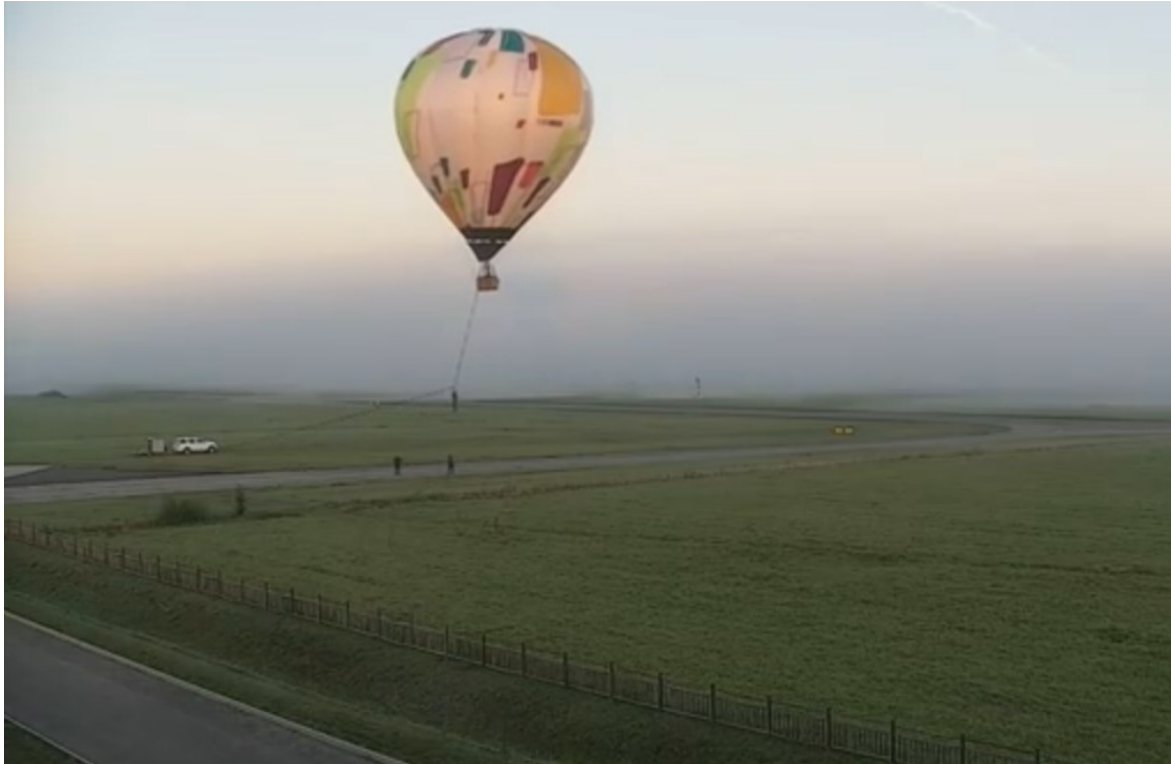
He found himself hanging from the taut guide rope. At a height of around eight metres, he let go and fell onto paved runway J.

**Figure 1: video recording just before the instructor let go
(source: surveillance video from Chambley aerodrome control tower)**

The combination of the reduction in weight and the heating of the envelope caused the hot-air balloon to quickly climb. The instructor had a reflex action and grabbed the guide rope connecting the vehicle to the balloon to act as a counterweight and to try to slow down the balloon's ascent speed. He then let go.

It is important to bear in mind that last-minute changes of plan, even for a flight that may seem simpler, involve risk factors that need to be taken into account and analysed carefully.
