**Incident** to the ATR72-212A  
registered **F-HBCM**  
operated by Chalais Aviation  
on Saturday 21 September 2024  
on Caen-Carpiquet airport

## Take-off with an erroneous centre of gravity

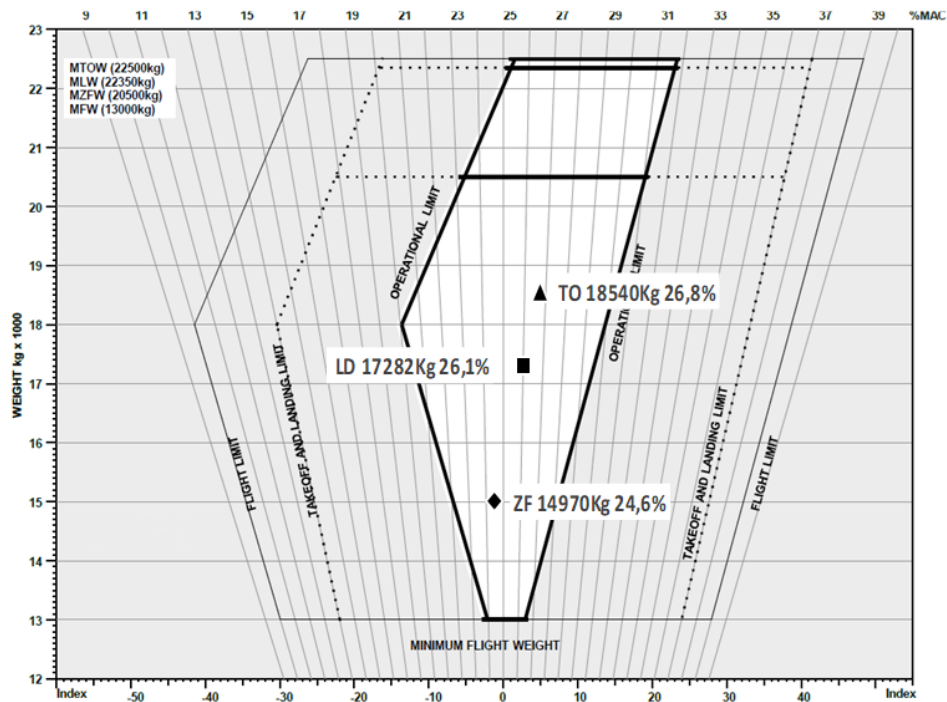
Chalair estimated that the centre of gravity value was 15.9 % MAC on taking off from Caen - Carpiquet airport during the incident flight. This value was outside the operational limits (see Figure 2 and Figure 3) but was within the certified weight and balance envelope for take-off and landing.

Figure 2: weight and balance chart with a DOI of 15.5, as entered by the station agent for the incident flight, implying a certain passenger seat allocation in the cabin (source: Chalair)

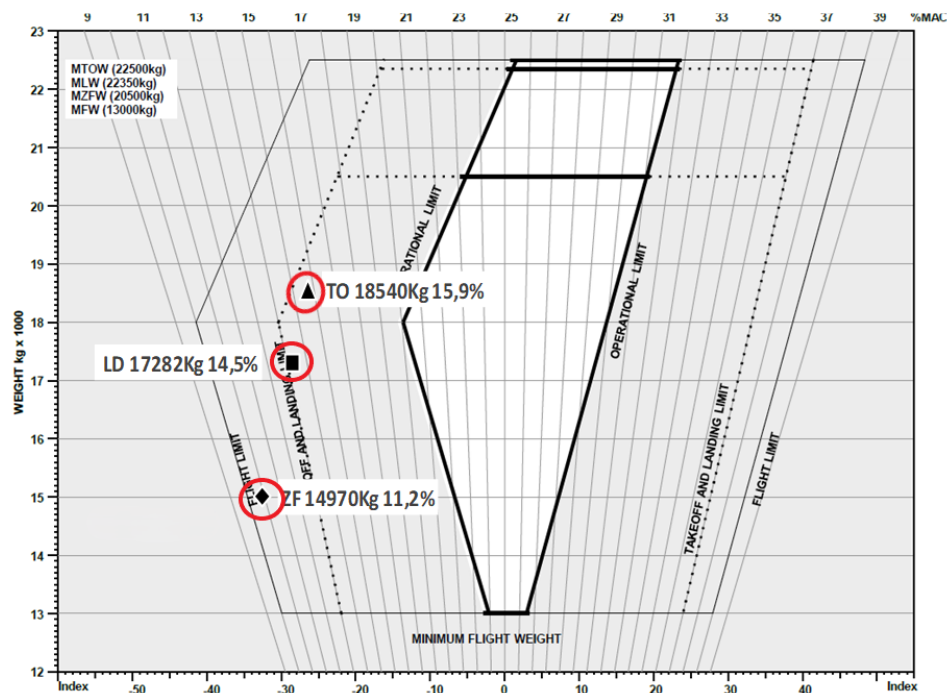
Figure 3: weight and balance chart with a DOI of -15.5 with an identical passenger seat allocation in the cabin (source: Chalair)

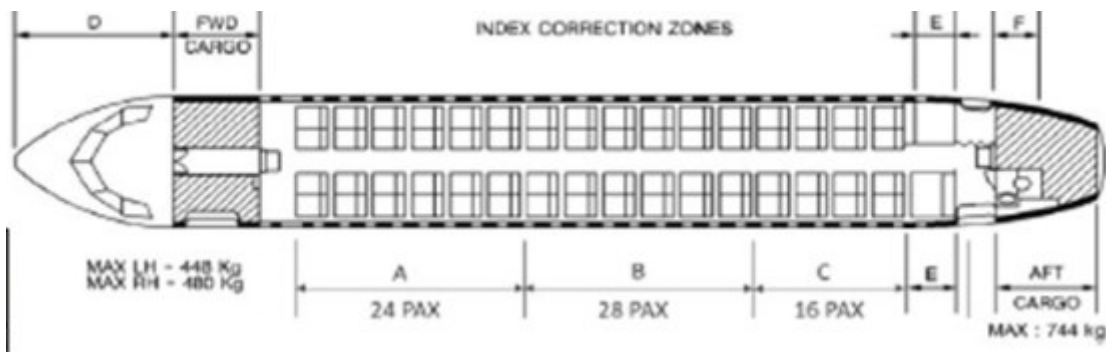
- The first simulation showed that an additional difference of 1.1% MAC with respect to the centre of gravity for the incident flight would have meant that the aeroplane was outside the weight and balance envelope for take-off and landing. This limit would have been exceeded on transferring a weight of 50 kg from zone C to zone A, 110 kg from zone C to zone B or 90 kg from zone B to zone A. On taking a standard passenger weight of 88 kg, this corresponds to moving **one** passenger from zone C to zone A, **two** passengers from zone C to zone B or **two** passengers from zone B to zone A.

Figure 4: diagram of F-HBCM cabin (source: Chalair)
