Incident

between the EMBRAER ERJ190 registered **F-HBLJ**
and the ATEC 321 identified **84OM**
on Wednesday 5 June 2024
at Marseille – Provence airport

Airprox between a passenger commercial air transport aeroplane carrying out a go-around and a microlight in cruise

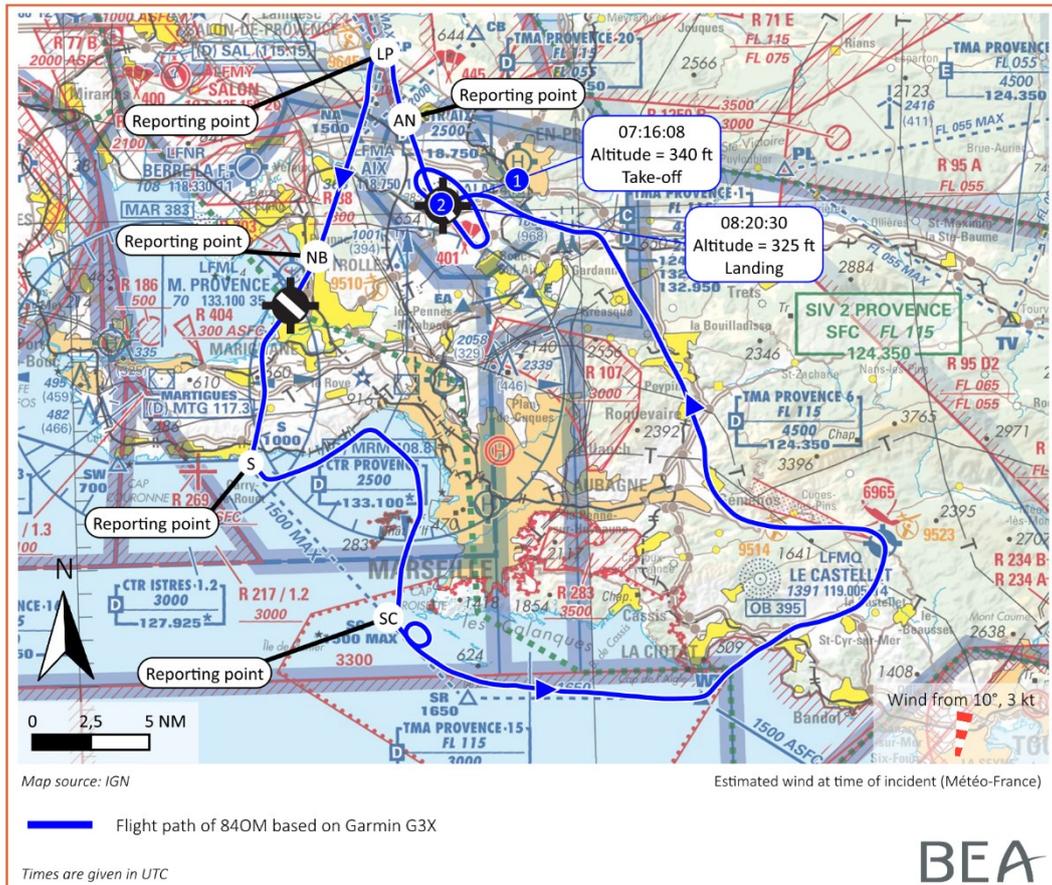
Figure 1: flight path of microlight (map source: IGN 1:500,000)

The pilot explained that he had already flown through the Provence CTR six or seven times. As Aix-les-Milles aerodrome was operating with the A/A frequency, he had planned to exit the Aix CTR at reporting point AN before joining reporting point LP to enter the Provence CTR (see **Figure 1**).

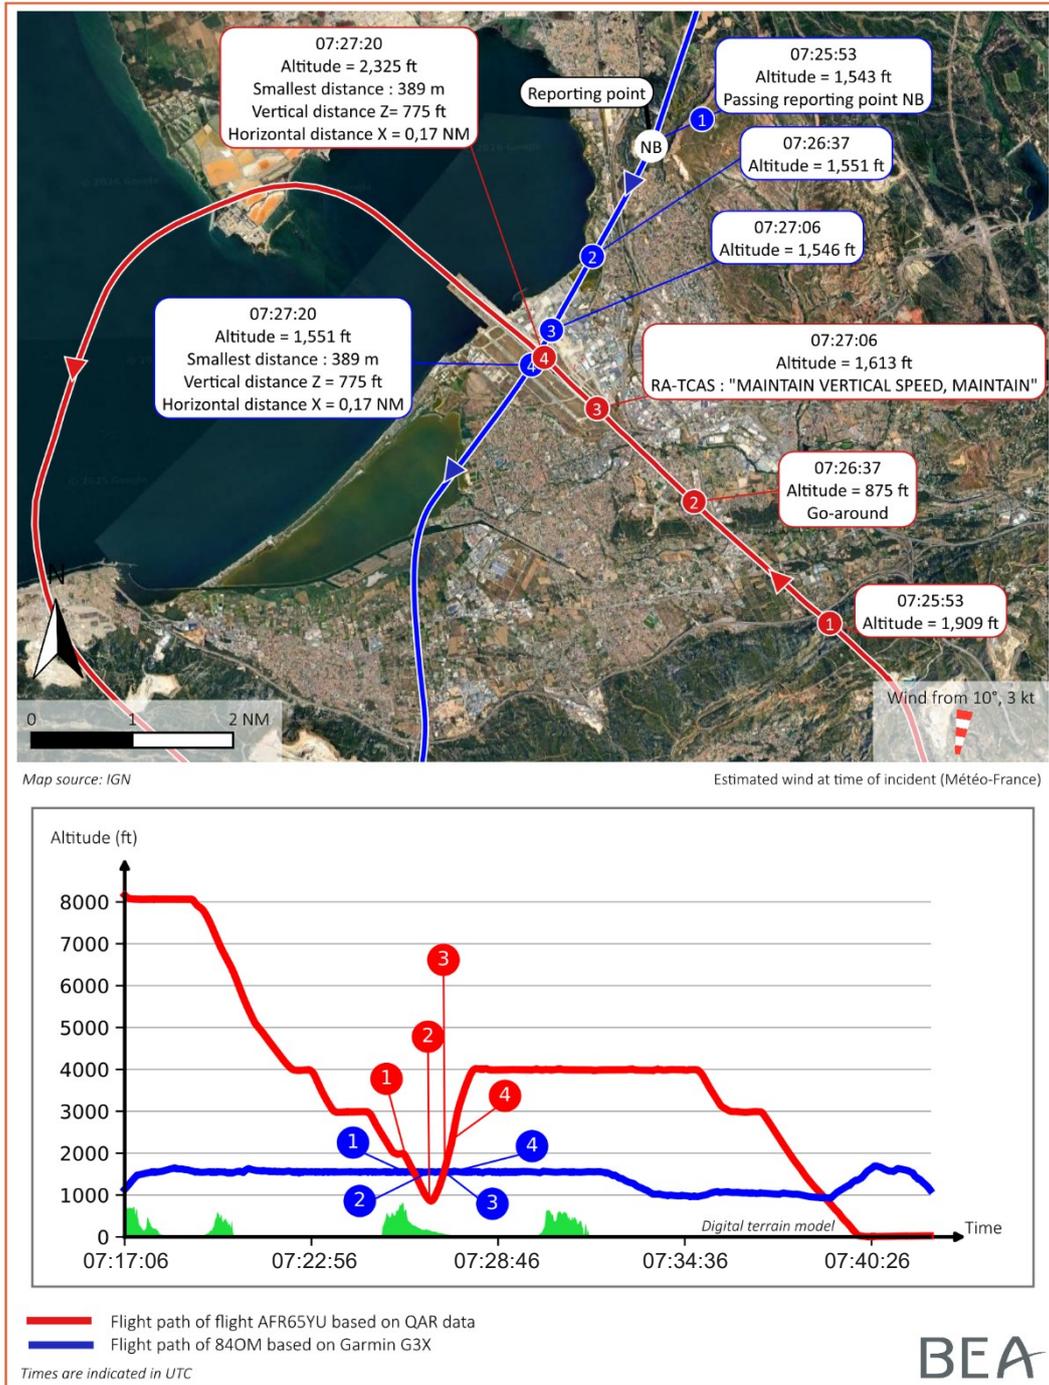
At 07:27:06, a TCAS TA alert, followed by a TCAS RA to “MAINTAIN VERTICAL SPEED, MAINTAIN,” was triggered on board flight AFR65YU. In climb, the flight path of flight AFR65YU crossed that of the microlight with a minimum separation of 389 m (0.17 NM horizontally and 775 ft vertically).

Figure 2: crossing of both aircraft

As the microlight approached the runway axis, the crew of flight AFR65YU, on final for runway 31R, realized they were not stabilized and decided to reject the approach. The go-around flight path of flight AFR65YU conflicted with that of the microlight, and the pilots of the two aircraft were not aware of each other's respective positions. A TCAS alert was triggered on board flight AFR65YU and the minimum separation between the two aircraft was 389 m (0.17 NM horizontally and 775 ft vertically).

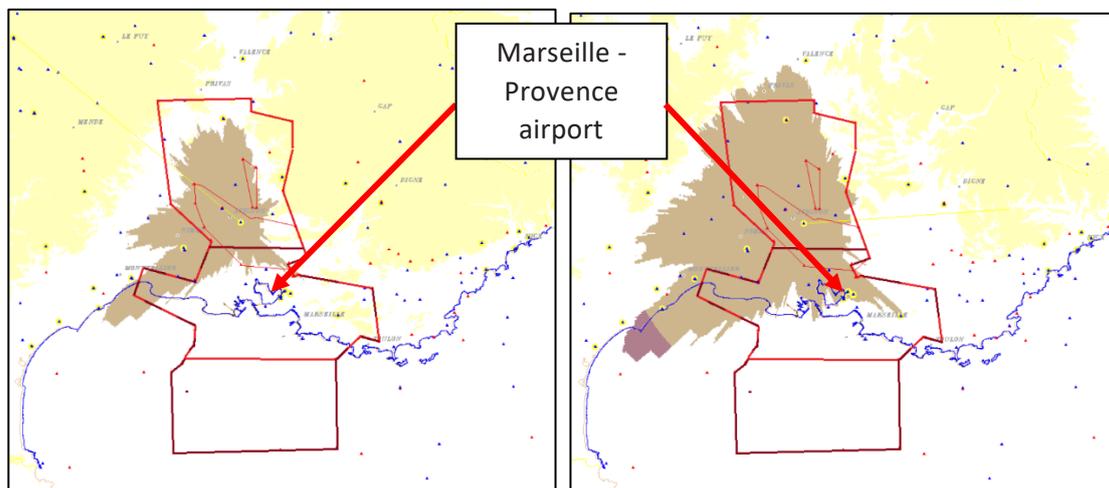
A study conducted in 2016 by the DSNA as part of the modernization of air-to-ground communications describes the coverage of the various transceivers. It can be noted that, due to the distance and terrain in the surrounding area, the transceiver in the northern sector of the TMA did not cover the position of Marseille - Provence airport at FL 015. Thus at the microlight’s altitude and position, its pilot could neither hear nor be heard by the Approach controller. He could only communicate with other aircraft within direct radio range.

Figure 4: in brown, coverage of Avignon transceiver at FL 015 on left and FL 030 on right (Sources: DSNA)

At 1,500 ft, overhead Marseille - Provence airport, the microlight was flying below the area covered by the transceiver in the northern sector of the Provence TMA. This lack of radio coverage at low altitude contributed to the read-back error not being recovered. After the microlight pilot switched to the Provence Approach frequency, he and the Approach controller were unable to communicate.
