**Accident** to the Airbus A320-214  
registered **F-HBNJ**  
on Wednesday 20 August 2025  
in descent to Ajaccio (Corsica)

**Flight through an area of severe convective turbulence,  
during descent**

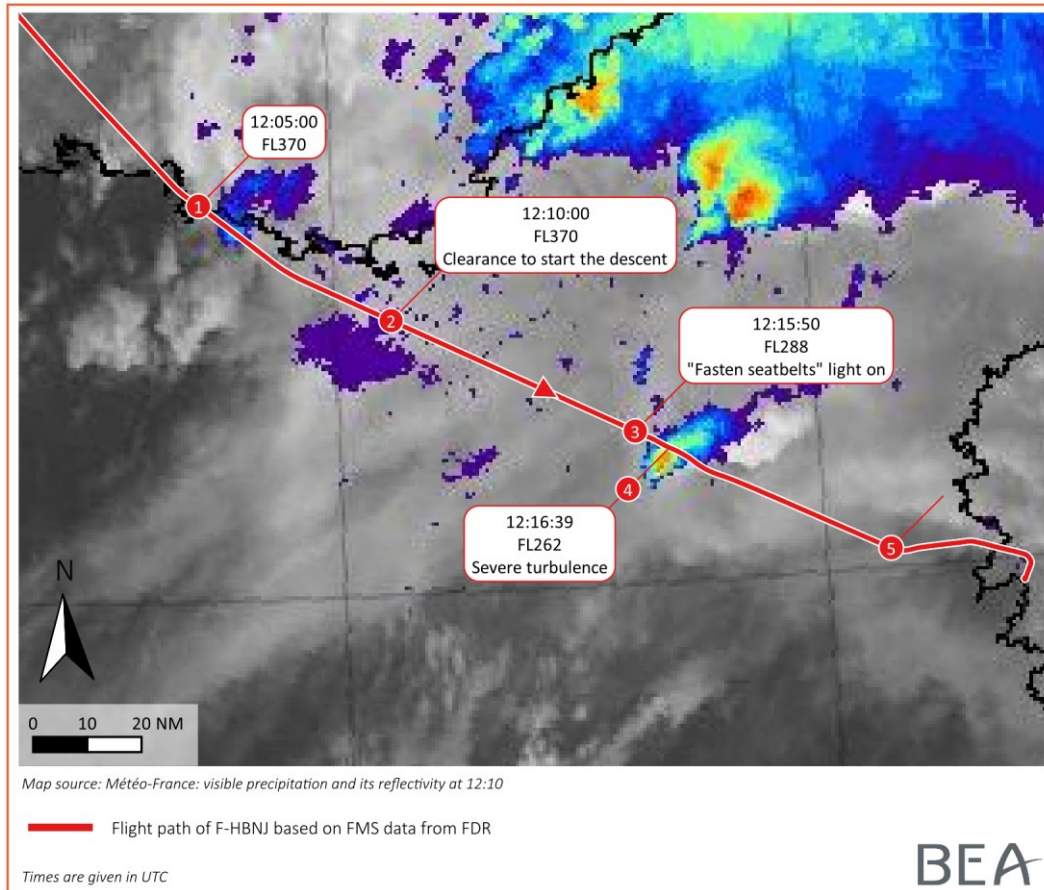
Figure 1: flight path of F-HBNJ from start of flight over sea

At 12:16:39, near FL 262, with a vertical speed of the order of -2,000 ft/min, the aeroplane entered an area of turbulence lasting thirty-one seconds, starting with four seconds of severe turbulence; the aeroplane then flew through a hail storm for twelve seconds (point ④).

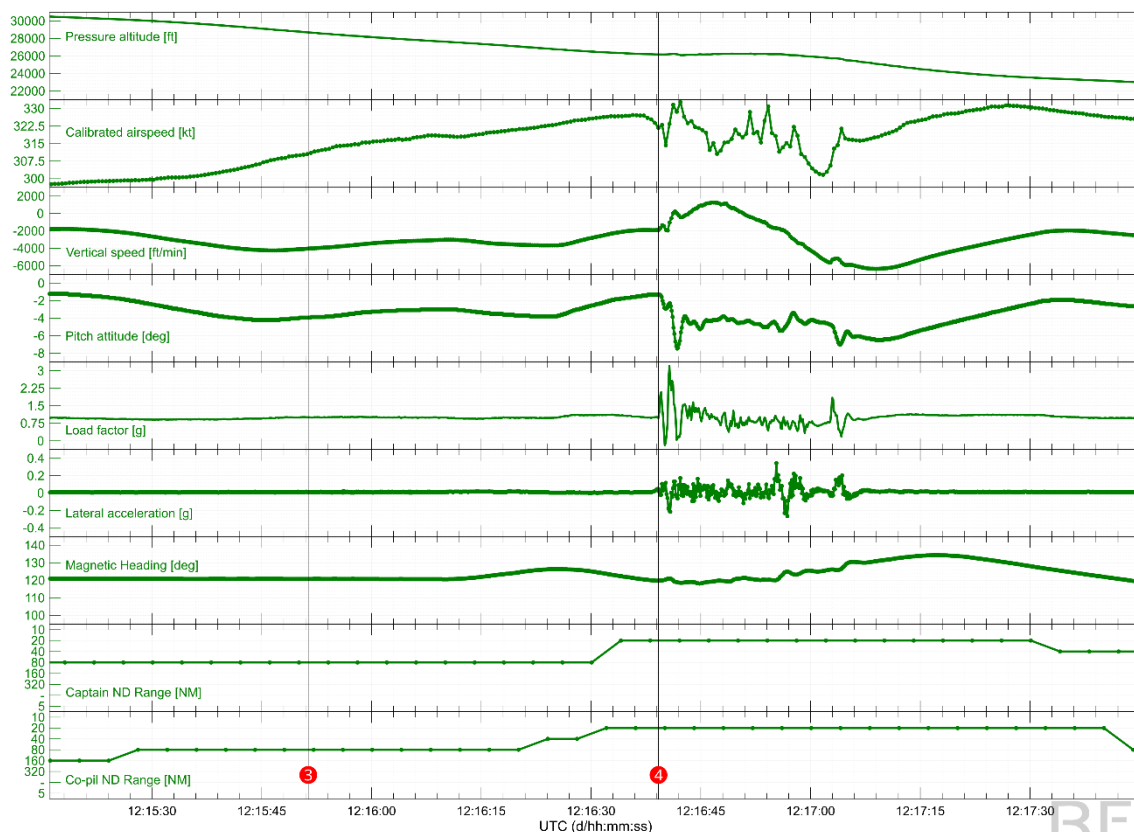
Figure 2: main flight parameters observed during turbulence

During the turbulence, the main parameters of the aeroplane (see Figure 2) varied as follows:

- load factor at the aeroplane's centre of gravity between -0.2 and +3.2 g;
- load factor at the rear of the aeroplane<sup>6</sup> between -0.4 and +3.5 g;
- lateral acceleration at the aeroplane's centre of gravity between -0.3 and +0.3 g;
- lateral acceleration at the rear of the aeroplane<sup>6</sup> between -0.5 and +0.5 g;
- calibrated airspeed between 300 and 335 kt;
- pitch between -1.5 and -7.5°;
- vertical speed between -1,300 and +6,000 ft/ min.

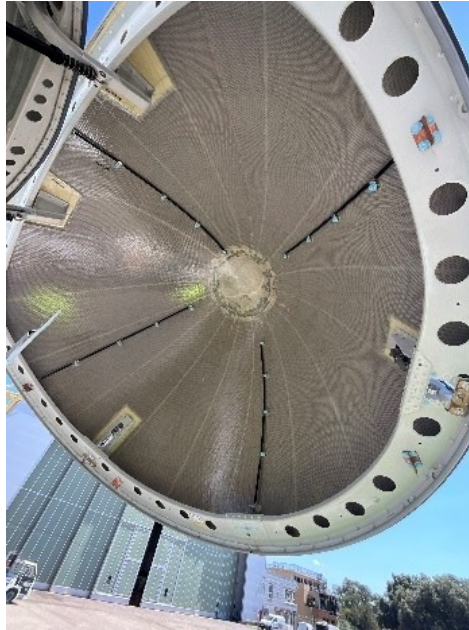
*Figure 3: damage on inner face of radome (source: Air France)*

The inner face of the aeroplane's radome was delaminated in the centre (area of light colour in **Figure 3** below). The manufacturer, Airbus, indicated that this was characteristic damage from hailstone impacts.

The operator carried out a detailed inspection of the aeroplane, in cooperation with the manufacturer due to the high level of in-flight turbulence encountered. No anomaly was detected. The aeroplane was returned to service after the radome had been replaced and damage in the cabin repaired.

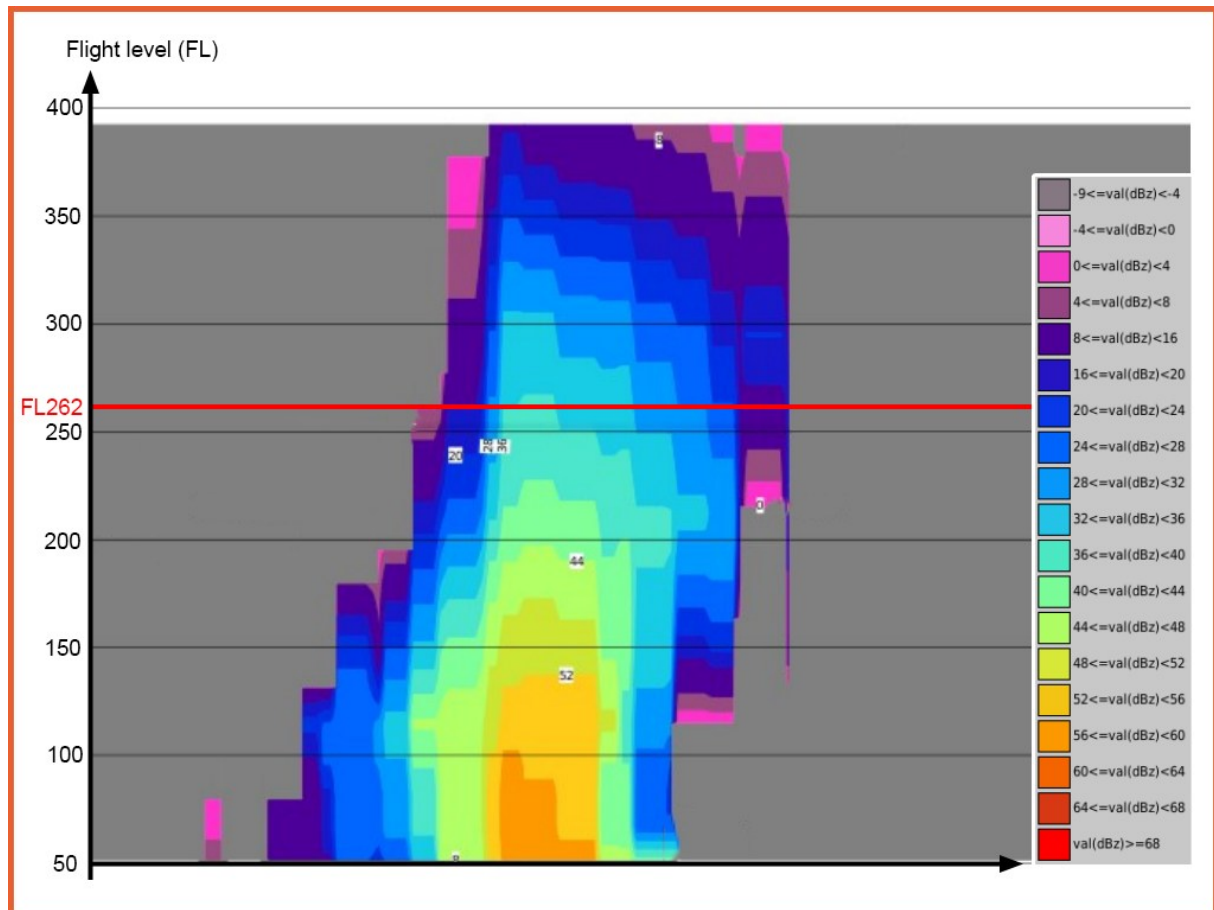
Figure 6: vertical profile of radar reflectivity field at 12:10 of convective cell on flight path of aeroplane, reflectivity scale on RH side (source: Météo-France)

The analysis of the data from the Météo-France ground precipitation radar concerning the convective cell which the aeroplane flew through at FL 262 showed:

- from 11:30:
  - light to moderate precipitation (reflectivity greater than 20 dBz) culminating at FL 210,
  - heavy precipitation (reflectivity greater than 40 dBz) culminating at FL 140,
- from 12:00, and notably 12:10:
  - light to moderate precipitation culminating at FL 350,
  - heavy precipitation culminating at FL 230,
- from 12:20, heavy precipitation culminating at FL 270.

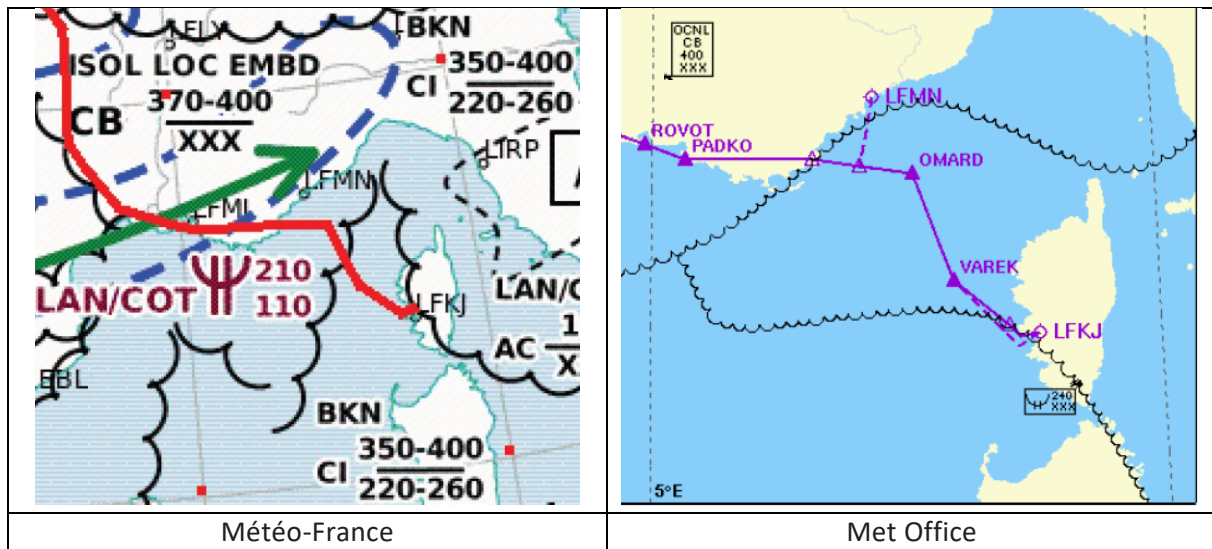
Figure 7 and Figure 8: excerpts from SIGWX charts, flight path specified in flight plan  
(source: Air France)

The Met Office SIGWX chart (see **Figure 8** below) did not mention the presence of isolated cumulonimbus embedded in the cloud mass in the area of the accident.

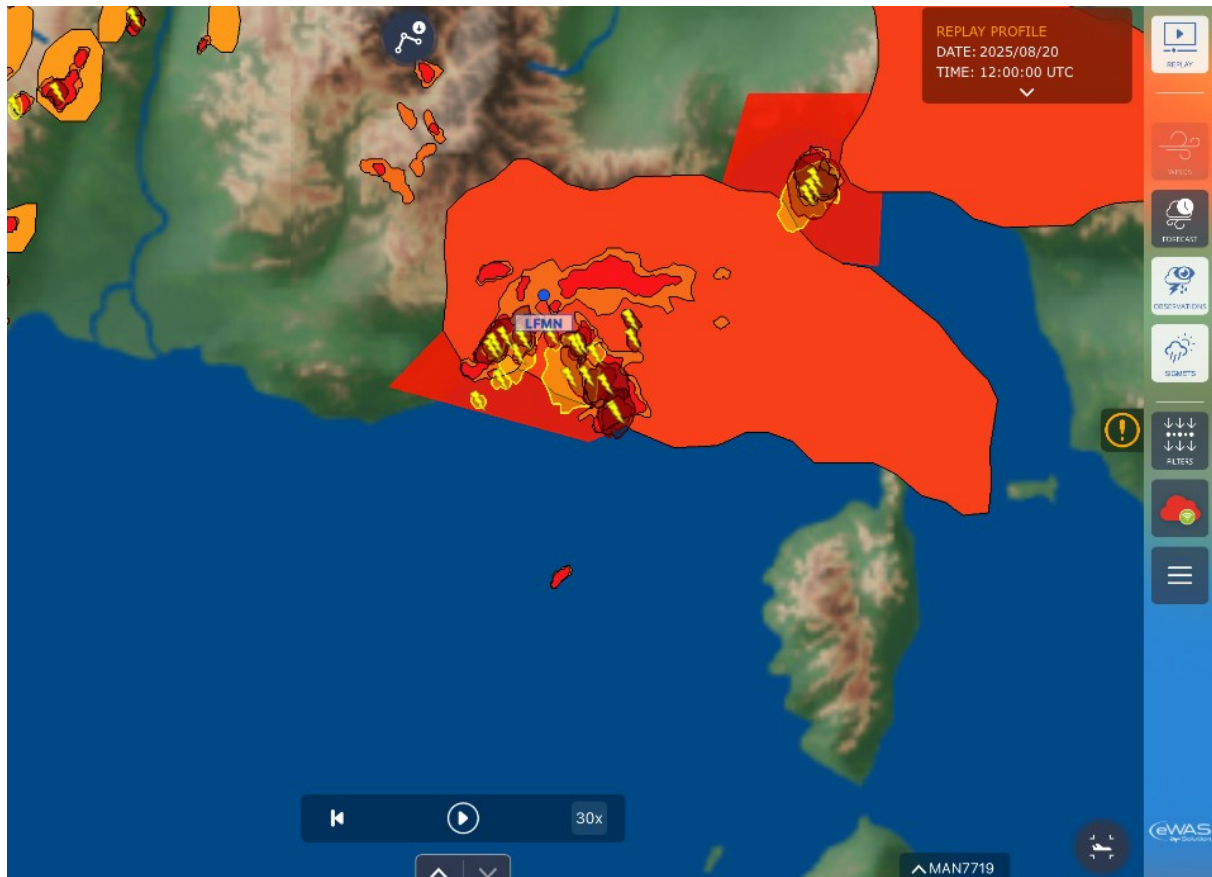
Figure 9: information available on eWAS at 12:00 (source: Air France)

The operator was able to provide the recreated image<sup>27</sup> available at 12:00 (see **Figure 9**), a few minutes before the briefing and around ten minutes before the start of the descent. It showed:

- the convective system off the coast of Nice mentioned by the PF in his statement;
- clear sea between the continent and Corsica except for the small, isolated convective cell off the coast of Ajaccio, the cause of the turbulence encountered. The information regarding this cell was: severe cumulonimbus observed between the ground and FL 310 from 11:40.
