**Accident** to the TECNAM - P2008 - JC  
registered **F-HBRD**  
on 20 May 2021  
at Messimy (Rhône)

## Loss of control in initial climb, collision with ground

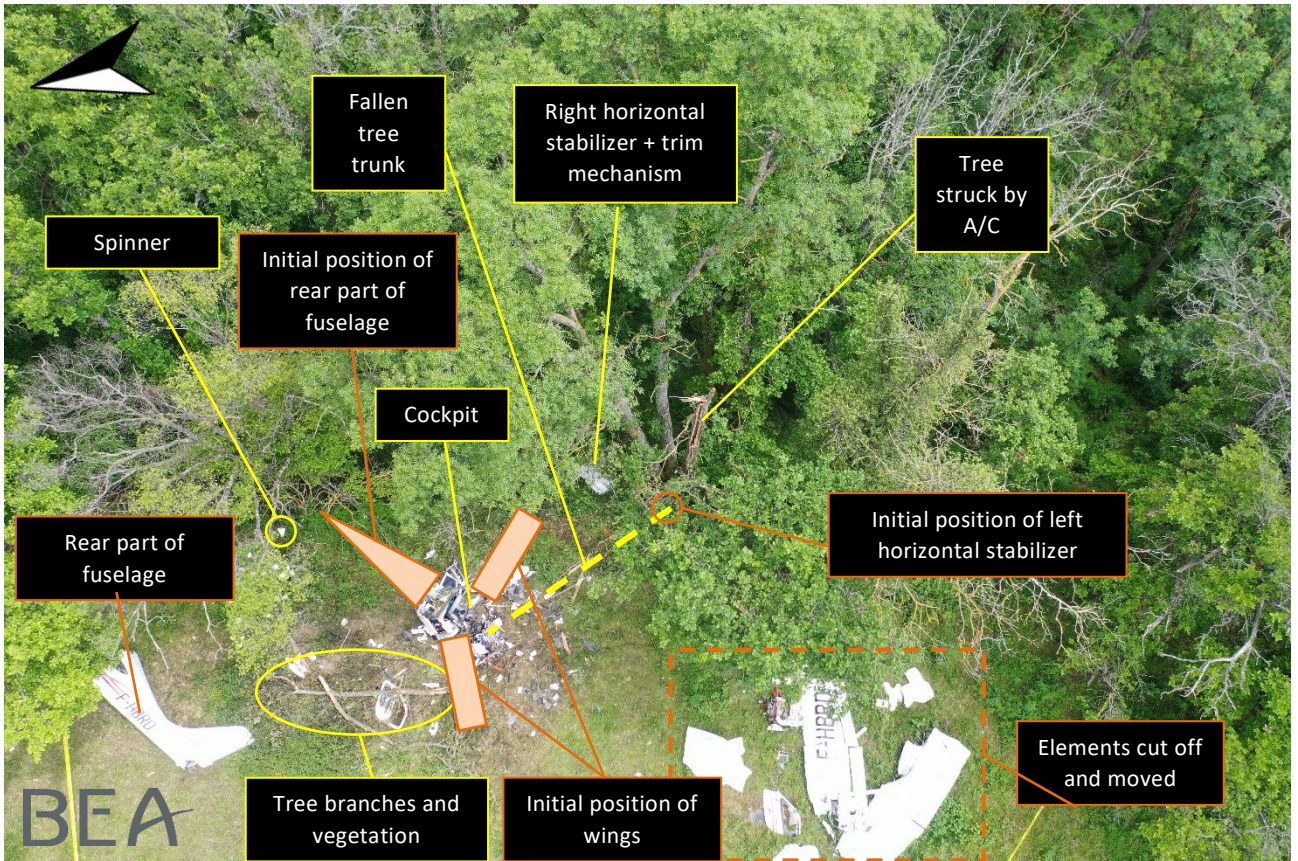
**Figure 1: aerial view of site**

The wreckage, oriented 168°, was lying between the edge of a field and the fringe of a group of trees at around 940 m from the south end of the runway at Lyon-Brindas aerodrome. The wreckage was complete and grouped together. Observations of the site and of the wreckage found that the leading edge of the aircraft's left horizontal stabilizer (in the area of the root) had struck a tree. This collision resulted in the two parts of the horizontal stabilizer being torn off. It was not possible to determine the attitude of the aircraft before the impact with the tree.

*In orange, the elements moved and their original position; In yellow, the elements not moved.*
